# Photo report

## wi\_8\_f\_2500\_r8\_MegaBore2014

Photo report 07.30.2014 / 14.10.2014 /21.12.2014  
CNC Fanuc 18i control exchange on Sinumerik 802 Dsl  
"Hans-Peter Widmer"

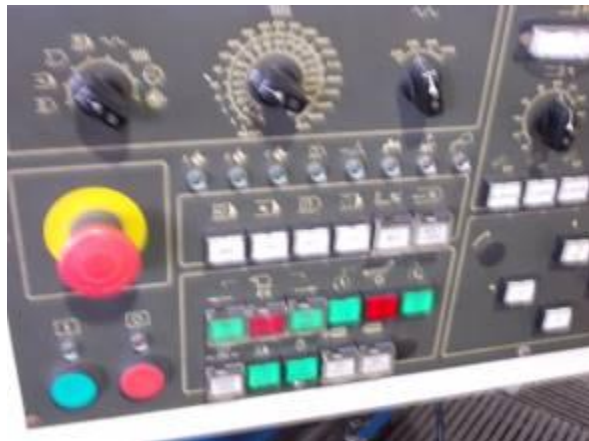
P3) The old Fanuc panel is replaced.

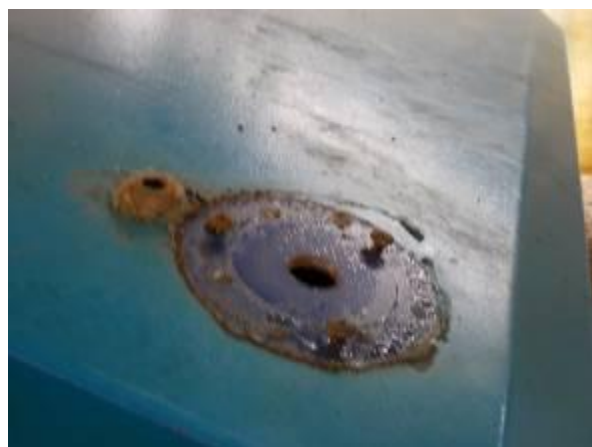
P1) That was a lamp. Above where the screw was a hole. That was the reason why the CNC Fanuc 18 i was destroyed.

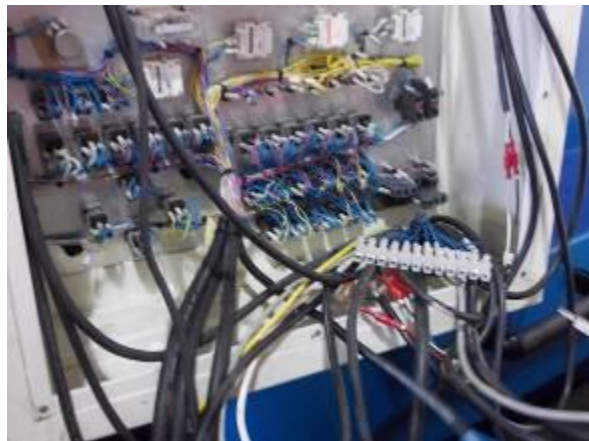
P4) Interior of the old panel. It is remarkable that here a 50-pin cable connects to the front CNC CNC rear. We will replace this with a Profibus cable, 2-pole.

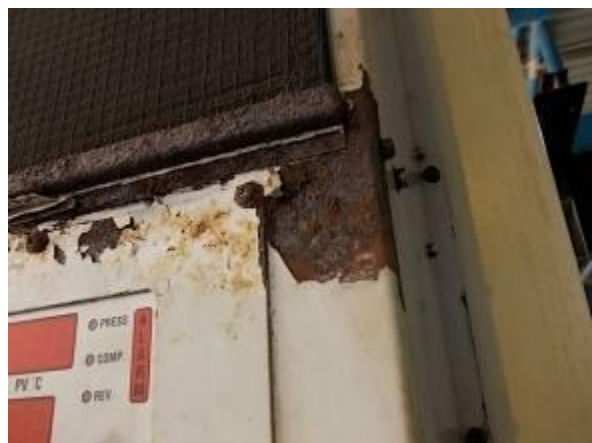
P2) The extremely harsh climate in Angola, see the devices cheaply produced in 2 years from then.

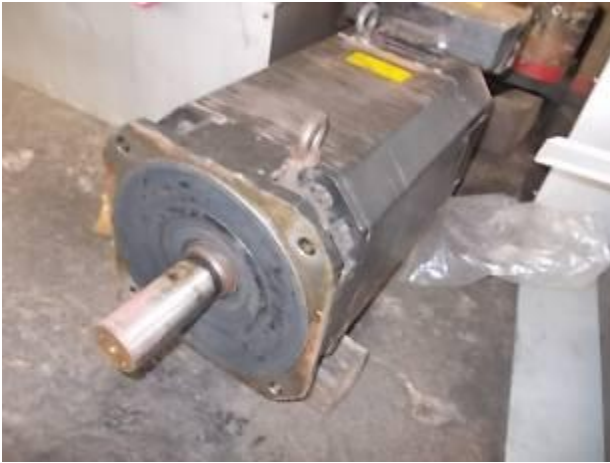
P12) The Fanuc spindle motor seen in Angola after a short period of use, very battered. The climate is very strong here. Impellers crumble in the rule.

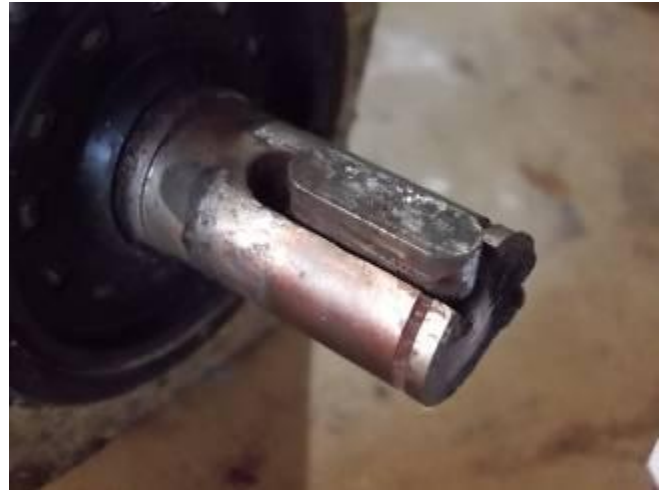
P27) The Fanuc encoder has much fretting because it's mounted without Achsflechtfehler clutch. So how do we do it with the donors that we build on the Siemens CNC.

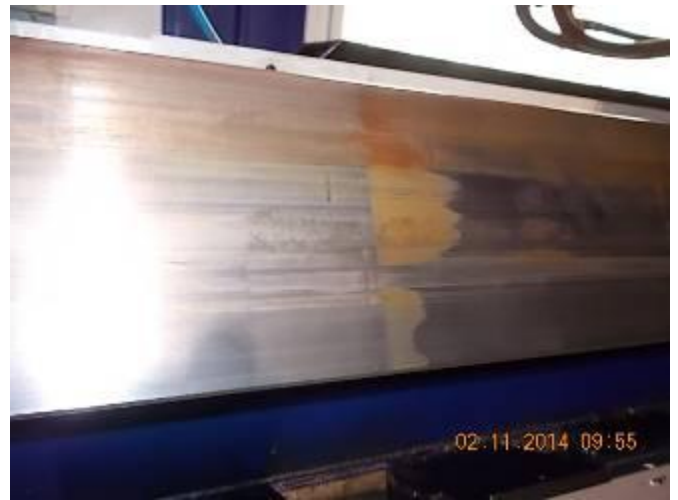
P39) The machine has a faulty lubrication. Only when oil came, the brown sliding coating abrasion appeared.

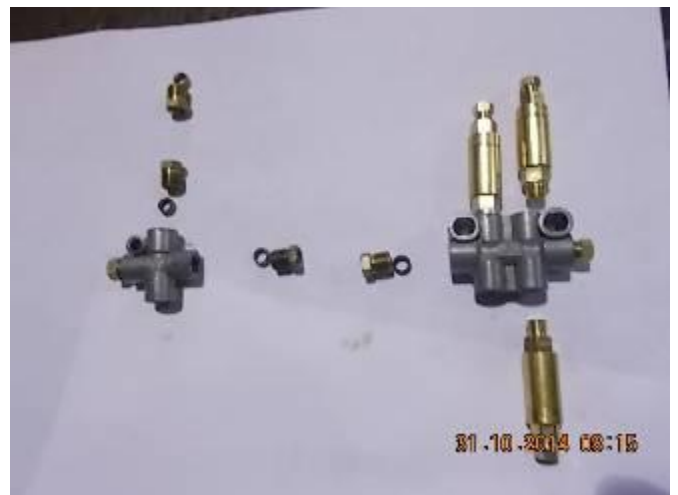
P41) Lubrication tag. The ball screw gets a double quantity of oil.

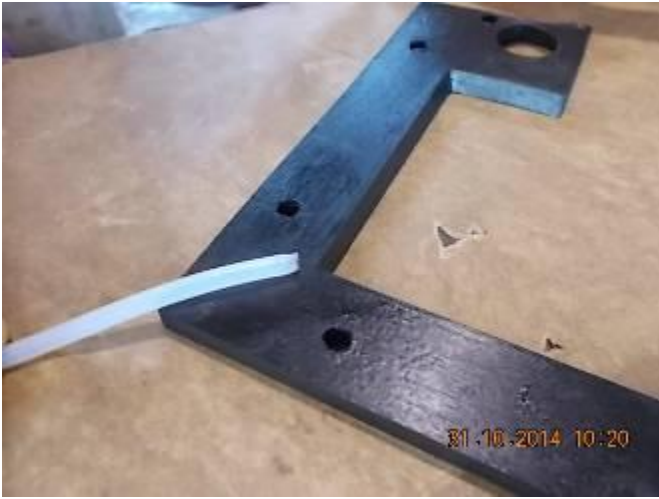
P42) Additional lubrication points for the Z-axis. Normal makes a good mechanical engineer at short stroke machines more lubrication points in the travel axis. Mega Bore made only in the Z axis. If again thread is cut with a moving stroke of less than 200 mm, the carriage is long, inadequately lubricated by only one lubricating point. We now represent 3 lubrication points per track. Ideal would be 5 lubrication points for the long carriage. Dch then we would have to remove the slide.

control. The X-axis got too much oil, the Z axis far too little. That's why now is the 2nd spindle Kugelroll- already back defective. She sounds like a tractor transmission.

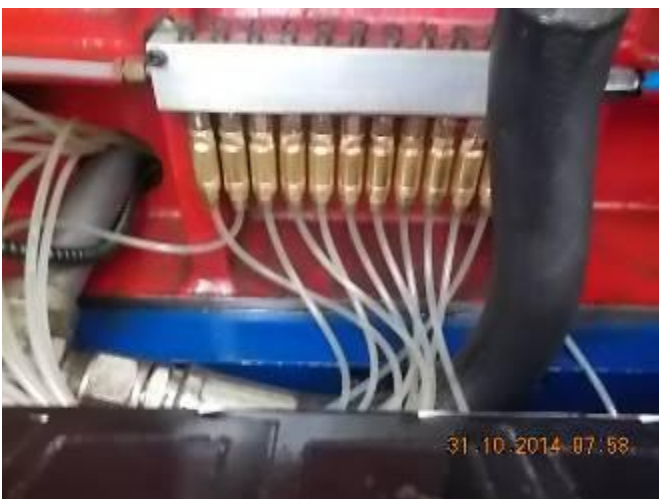
P44) New Dossier unit for controlled lubrication. The CNC lathe Mega Bore has just oil pumped, without volume

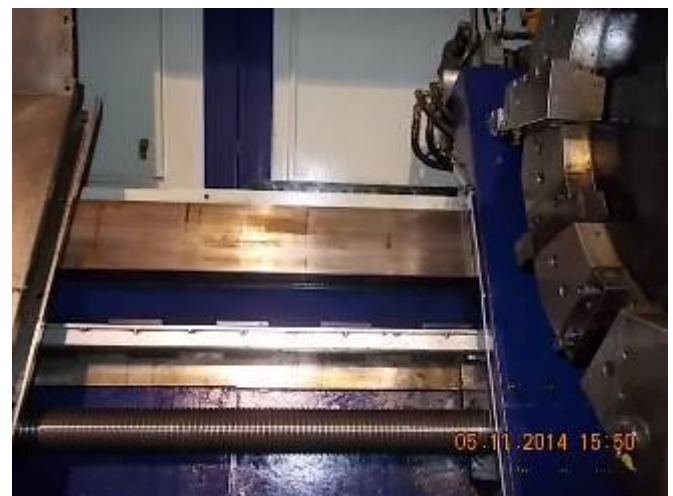
P46) The more oil came, the more wear of the sliding coating came out because it ran dry a long time.

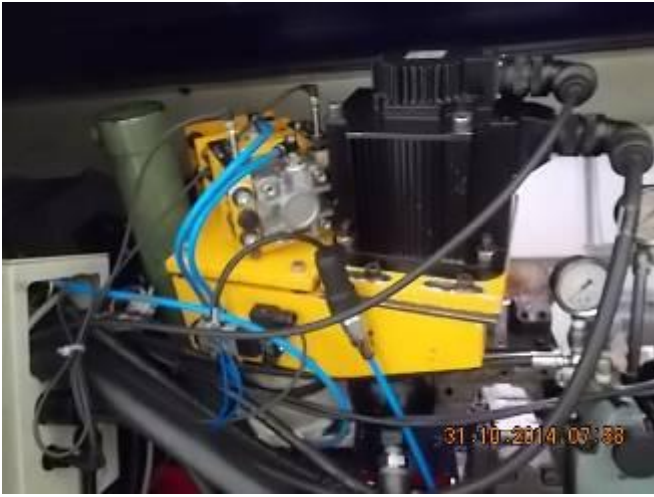
P47) New X braking system

Hydraulic hoses are damaged badly, as they were contaminated to a hard edge.

Lubrication is replaced by a pulse lubrication so that all lubrication points are also working properly.
