Photo report CNC machine headstock torn WU230

Photo report remodeling CNC lathe WIAP a partner for many projects

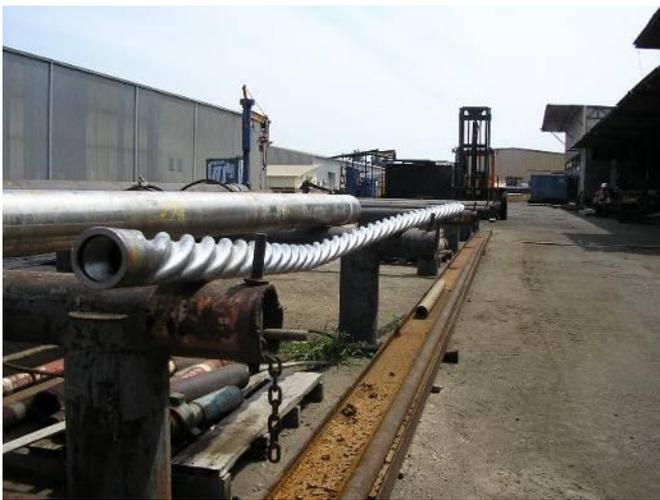
At the Oilfield CNC lathe Opera Expensive have started accidentally high speed. A rod buckled and tore away from the rear feed. It had to be ordered a new headstock. It was several months to return the machine could be used.

Figure 1: This workpiece was clamped on the fly in the CNC turning machine, the back of the lining about 4 feet to rotate freely. Only under special circumstances was finally told me, how the accident actually happened. Then broken a blast machine.

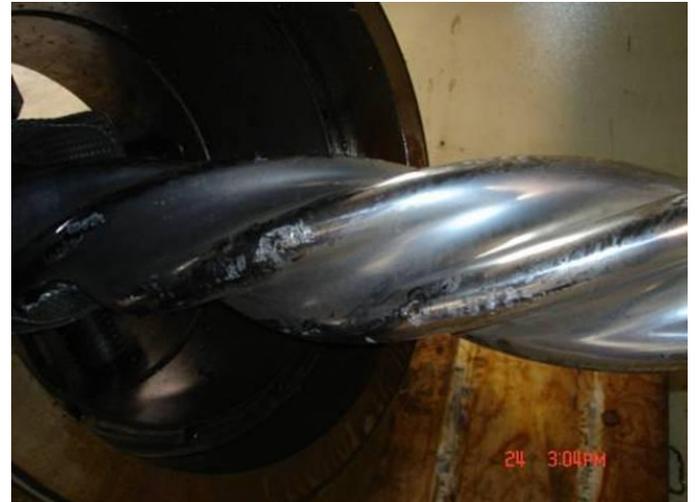
Figure 2: The defective spindle.

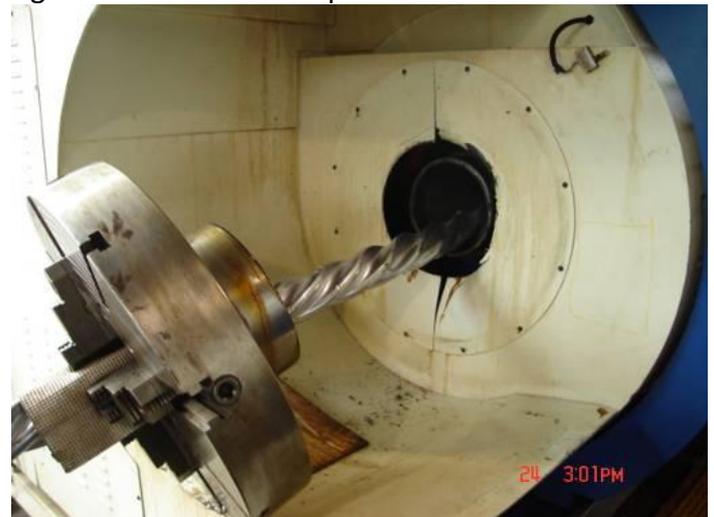
Figure 3: The broken stem. A damage over USD 100`000.- Please see the new report describing the revision. Thank you.
