Photo report

wi_8_f_2500_r8_MegaBore2014

Photo report 07.30.2014 / 14.10.2014 /21.12.2014
CNC Fanuc 18i control exchange on Sinumerik 802 Dsl
"Hans-Peter Widmer"

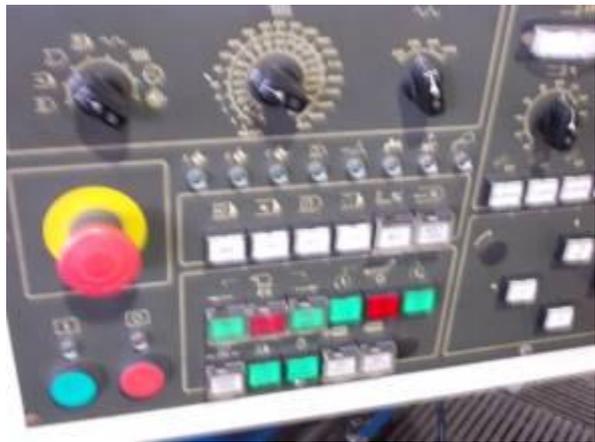
P3) The old Fanuc panel is replaced.

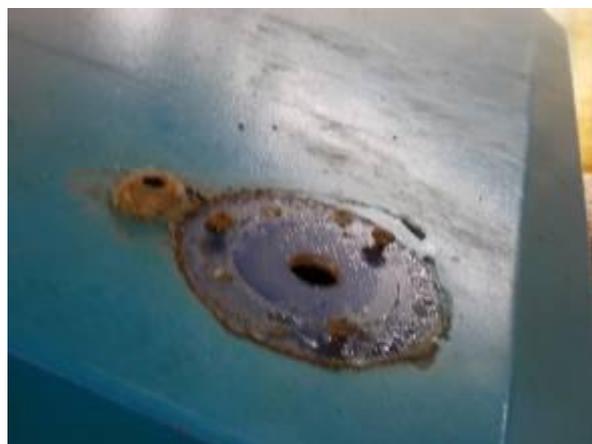
P1) That was a lamp. Above where the screw was a hole. That was the reason why the CNC Fanuc 18 i was destroyed.

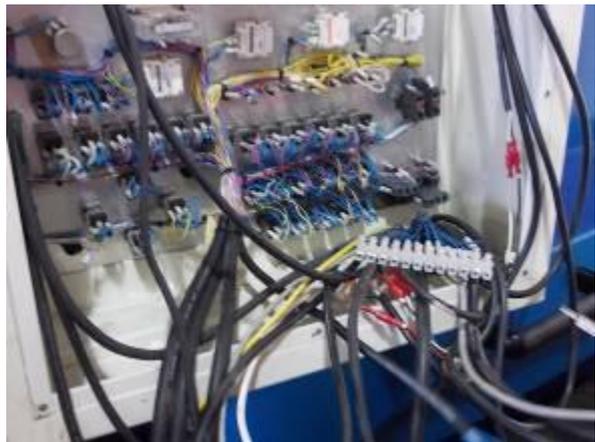
P4) Interior of the old panel. It is remarkable that here a 50-pin cable connects to the front CNC CNC rear. We will replace this with a Profibus cable, 2-pole.

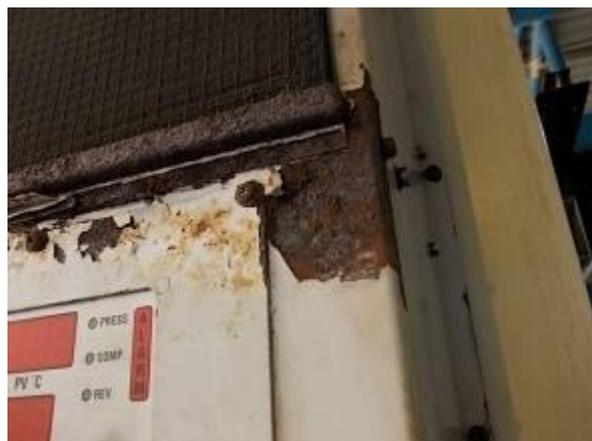
P2) The extremely harsh climate in Angola, see the devices cheaply produced in 2 years from then.

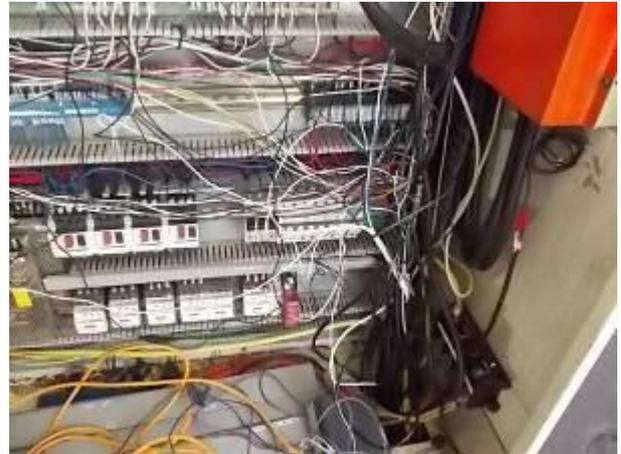
P9) Mixed and cable networks. Strikingly, the manufacturer has the 0 head, as well as power, made for the 220 volt with various colors. Cables were too short, have been extended with cables of different colors. Some in the cable channel were soldered together!

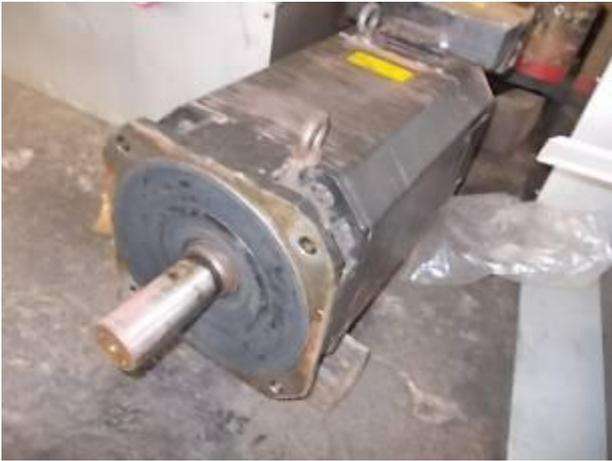
P12) The Fanuc spindle motor seen in Angola after a short period of use, very battered. The climate is very strong here. Impellers crumble in the rule.

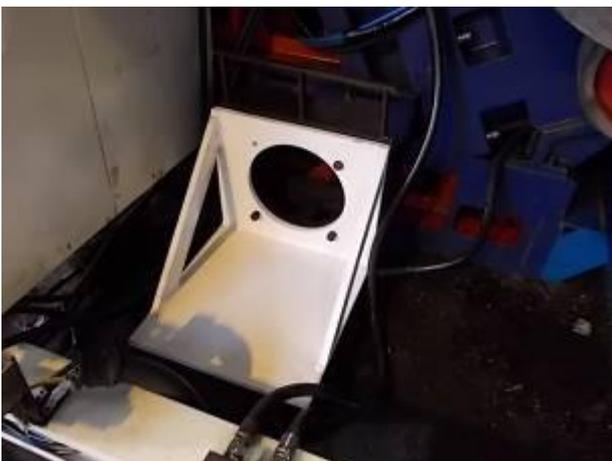
P14) Since the new motor is a motor foot, we had to make a standing frame hole. We install the same engine on all machines. Thus, the spare parts inventory is easier.

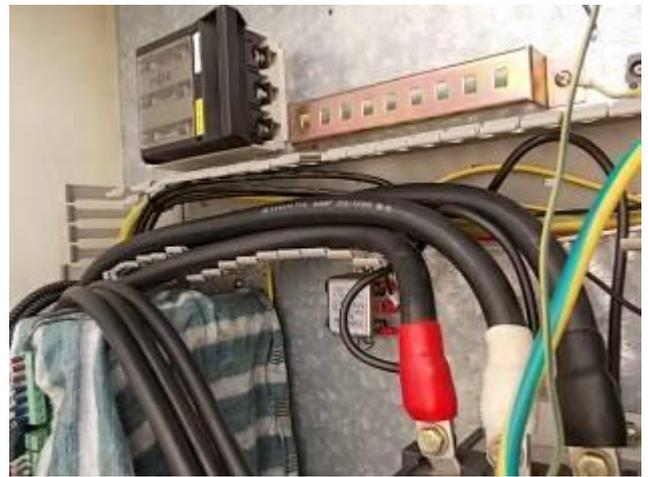
P21) Here we make the security system underst, more safeguards. No thin and thick wires without protection.

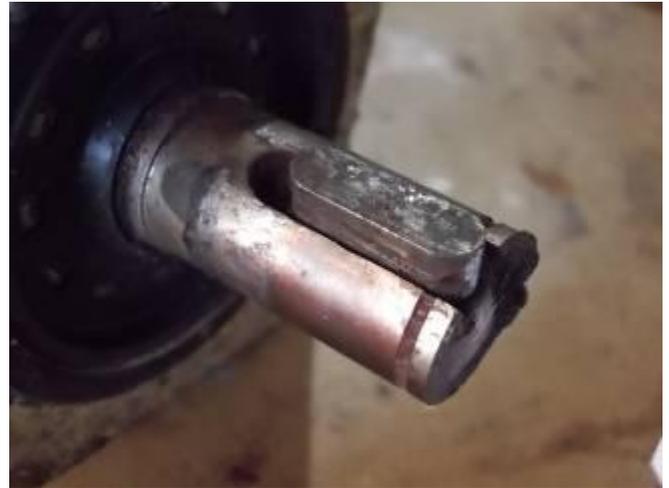
P27) The Fanuc encoder has much fretting because it's mounted without Achsfuchtfehler clutch. So how do we do it with the donors that we build on the Siemens CNC.

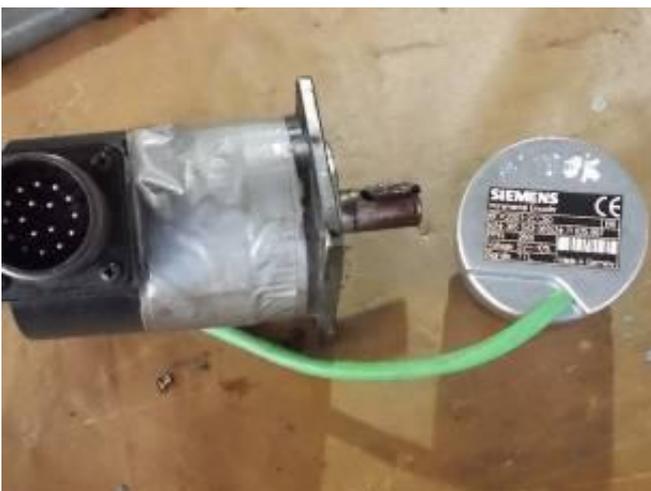
P26) The old Fanuc encoder (left) is coming off. A new (right) is mounted.

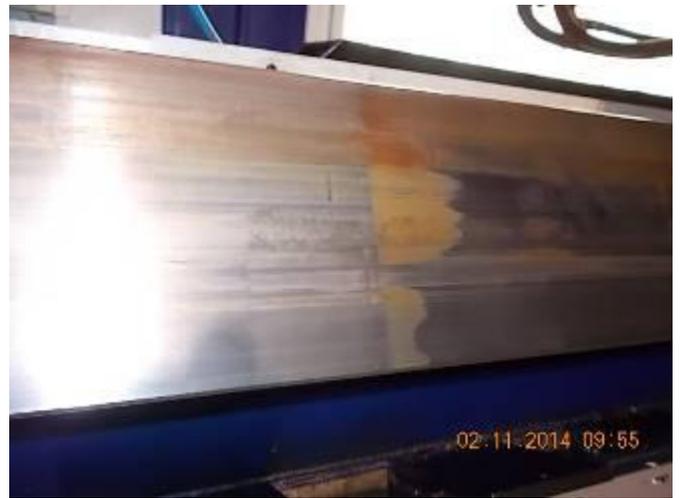
P39) The machine has a faulty lubrication. Only when oil came, the brown sliding coating abrasion appeared.

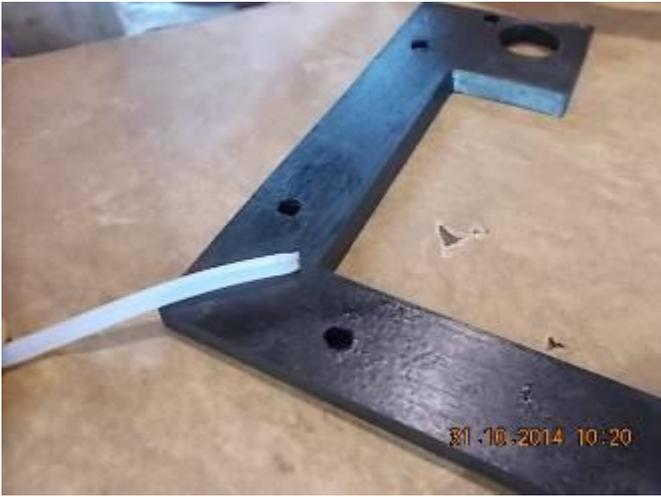
P42) Additional lubrication points for the Z-axis. Normal makes a good mechanical engineer at short stroke machines more lubrication points in the travel axis. Mega Bore made only in the Z axis. If again thread is cut with a moving stroke of less than 200 mm, the carriage is long, inadequately lubricated by only one lubricating point. We now represent 3 lubrication points per track. Ideal would be 5 lubrication points for the long carriage. Dch then we would have to remove the slide.

control. The X-axis got too much oil, the Z axis far too little. That's why now is the 2nd spindle Kugelroll- already back defective. She sounds like a tractor transmission.

Leadership of the Z-axis to run dry. Also rust. Lubrication must have stopped working properly for a long time.

Z ball screw makes extremely loud noises. It must be replaced. Again, the lubrication was dry. You must be replaced with units Dossier

Lubrication: The ball screw of the Z-axis has too little lubrication. The 2nd spindle is noisy, it must be ordered a replacement. The Z-guide has strong corrosion. The lubrication must be extended with 2 more lubrication points. It has only one lubricating point in the Z axis. The headstock makes off at various speeds and comic resonance noise. Bearing damage is not excluded. At least one bearing bias voltage may not be enough available, which explains the vibration.

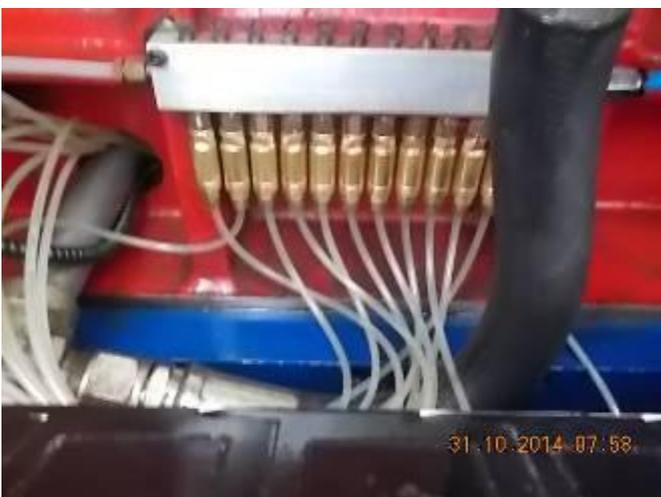
P44) New Dossier unit for controlled lubrication. The CNC lathe Mega Bore has just oil pumped, without volume

Lubrication is replaced by a pulse lubrication so that all lubrication points are also working properly.

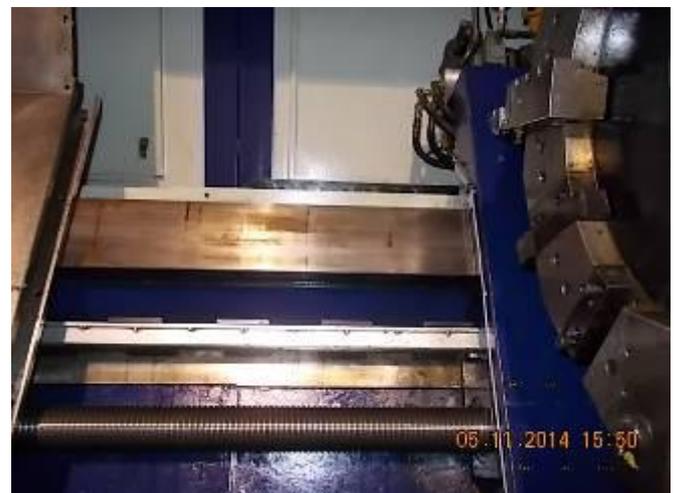
P46) The more oil came, the more wear of the sliding coating came out because it ran dry a long time.
