Photo report WU_232

Photo report Angola remodeling Mega Bore Oil Field Lathe WU232

Control exchange Fanuc 18i on Sinumerik 802D sl

A hole in the casing of the Mega Bore CNC machine has caused damage to the water control Fanuc 18i. It was so complicated by the spare parts warranty and the support of the manufacturer's control, that we decided to replace the CNC control incl. All engines with a new CNC control Sinumerik 802 D. We had no spare parts of Fanuc's stock and control, even after the third time in Fanuc repair, still not running. The respective repair costs with screen replacement and CPU did not lead to the goal. The stoppage lasted nearly 3 months. After the conversion decision, the machine was running in 2 weeks. The electric plans everything in Asian writing to the PLC program text. nevertheless it went well thanks to the experience of the many CNC machines that are already in use in Europe.

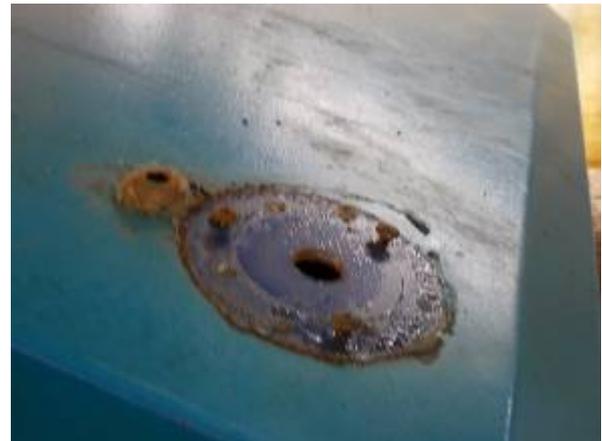
WU_232_10

Figure 1: Here was a lamp. Above, where the screw is, there was a hole through which at leaking roof by a storm, the CNC control Fanuc was 18 i destroyed.

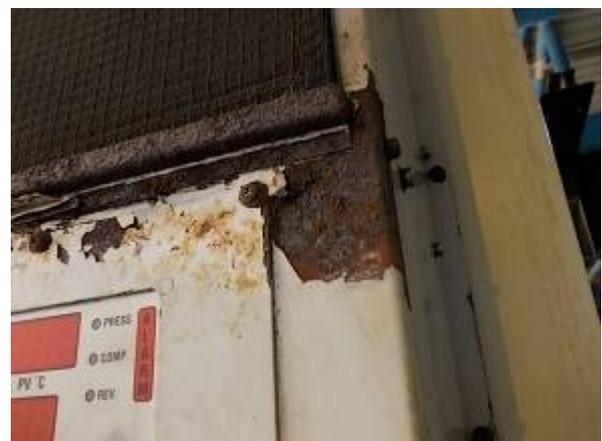
Figure 2: Due to the climate in Angola see the devices cheaply built like this in 2 years. Good to know from which countries better and from which countries, comes lower quality. WU_232_20

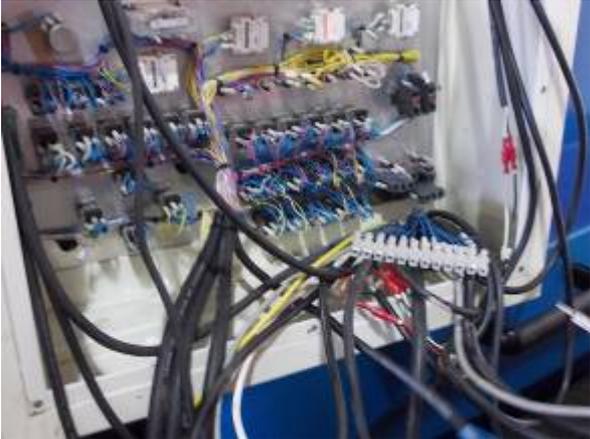
Figure 4: Here is the inside view from the old panel. It is striking that the CNC is connected to a 50-pin cable. We will replace it with a 2-pole Profibus cable. WU_232_40

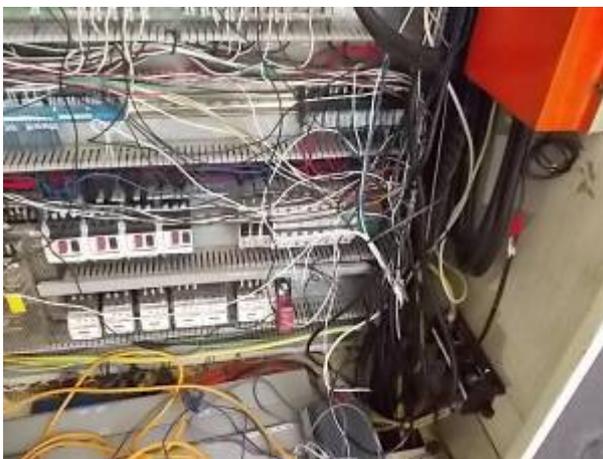
Figure 9: Mixed cable networking. It is striking the machine manufacturer has the 0 conductor and the supply with various colors wired for 220 volts. Cables that were too short were extended in the

electrical cabinet with cables with different colors. Recognized quality assurance for machines to Africa is not very good. WU_232_90

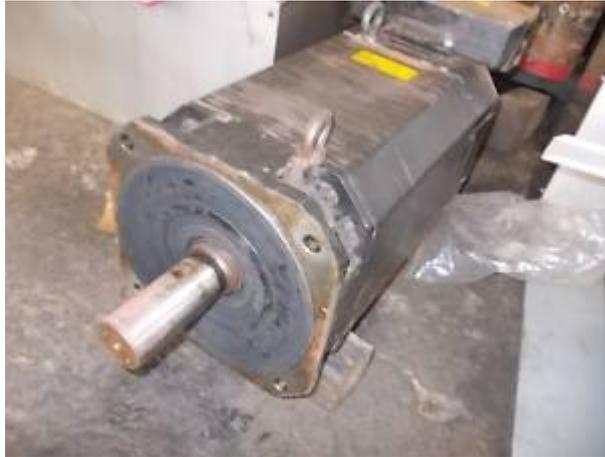
WU_232_120

Figure 12: The Fanuc spindle motor seen in Angola after a short period of use very battered. The climate is very angriffig here it verfrisst almost all products.

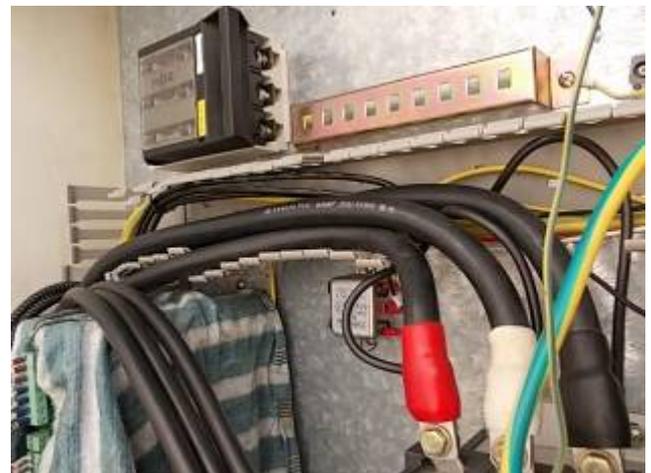
Figure 27: The security system is improved. No wires without protection. WU_232_210

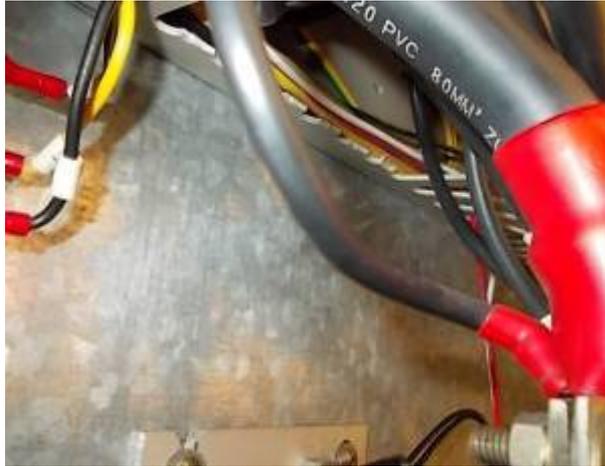
Figure 28: Front 80 mm / 2; rear 10 mm / 2. Unsafe we close the 10 mm / 2 directly to a backup. WU_232_220

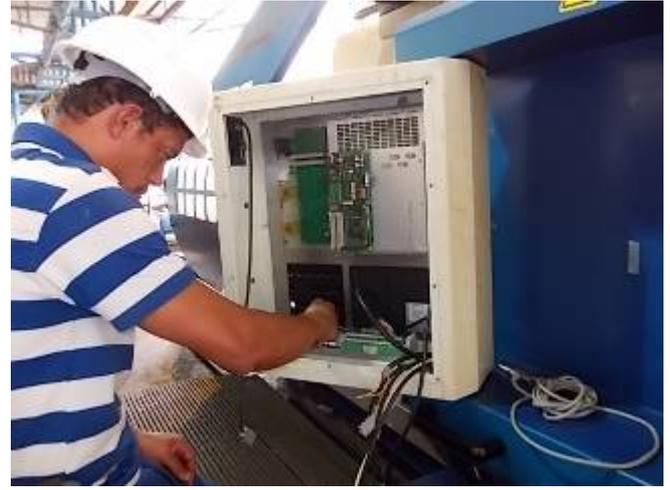
Figure 32: The old Fanuc encoder is missing. A new one is installed.
WU_232_260

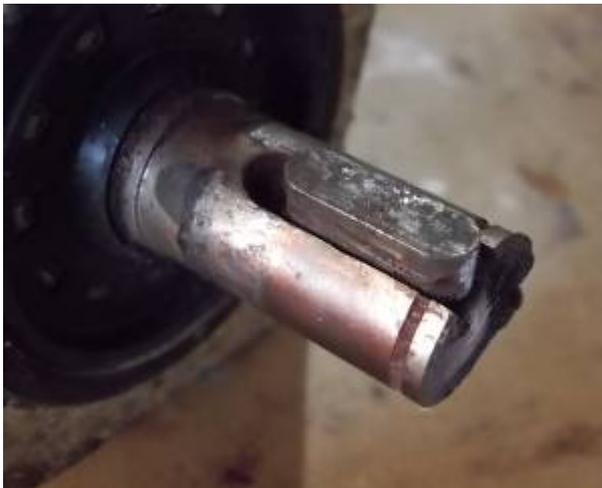
Figure 33: The Fanuc spindle encoder has a lot Pass rust because it was installed without Achsflechterfehler clutch. The shaft and the Pully did not look good. We have installed the encoder with a misalignment compensation. WU_232_270

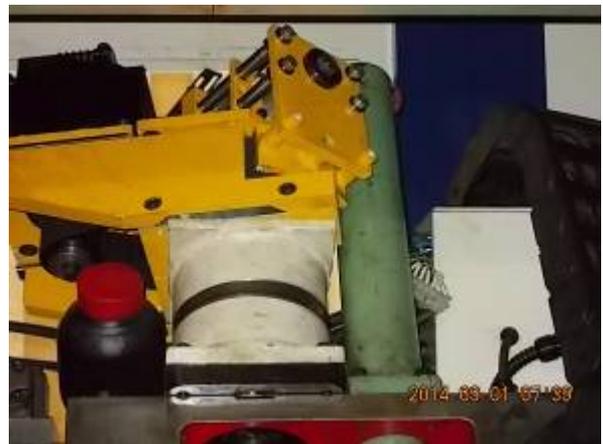
Figure 39: The X motor with the new brake. The brake was made, so that everything can be used the same feed motors.

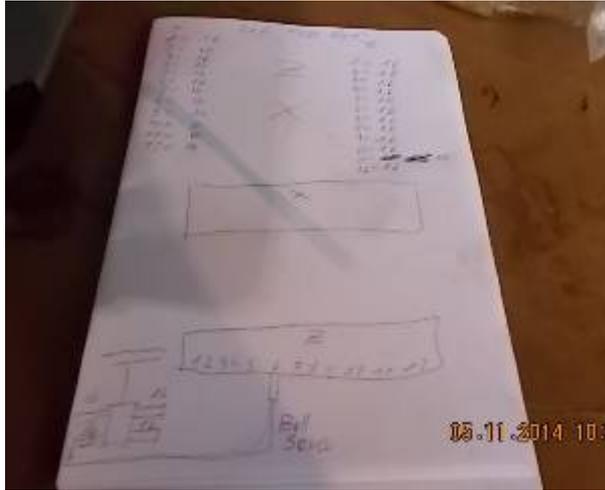
Figure 45: New lubrication schedule. The maintenance people in education have had to draw everything. Under grips with 0:06 quantities. Large areas with file units of 0:16 and the ball screws with the double amount of 0.32

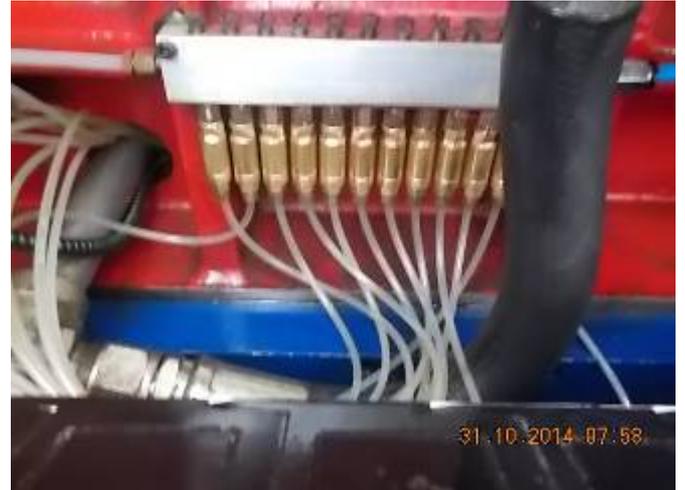
Figure 47: New Dossier unit for controlled lubrication. The CNC lathe Mega Bore simply pumped oil, without volume control. The X axis got too much oil, the Z axis far too little. That is why now spindle already again broken the second Kugelroll-. It sounds like a tractor transmission.

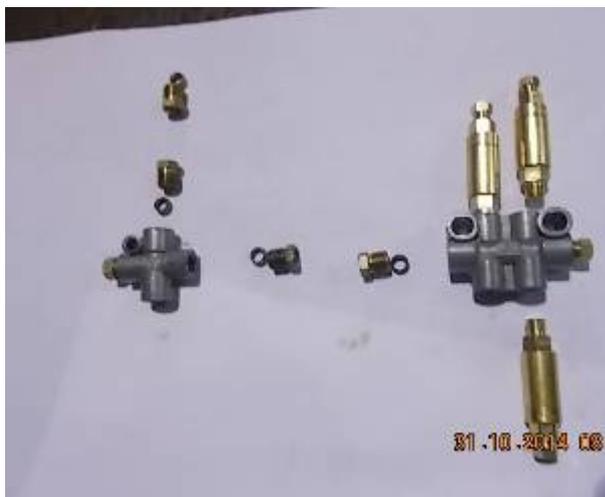
Figure 46: Lubrication remodeling. The ball screw gets a double amount of oil.

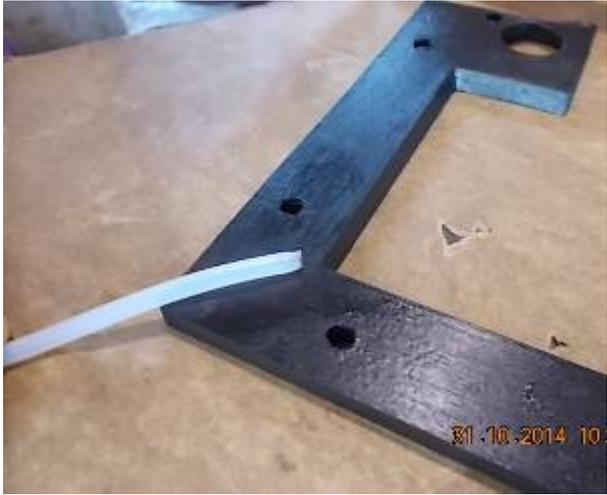
Figure 49: Additional lubrication points for the Z-axis. Normal makes a good mechanical engineers in short-stroke machines more lubrication points in the traverse axis. Mega Bore made only in the Z axis. Now, if ever thread is cut with a moving stroke of less than 200 mm, the long slide with only a lubrication point is lubricated insufficient. We now made three lubrication points per guideway. would be ideal for the long slide 5 lubrication points. But then we would have to dismantle the slide.

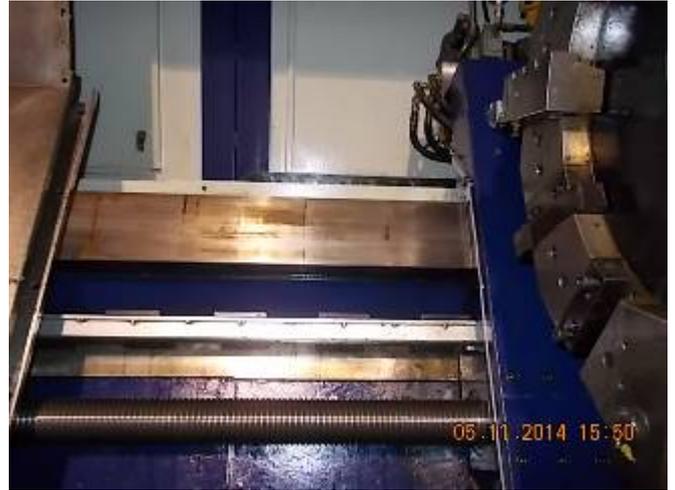
Figure 51: The more oil came, the more abrasion of the sliding coating came out because it ran dry a long time.

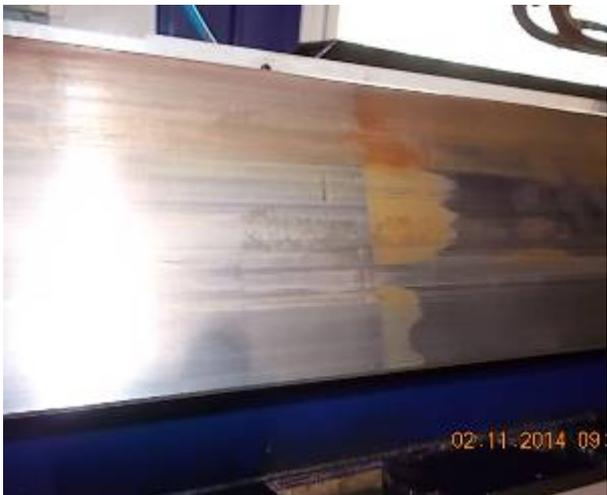
Figure 50: The machine has a faulty lubrication. Only when oil came, the brown sliding coating abrasion appeared.
