Photo report WU 125 Bank 11

Roll lathe Hercules revised by the WIAP AG

Created hpw 02_12_2018

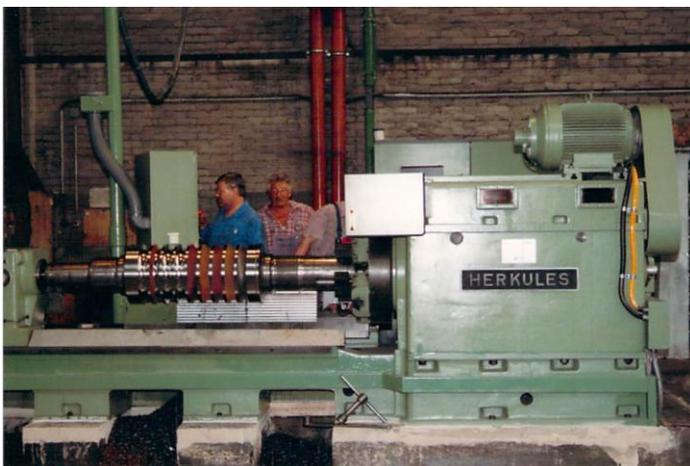
Figure 1: This roll lathe Hercules is very robust built. We had in the Z-axis 80 mm ball screws installed because extremely high forces arise when four steels are simultaneously engaged.

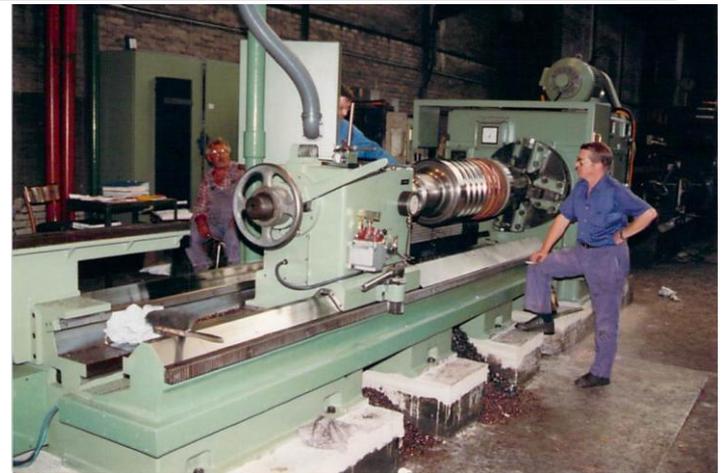
Figure 2: The sub base is being filled with cement, so that the vibrations are damped and that with special cement, which behave properly when dehydration.

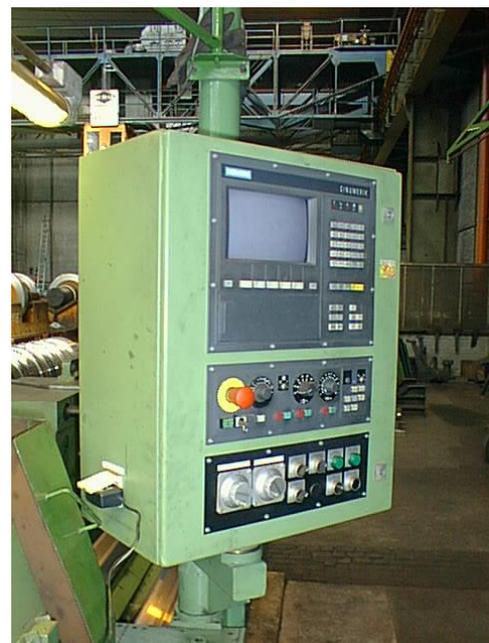
Figure 3: The CNC Sinumerik was equipped with a special program. The WIAP developed parameterized special programs, so that the operators, some of which were about to board, without expertise, respectively. very easily could operate this machine after reconstruction CNC experience.

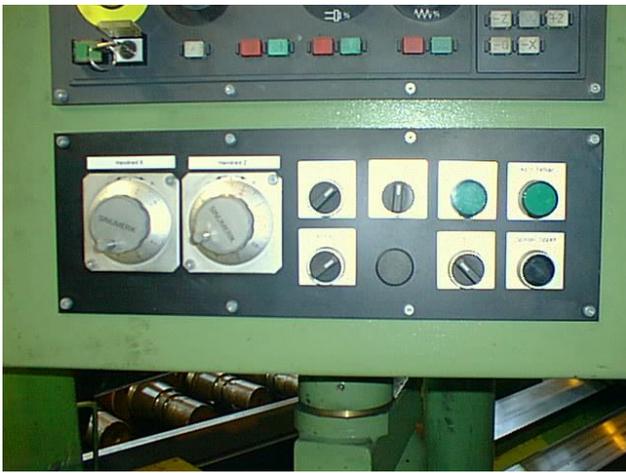
Figure 3: The two axes X and Z have a hand wheel for better scratching at the tool zeroed.

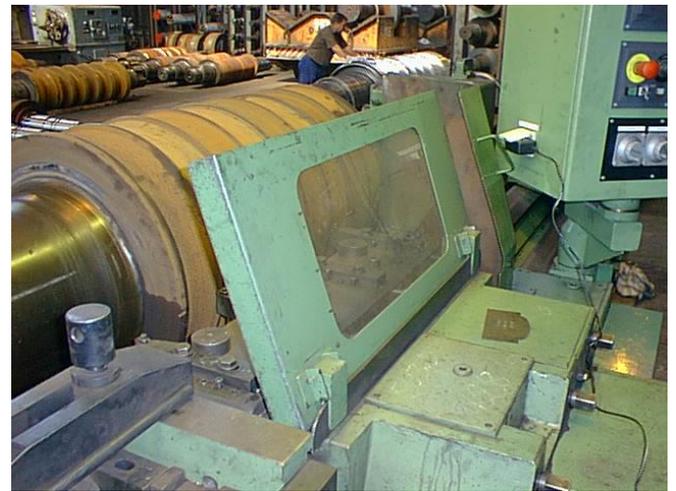
Figure 5: The material is very hard. The speed was slow with ceramics. It was good to hear how hard the rolls were.

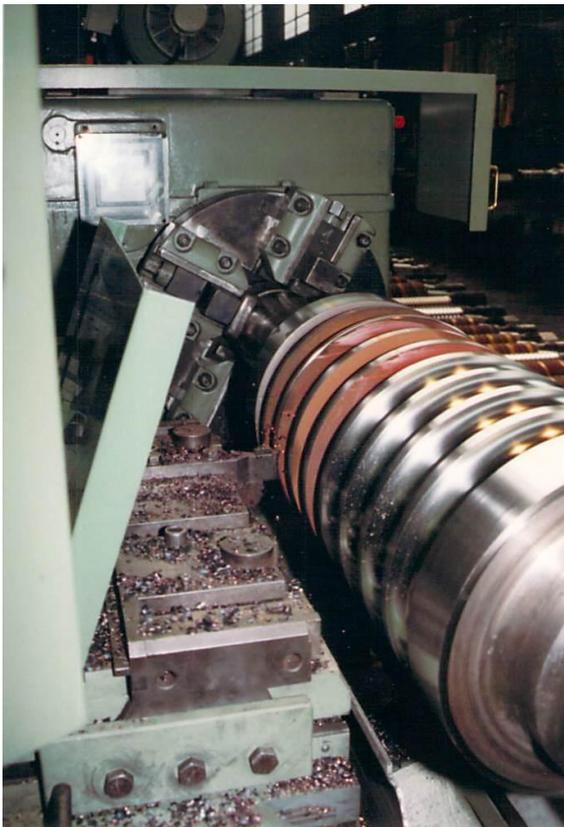
Figure 4: Normal 4 steels were engaged simultaneously. Program test was only one in use.

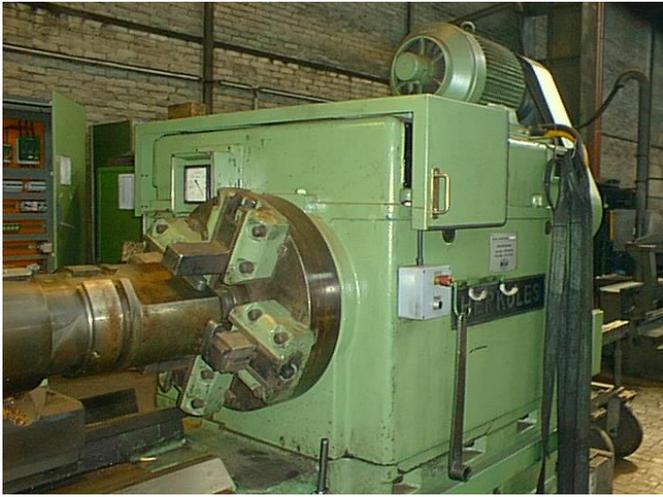
Figure 8: The claws box has the WIAP all revised so that the machine almost like a can work new machine. Often even better than a new one, because today a lot is no longer built as sturdy and stable, as in the old machines.

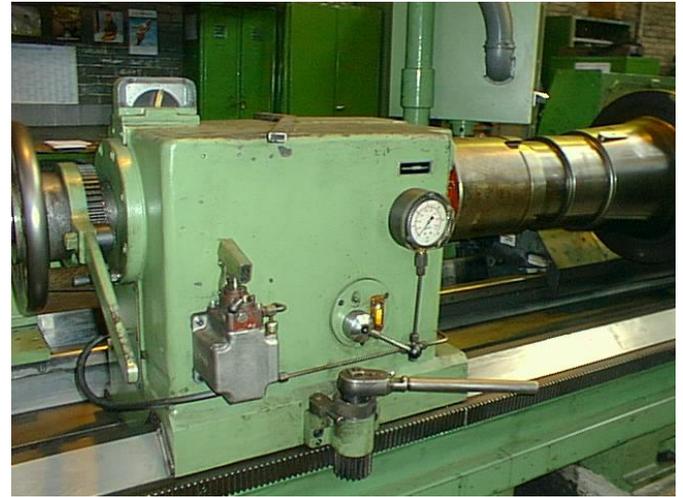
Figure 10: The tailstock has to go out the rollers from the claws box, always unclamped with an extremely good clamping and are then moved back. The hydraulic always had to be revised in all machines, because there was leakage, which complicated the handling.

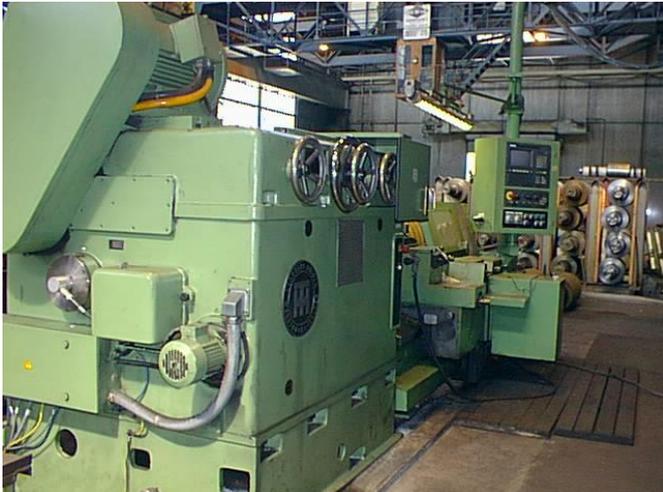
Figure 9: Extremely robust and stable is the headstock. The new spindle motor was put back on the headstock and electrically designed for stepless speed regulation.

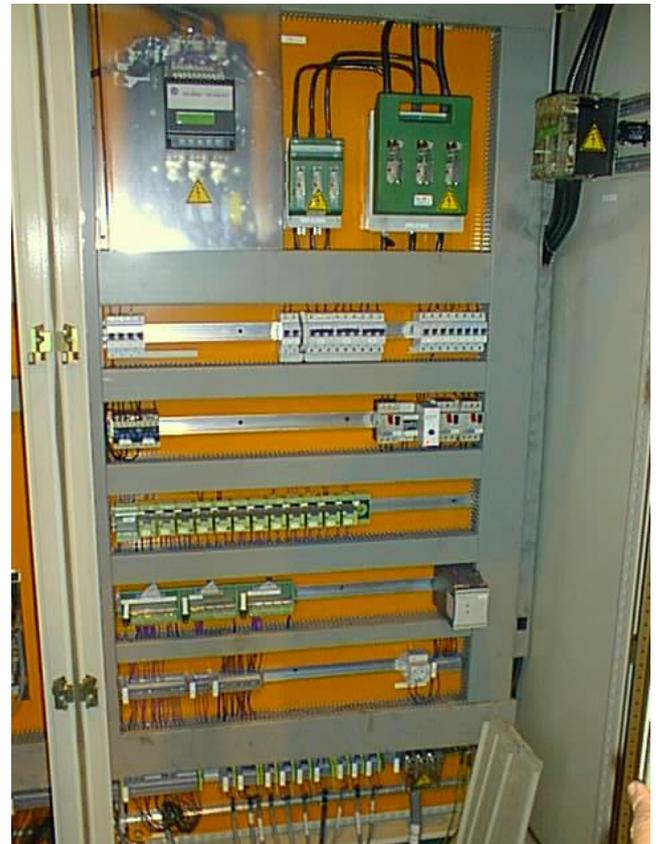
Figure 11: The whole electrical system was completely renewed, according to the provisions of the final customer.

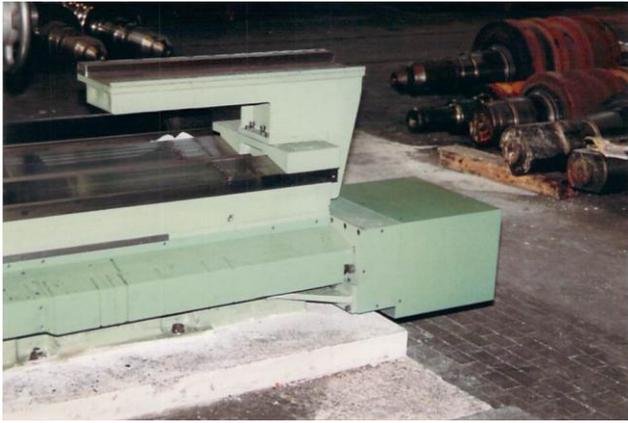
Figure 12: The 4-way tool holder had to agree to the hundredths. That went, she was hired in Werkzeugvoreinstellraum and the heavy holder had a special tool system for assembly and disassembly.
