### Photo report WU 150

Lathe for long tube processing  
Heyligenstaedt. Headstock defective  
Repair of headstock bearing defect  
by WIAP AG

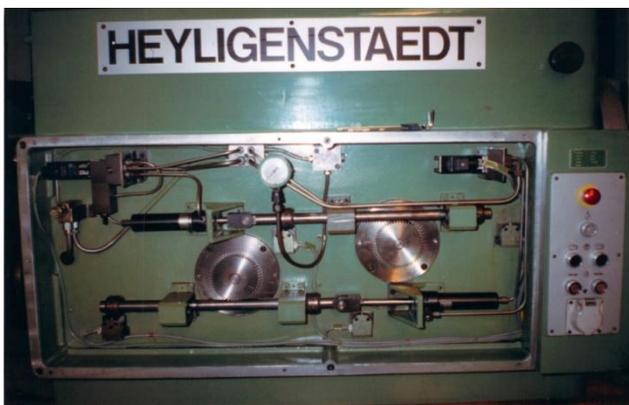
Figure 1: The shift linkage of the shift forks is controlled by cylinder. A thoughtful, intelligent switching solution.

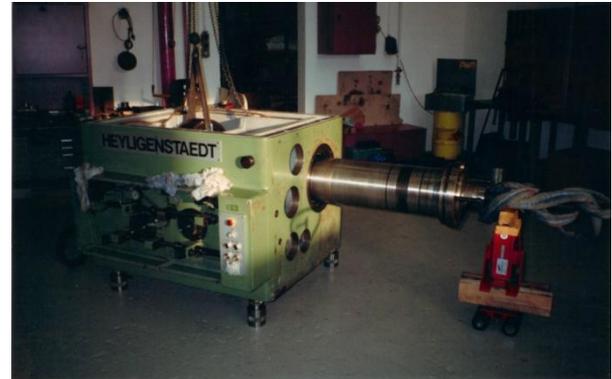
Figure 2: An extremely well-designed gear a lathe.

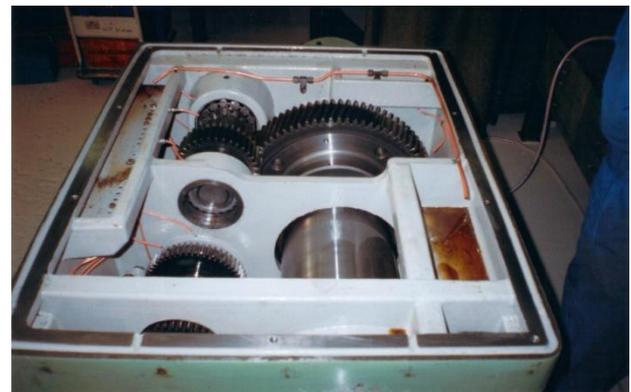
Figure 3: Good construction. From the top of the lid is removable. The headstock damage was bearing damage. He must be opened. For this purpose the headstock was taken in our workshop.

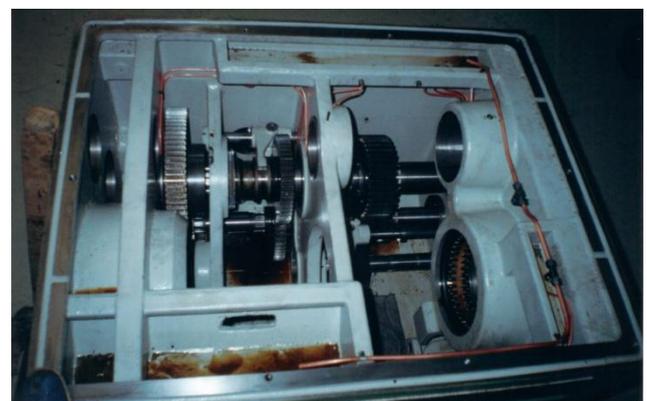
Figure 4: A clear lubricating concept where each lubrication point is smeared.

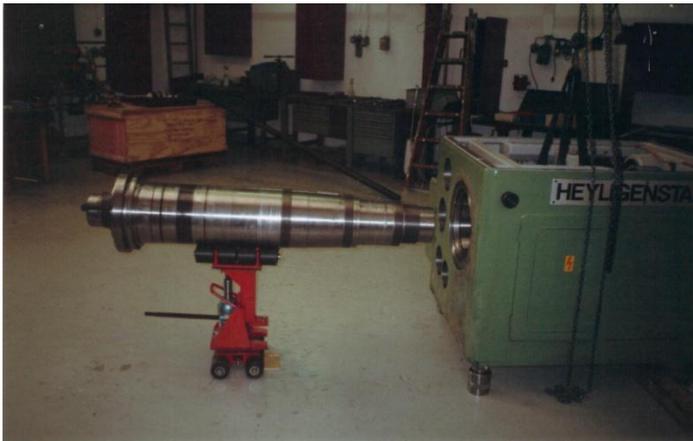
Figure 5: Here we have expanded the spindle.

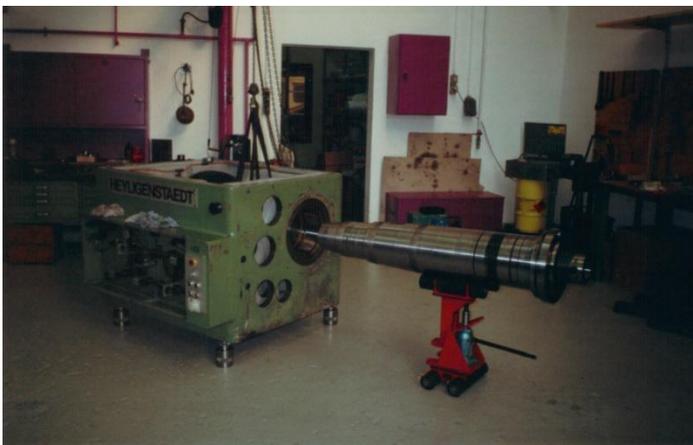
Figure 6: Second Repair of headstock bearing defect. View of the expanded main spindle of the machine Heyligenstaedt.

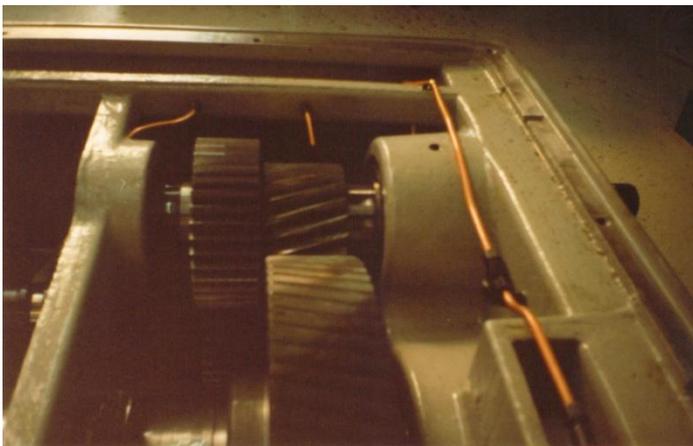
Figure 7: Here are the stable transmission gears of the different stages.

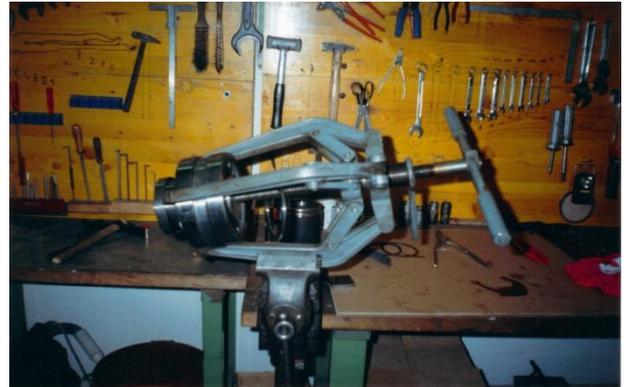
Figure 8: It needs some pullers to pull the gears and bearings.

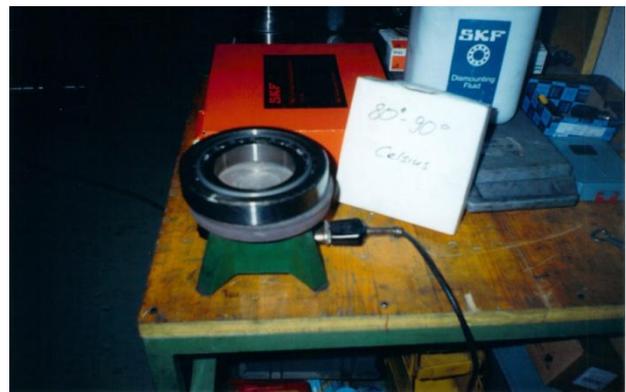
Figure 9: raise spindle bearings again goes well with heat. A hot plate can ease much. It is important to work very clean so that no dirt can get into the camp. Back is also the oil tank for the Press Association Abpressvorrichtung.

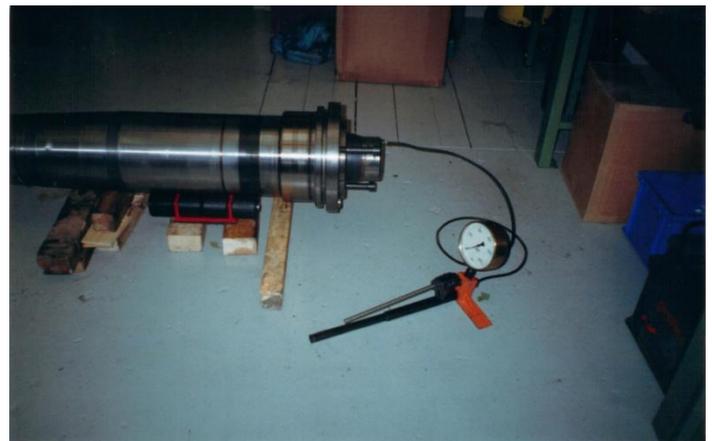
Figure 10: Here is pressed with the Press Association pump the camp. The procedure was very popular a few years. However, when such a pump is missing, which will cost about 3000 CHF and the oil, then the removal can not take place.

And when the seat is a little damaged is not ok in the assembly and sealing, then disassembly is very complicated and requires some imagination to reach the goal. For the Abpress pressure is enormous during the press association. For example, 2500 bar. In the case of interference fit oil port on the front was at the spindle nose.

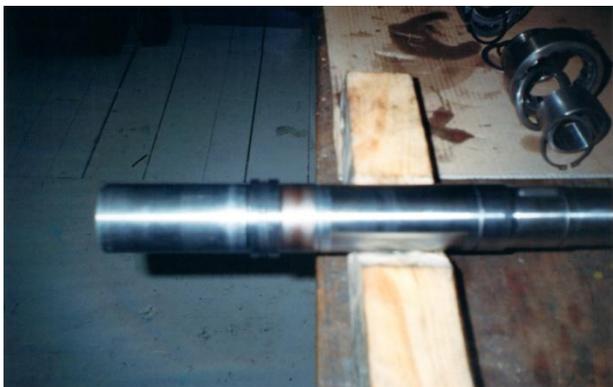
Figure 11: The drive shaft was removed from the headstock. Usually you do everything without a hammer, but with thoughtful deduction solutions.

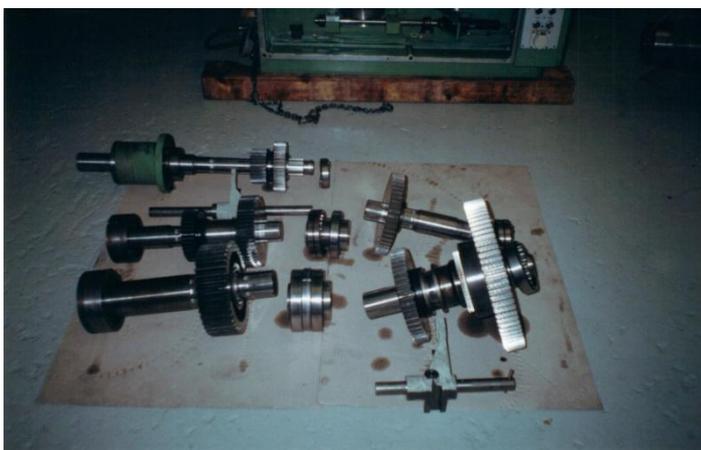
Figure 12: Here everything is laid on the headstock so, so that all spacer rings come back to the right place.

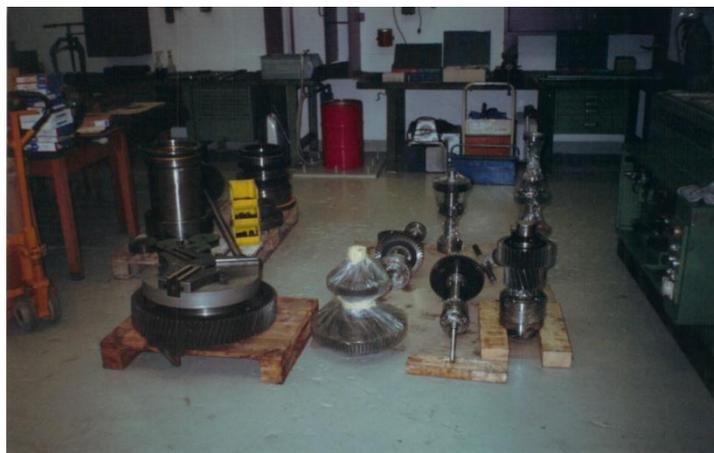
Figure 13: gears, shafts, bushings and bearings are protected with wooden Before blows and impressions.

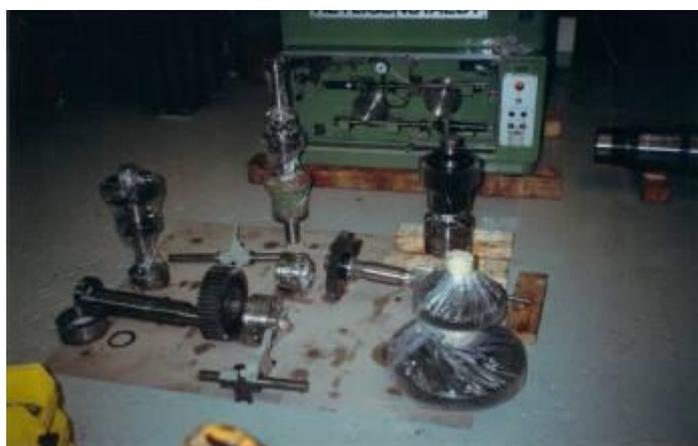
Figure 14: An ever good cleaning and covering before the replacement is also important so that not one state pollution affecting the service life.

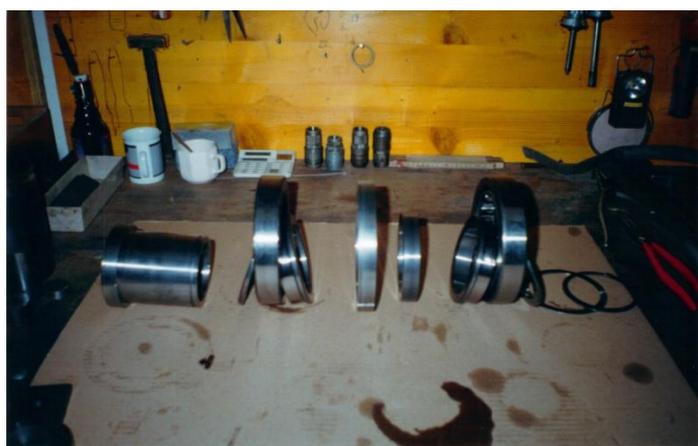
Figure 15: Converted bearings are not replaced, must be handled with great care. Make sure that the cages are not damaged. Always see on which side of the large opening is so is not pressed by

mistake on the outer ring Axial and the bearing can fall apart. In general, the storage label is always on the narrow side.

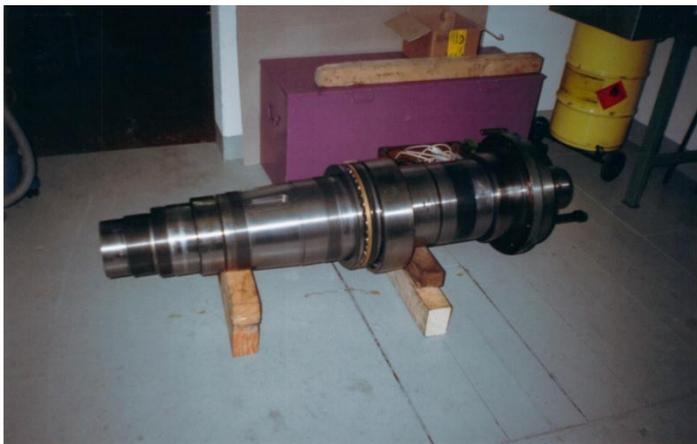
Figure 16: The main spindle of the lathe Heyligenstaedt has done its job even thousands of hours and can make many thousands of hours again.

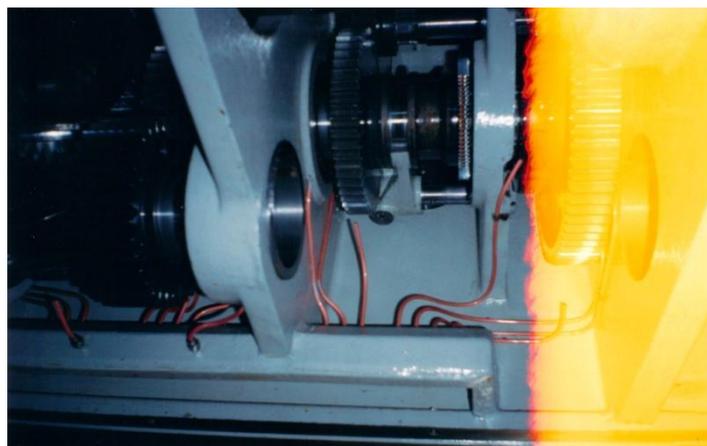
Figure 19: For the installation in such a headstock, it needs a good intuition, so that the shafts and bearings can also be pushed well into the purely just tolerated bearing seats. If there are small parts, it is one, but when the parts are heavy, often must be present high level of expertise that such an assembly also leads to a good destination.

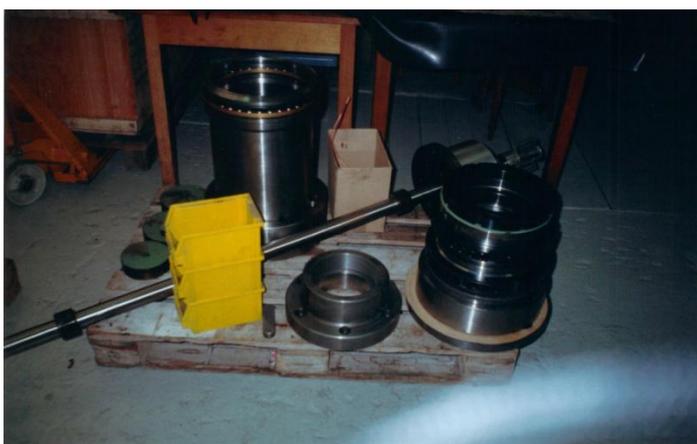
Figure 17: components prior to replacement of Heyligenstaedt lathe.

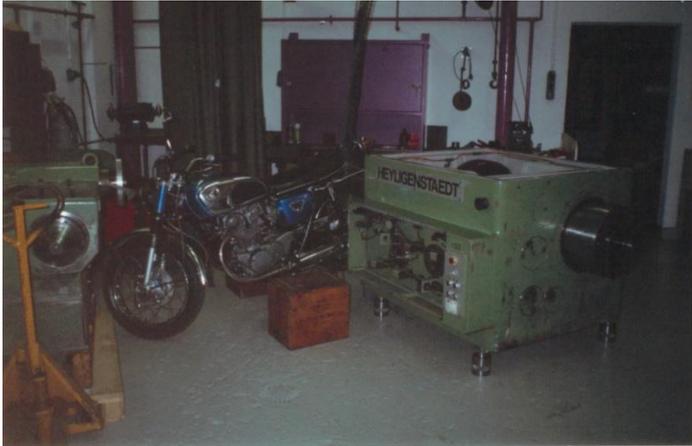
Figure 21: For us, the simplest, a motorcycle was to take a drive, such as a friction wheel.

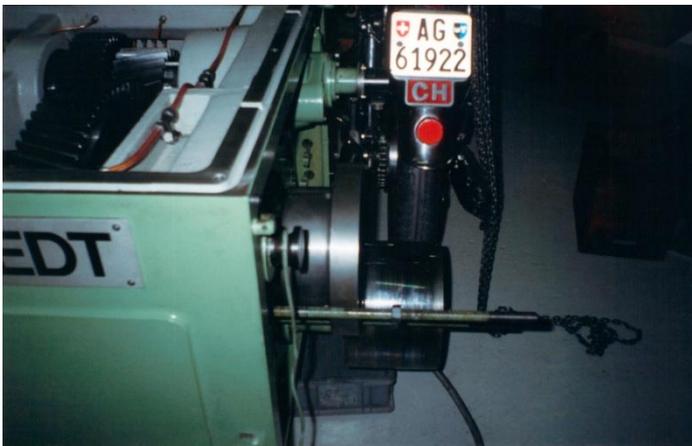
OK. Test passed. Ready for replacement at a major Swiss company owned by the federal government.

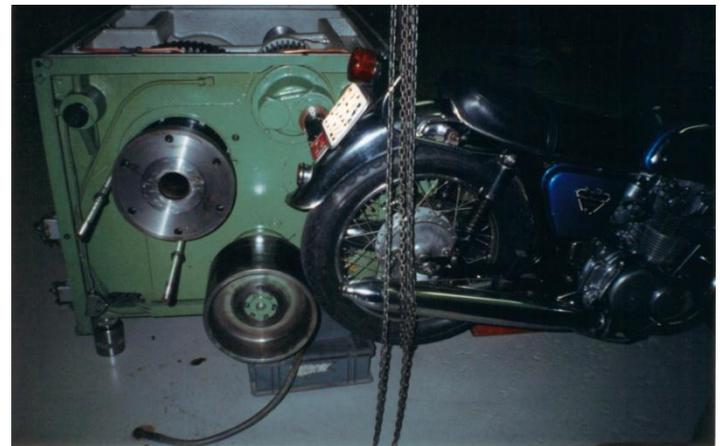
Figure 22: Once again, the side view of the improvisation of the headstock test run of the Heiligenstaedt lathe.
