### Photo report remodeling Karusell WU240

Vertical lathe TITAN

CNC grown and commissioning of WIAP in Angola.

Task: The conventional vertical lathe TITAN is to get a new CNC control with ball screw spindles and feed motors and covers. Incl. a partial revision. The machine was ordered in Denmark with a machine dealer. The dealer has then begun with the conversion but the control never grown nearly 1.5 years there have been delays because no man Siemens was available for Angola for the commissioning and training. The WIAP has taken over the job where Sven Widmer and Hans-Peter Widmer (WIAP) made the work. When dismantling the WIAP was not involved, making it difficult to build something, but was realized despite the well. The electrical part was completely prepared by WIAP. Planned and built the Caroline Widmer Widmer and Jim have in Switzerland. The add-on material has been brought to Denmark and loaded into the container with the machine. In Angola, Luanda positioned and attached the new CNC control with the motors. The start-up carried out, shot the first turning members and the people enrolled.

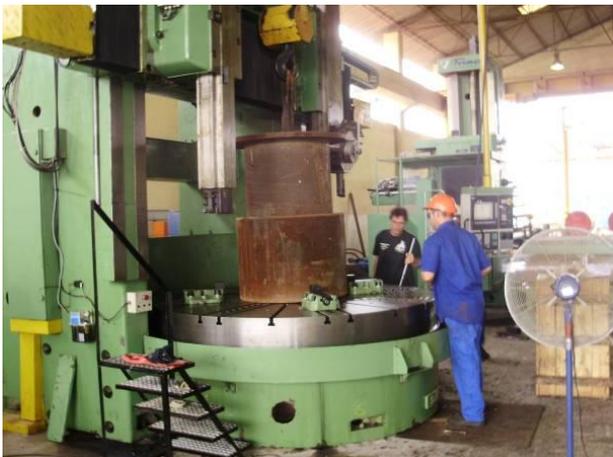
Figure 1: Former conventional TITAN VTL from Europe, in Angola converted to CNC control.

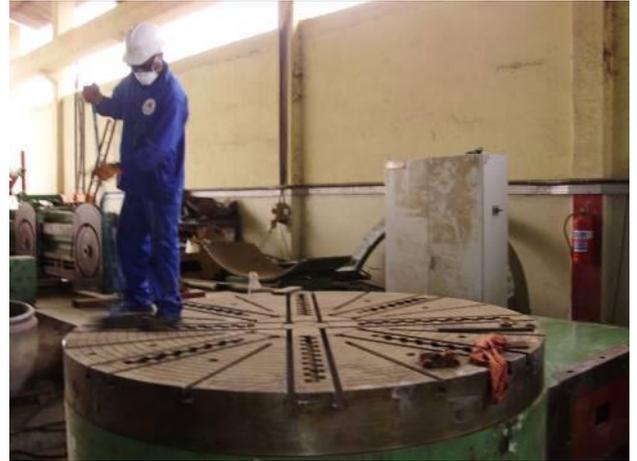
Image: 2 Search First, what was so from under the dust. By the anti-rust "Tektil" almost everything looks so, as if it were rusty.

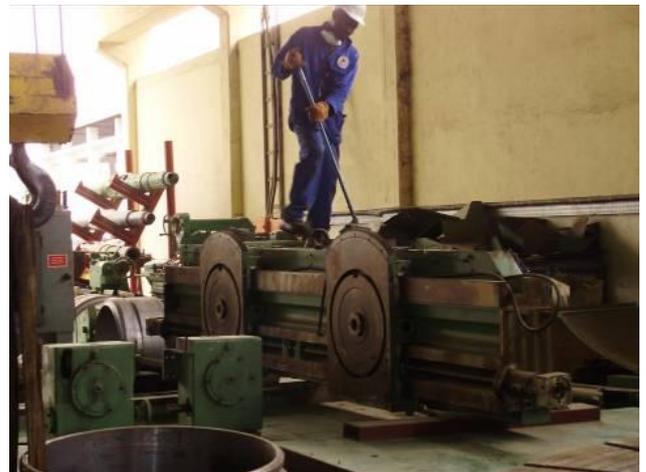
Figure 3: The cross bar was also completely protected against rust. Thus, the machine is transported from Denmark to Angola Luanda in a container which could be opened from above.

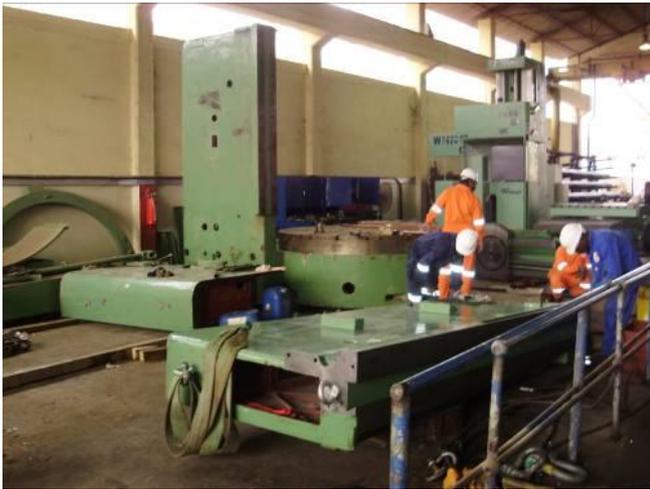
Figure 4: The guides are deducted before assembly, so that no damage caused by violations of the land done.

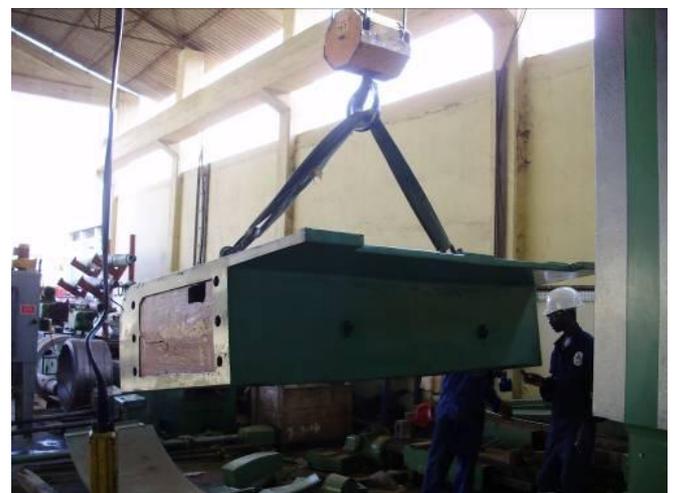
Figure 9: The roof and the interconnection with the intermediate plate, so that a good retraction

exclude tilting. The roof is connected with 18 pieces. M36 screws.

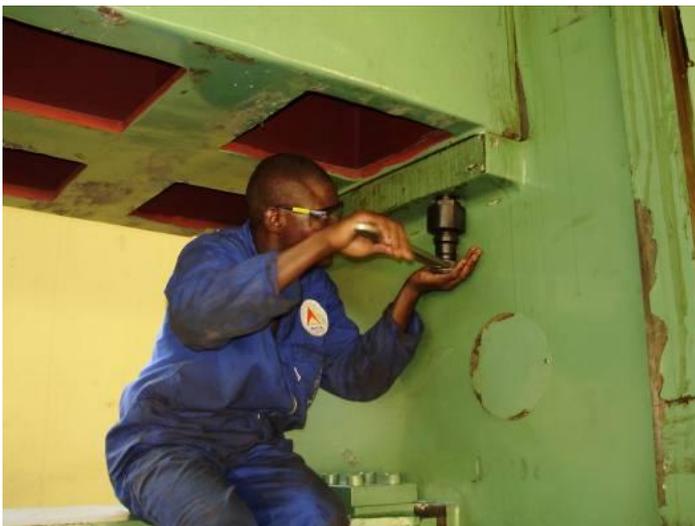
Figure 11: reindrehen With the 55 mm socket and ratchet the screw's one, but still re-cut threads in the roof is then exhausting.

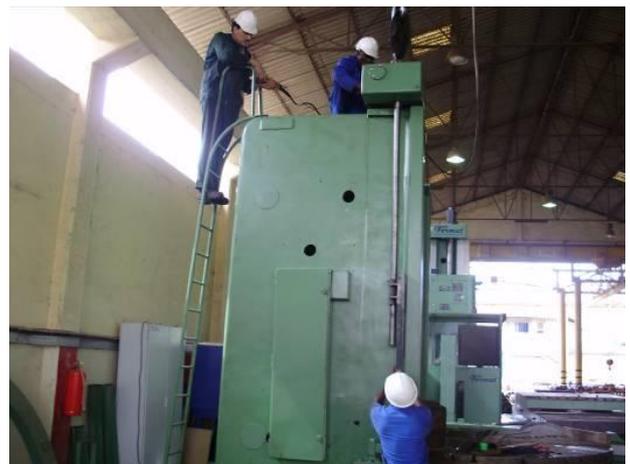
Figure 14: The Machine Head is mounted. A good thing, because after all, motors and spindles are driven up there. It's all instinct work and think ahead a lot is needed. Many screws were missing, still had to be organized.

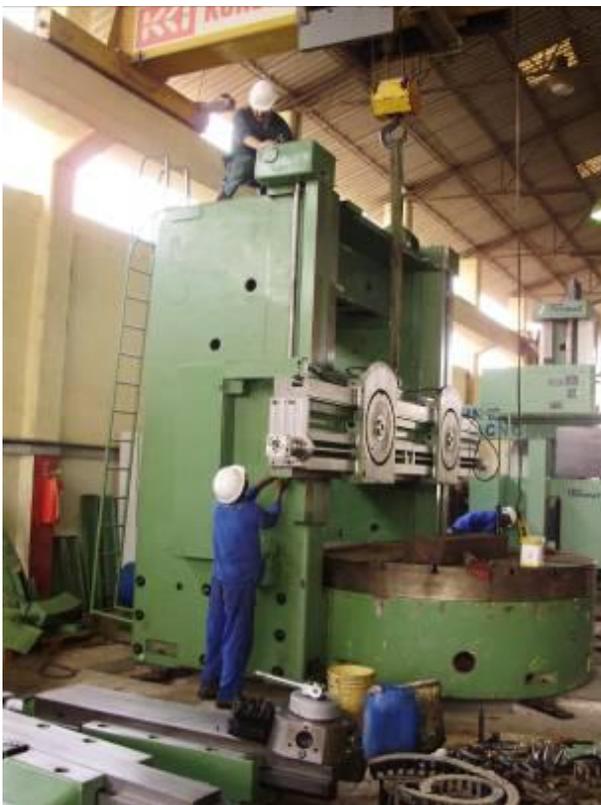
Figure 16: The transom is now above. He needs to be adjusted with a spirit level.

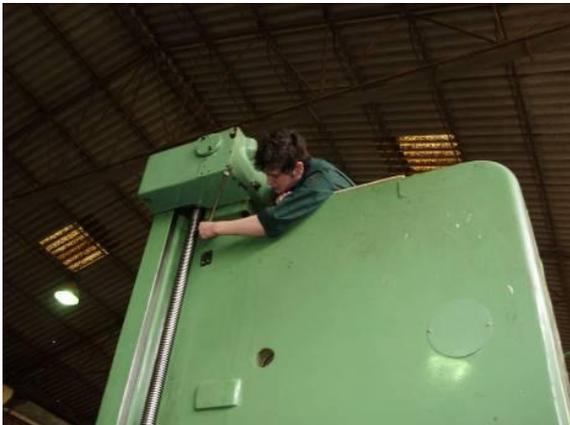
Figure 21: Sven Widmer when tightening the crossbar drive, after the pins have been set, we received from Switzerland, because many middle bolts were no longer available to the machine.

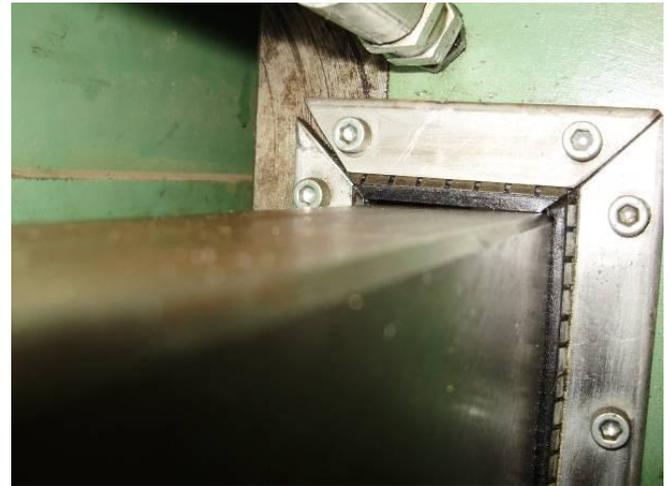
Figure 28: In the follow-up inspection such scrapers found. This press is insufficient to take the lead and so dirt can by under the wiper.

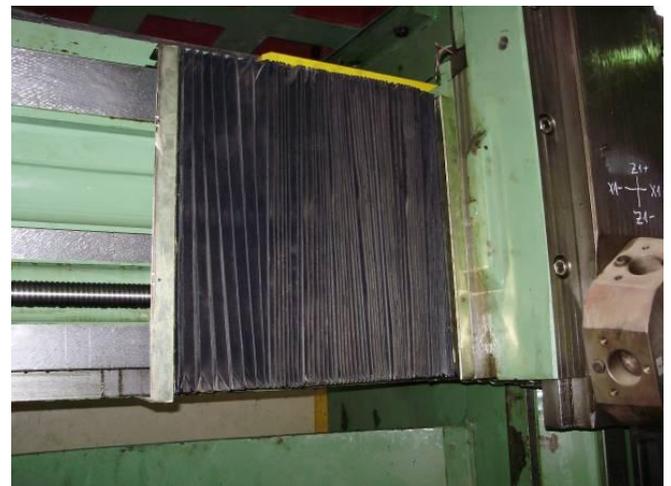
Figure 29: Right of the turret, after a short time already rusty! The new cover must be drilled yet been determined.

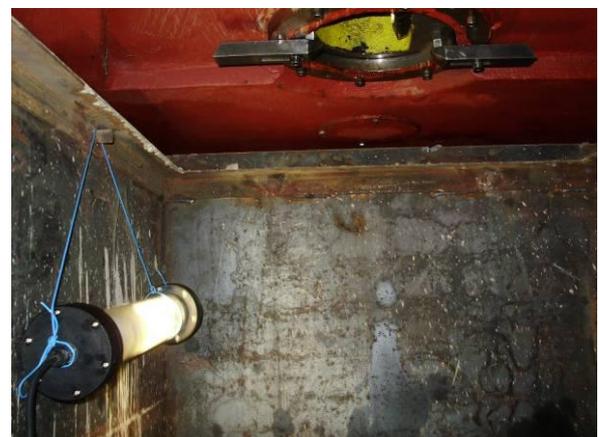
Figure 30: The machine lost daily oil because it turned out that still had some errors on the machine.

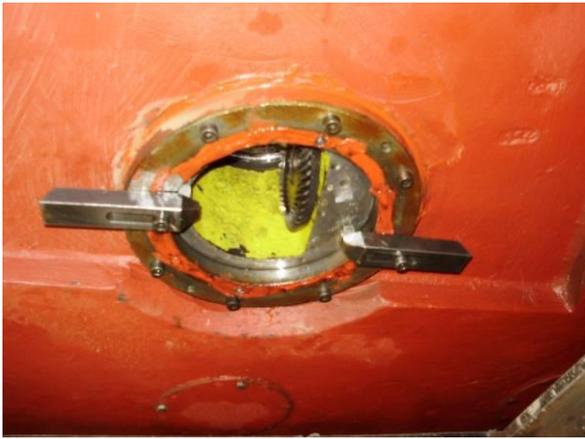
Figure 31: As under the machine a side wave came in, which measures the speed via the bevel gear in the image.

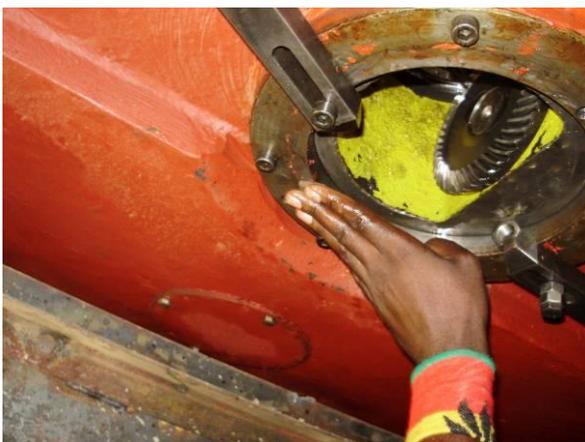
Figure 33: The bevel gear is pressed with spacer rings up so it was backlash.

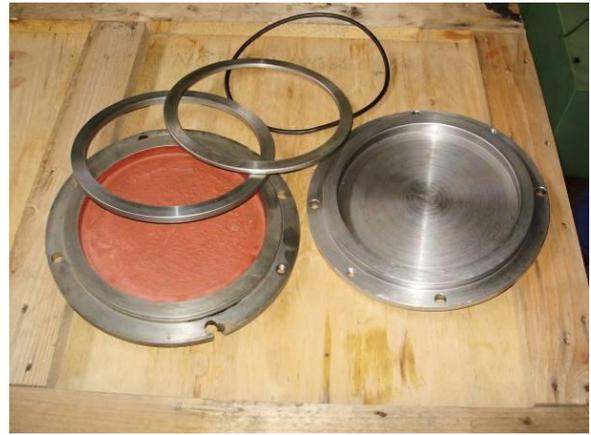
Figure 34: The cast iron lid down was broken. Then two spacers were fitted and these were 2mm too thick, meaning it pressed with full force against the bevel gear. We made a new cover and a spacer ring 2 mm thinner, so it had little game. The O ring in the lid was not fitted. So explained that the oil ran out.

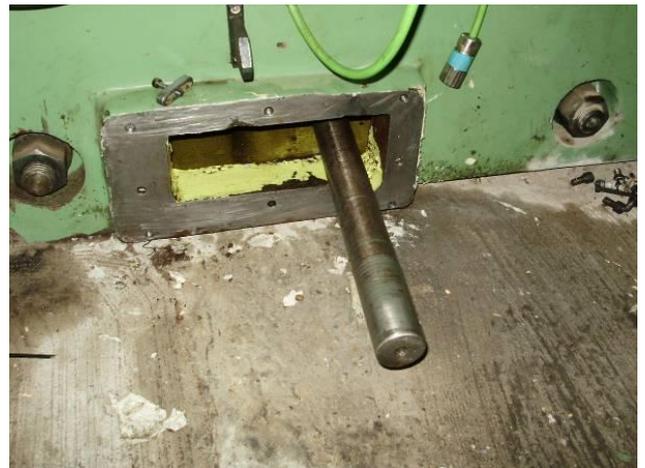
Figure 35: This wave was still about 4 mm long. So we shorten the shaft by a few mm so that the cover also has sealed properly.

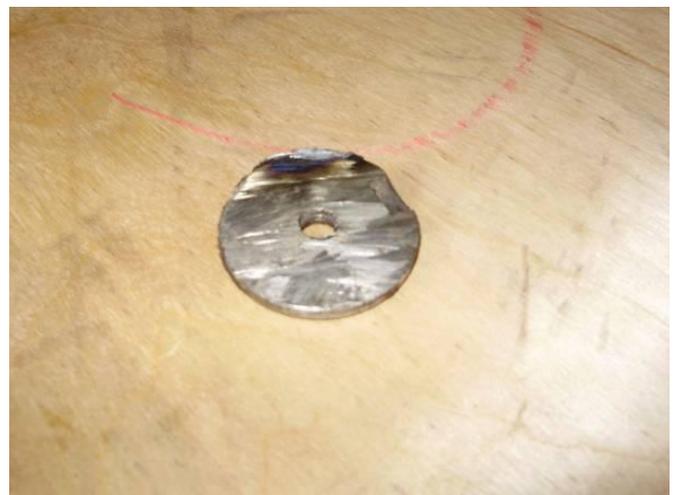
Figure 36: The section of the shaft.

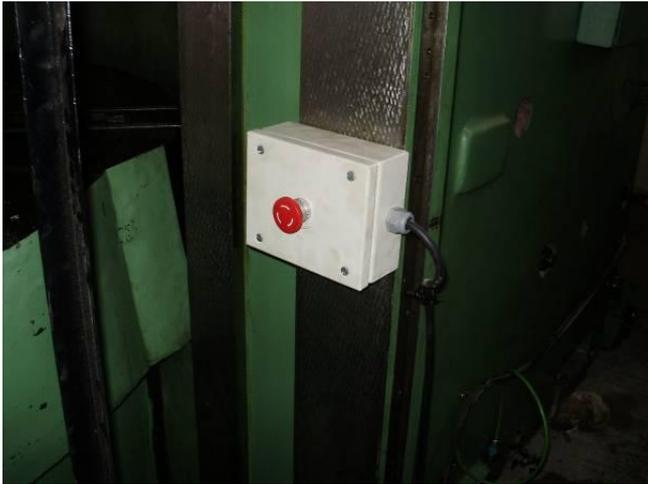
Figure 37: Emergency Stop buttons attached yet, so that when a man is in the machine, he can press the emergency stop.

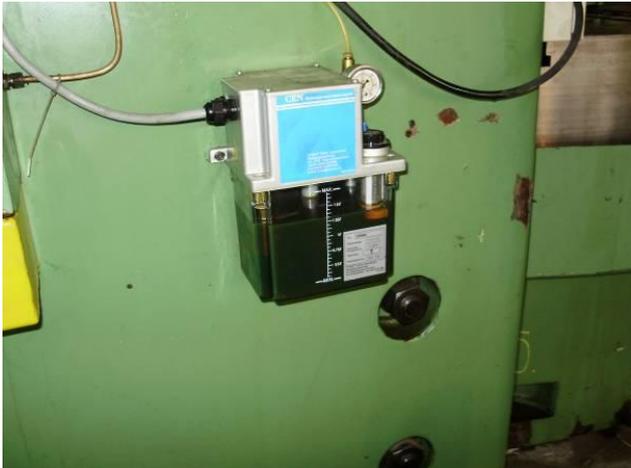
Figure 38: The cultivation of an automatic lubrication. The lubrication pump we have once again renewed with pressure switches and level switches, so that pressure line faults are detected at the control.

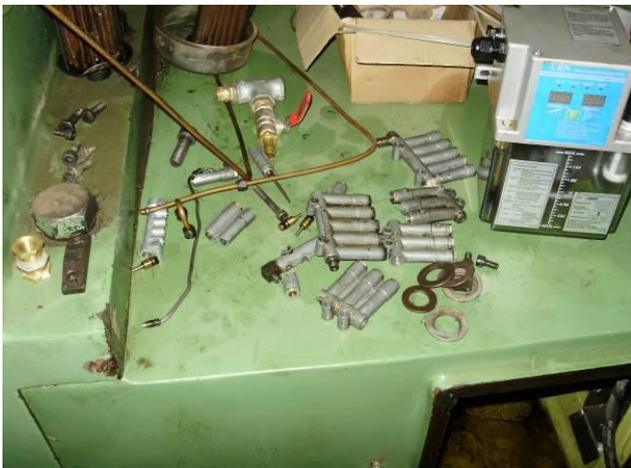
Figure 39: Many defective lubricating parts were replaced.

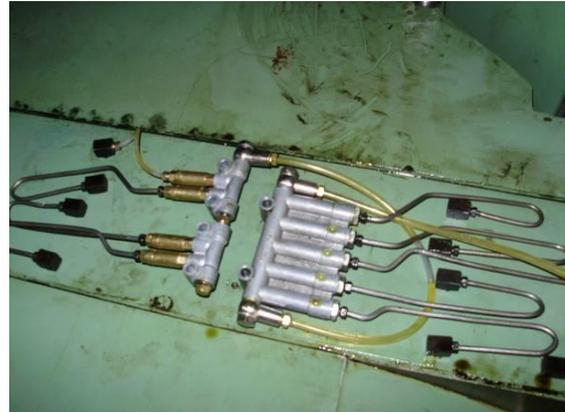
Figure 40: New and old grease mixed components.

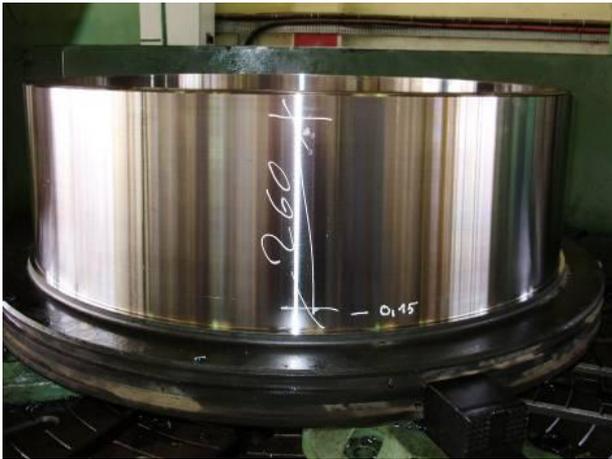
Figure 43: If Cylindrical is rotated with a carousel and in the case it was now 0:15 mm to 260 mm conical, ie always look at the radius, it is 0.07mm to 260 mm. This has now been adjusted.

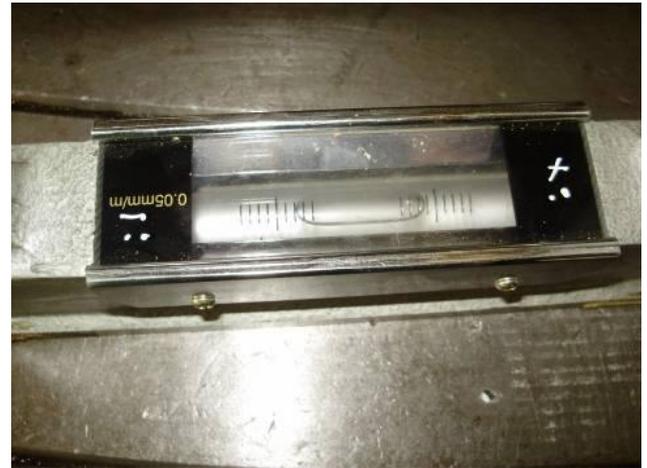
Figure 46: Consideration will be given to the frame-bubble level, as the faceplate is. We assume, as a rule, always a level with the accuracy of 0.05 mm per meter (0:02 is better, but is also very sensitive. Reacts instantly to sunlight.)

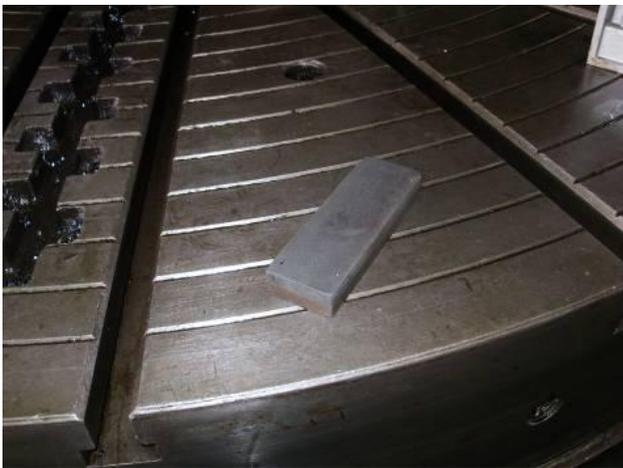
Figure 44: With the oil honing the table is deducted. Important to always deal with great care with the table and guides.

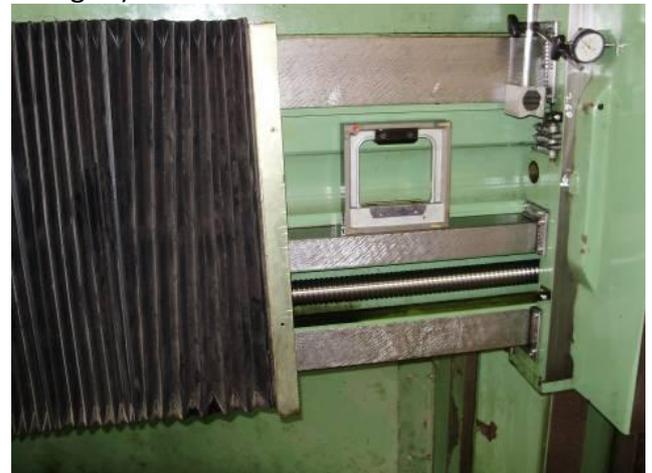
Figure 47: The transom is also checked. If that's not good, it can be set up on the shaft. But since you have to first make a plan rotation.

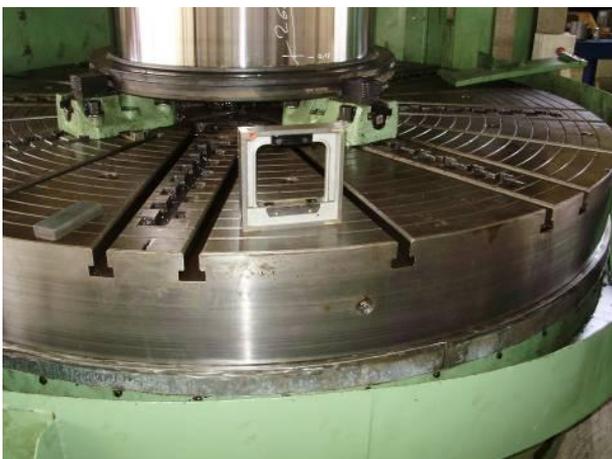
Figure 45: measuring with the frame level on the face plate.

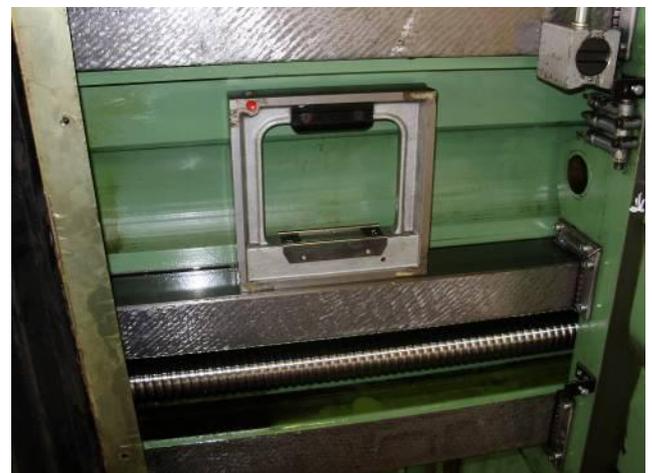
Figure 48: If it is possible to take a good reference surface to check with the spirit level the straightness.

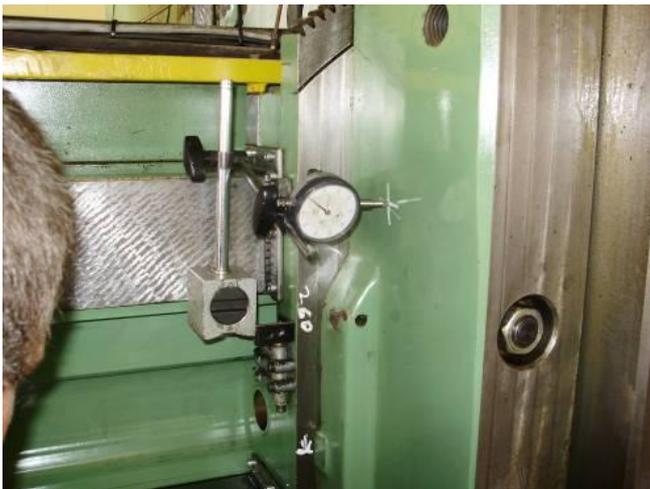
Figure 50: The RAM has a pivot point and the center of exactly 260 mm as long as the rotating surface, do the clock. Always remember that we turn radius and measure diameter, ie the error is 260 mm non-0.15mm, ie adjust only 0.075 mm. And is adjusted. The RAM has for this adjustment above a rotating screw.

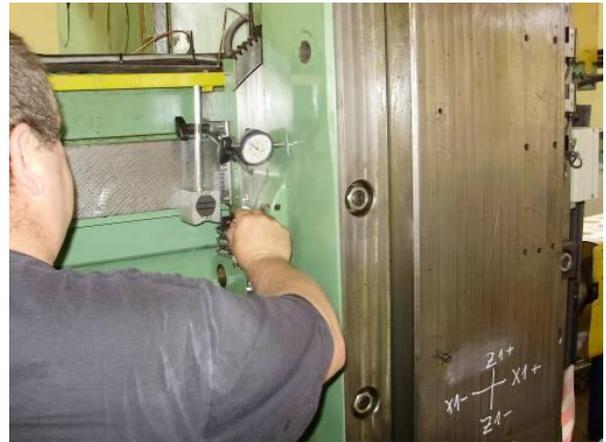
Figure 51: After adjusting the screws 4 are front retightened on RAM.

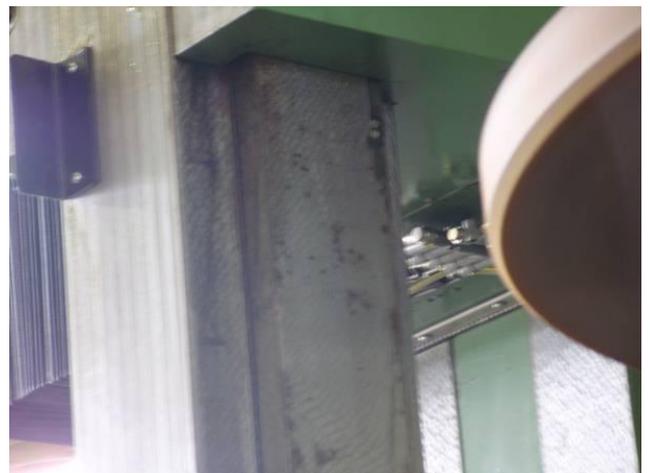
Figure 53: The plunger was long. Among the guides rust. This has then been involved, since it had no oil!
