Photo report Heyligensatedt WU 130

### Repair of headstock crack at Heiligenstaedt by WIAP AG

Gross lathe faceplate Heyligenstaedt. Headstock torn

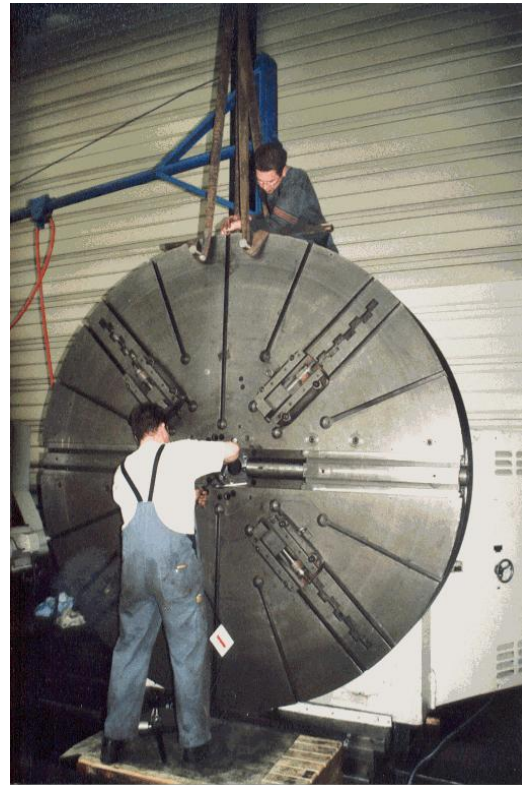
Figure 1: First, it is always dismantle these faceplates.

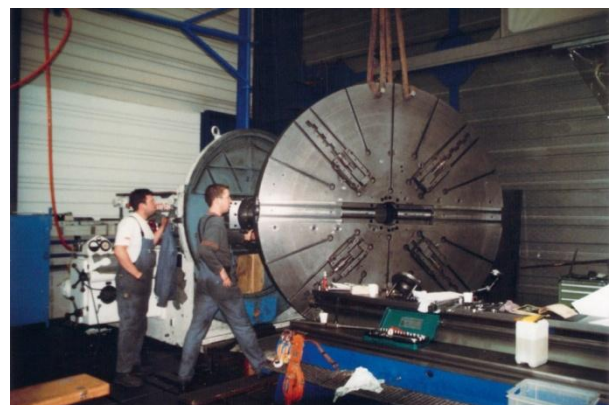
Figure 2: It takes a delicate handling by crane when a face plate must be removed from the spindle nose like that.

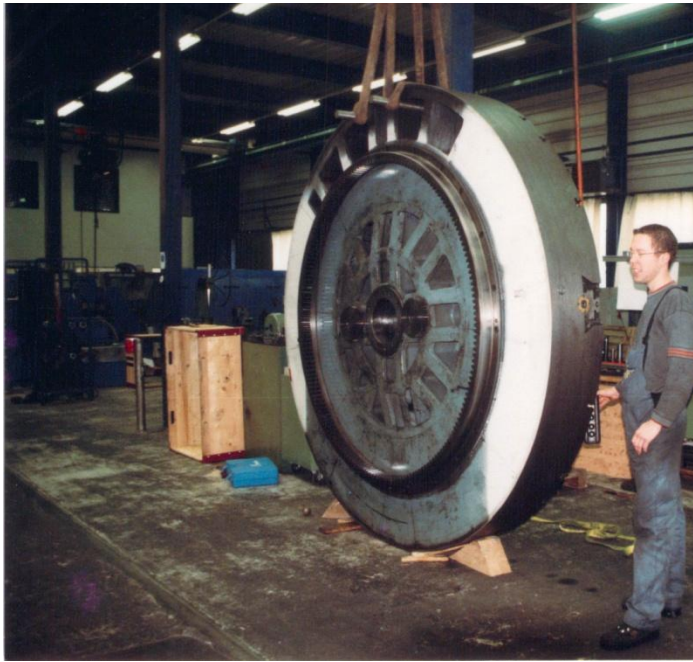
Figure 3: faceplates dismantling

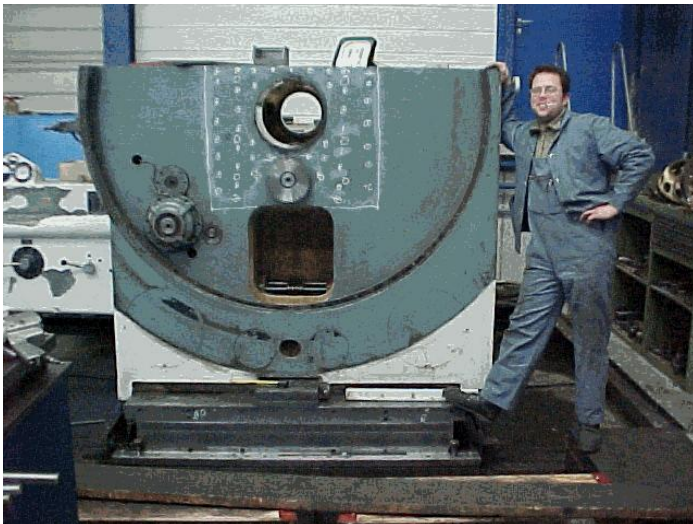
The customer had clamped too big a workpiece on the machine. This has torn the headstock. Measures of WIAP: Spindle dismantled. Headstock casting repaired. New spindle bearing made. , The proven NN storage in the existing main spindle bearings installed in place. This with a two-part box, so it was mounted. Construction, dismantling and installation of WIAP AG. Processing the customer. Of execution of the project: in Switzerland.

Figure 4: Here we have marked out as we attach a new front panel. The headstock had split a crack across. With the large front panel we have prevented the further spreading. On a boring everything had to be milled clean and many large threads were needed to enable the pressing force coincides with the friction to continue loading large workpieces.
