Umbauten, Erneuerungen, Retrofit

Photo report collecting information WIAP 2016 WU500

Detailed photo report remodeling Heid
WU190

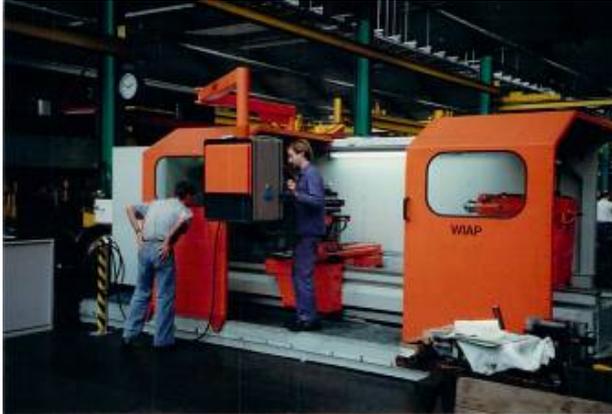
Finished machine after the rebuild. WU5291

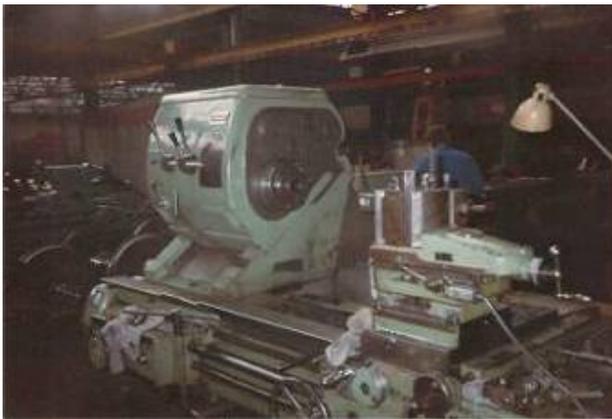
Old conv. Machine before the conversion.
WU5205

Task: The conventional copying lathe Heid is to get control of a new CNC. Through all the remodeling, it is to be a new CNC machine with automatic transmission shift, full enclosure and chip conveyor. It is a complete revision. Very simple parametric programming, conceived by WIAP and created CNC programs. New ball screws 63 it in the Z axis and in the X-axis 50's. reground the bed; New eingeschabt sled. To allow the feeding voltage for roughing and finishing with 2 clamping pressures working new tensioner with WIAP clamping concept, double

clamping cylinder in operation. New, automatic lubrication system. 4-head turret for a collision-free turning of the train wheels. The machine produced in the Federal Railways. WU5205

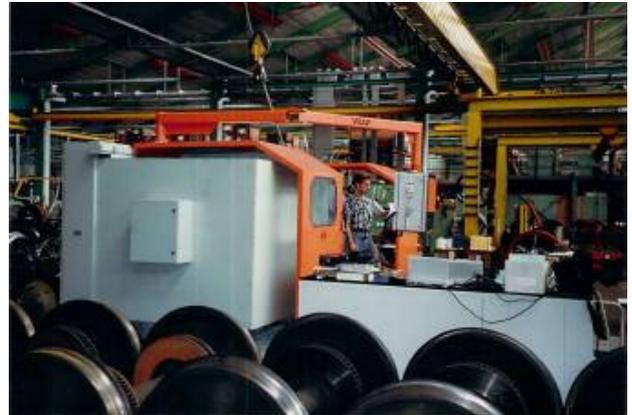
The machine at the customer placed. That everything is always included. Everything from A to Z is made of the WIAP. No third party, thus no coordination planning for the customer needed, making the costs controllable. Here the machine is already in production. WU5290

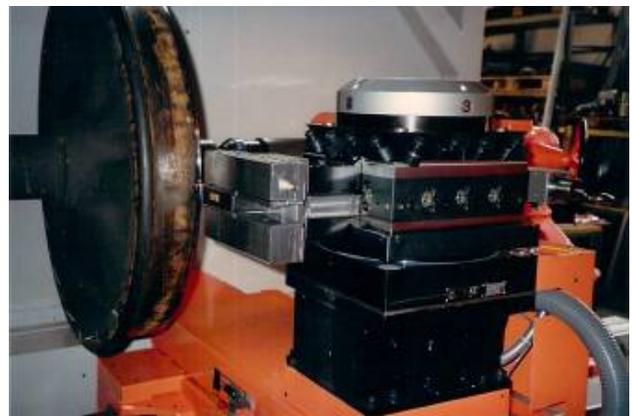
Turn the wheel flanges is a particularly topic. But the CNC technique known as no limits. In contrast to the previous point turning certainly much easier. WU5287b

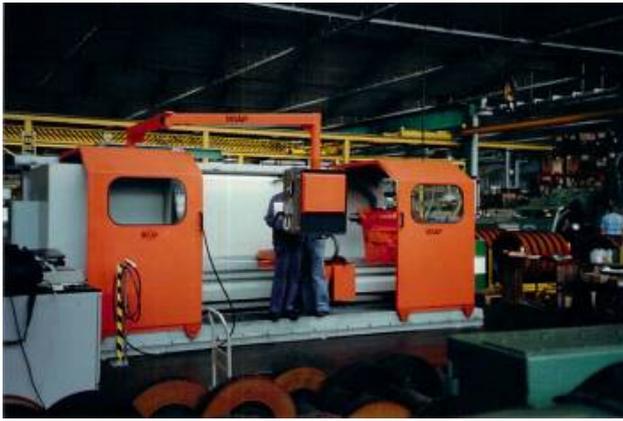
Task: The conventional copying roll lathe is to get control of a new CNC. With total revision. The surgeons had to copy itself usual, so very simple, parameterized, designed by WIAP and created CNC programs. Only the entries of R parameters could all be programmed after reconstruction. New ball screws 80's in the X and Z axes. reground bed; New eingeschaft sled. New, automatic lubrication system. The 4 claws box were also revised. Insert strips made of spring steel, which we shared. WU54715

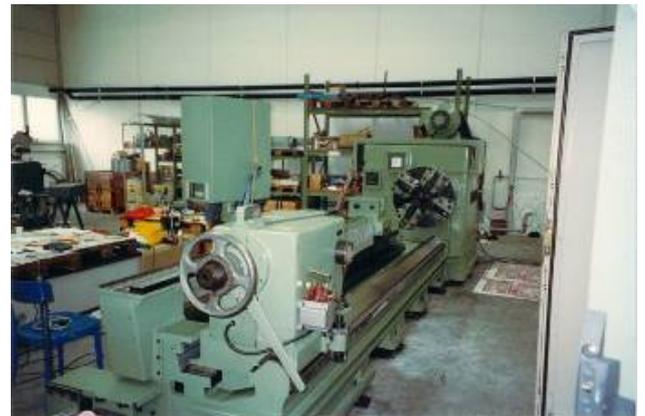
The machine consists of good, heavy cast, so this machine can turn vibration. WU4735

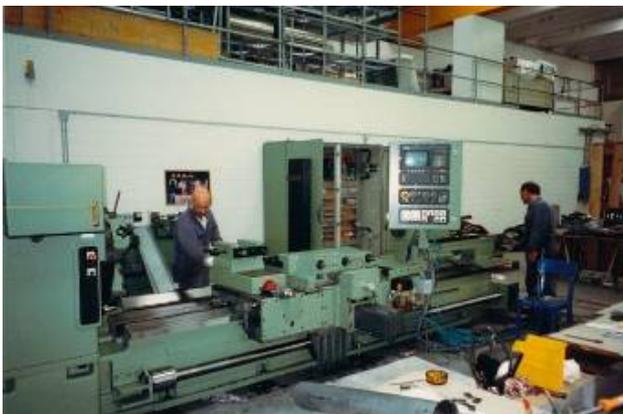
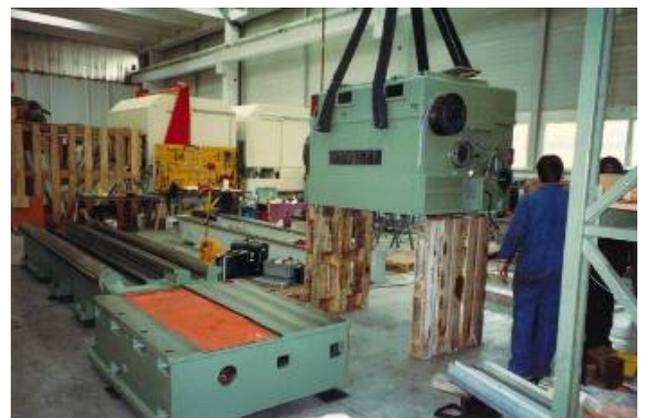
This sturdy, heavy, conventional roll lathe was rebuilt by the WIAP on CNC. WU4725

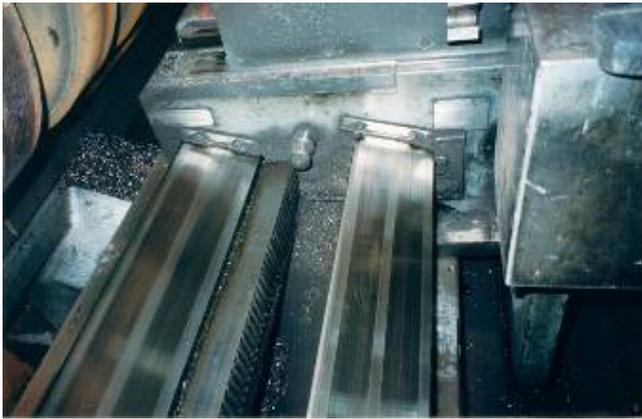
The Z-axis guide is designed for a very strong cross-shaft cutting pressure. The machine has 4 steels, which simultaneously rotates the roller contour. This gives a very large management burden. The machine had insert strips made of spring steel, which we shared. WU4740

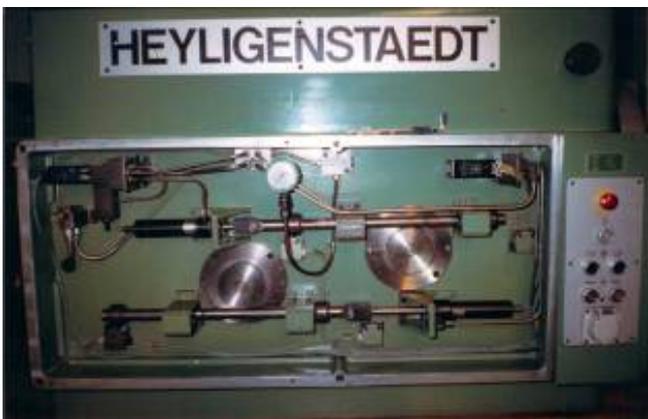
The shift linkage of the shift forks is controlled by cylinder. A thoughtful, intelligent switching solution. WU3420

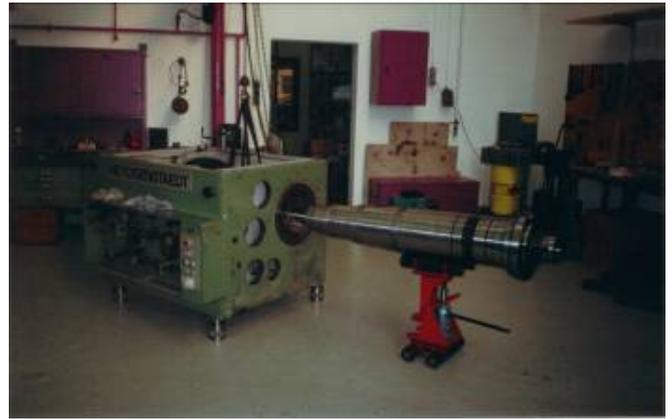
Second Repair of headstock bearing defect. View of the expanded main spindle of the machine Heyligenstaedt. WU3470

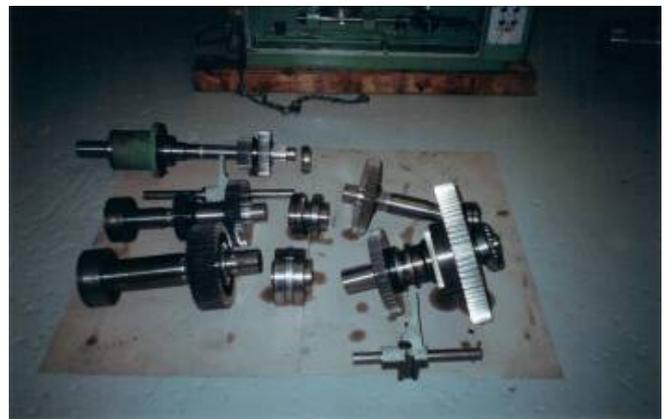
Everything is laid on the headstock so, so that all spacer rings come back to the right place. WU3490g

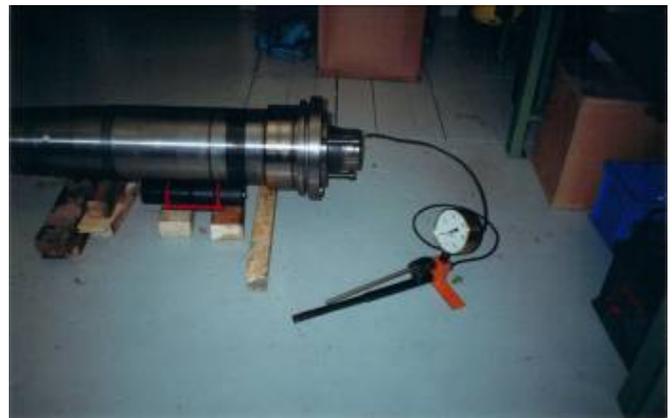
Here, the bearing is pressed with the Press Association pump. The procedure was very popular a few years. However, when such a pump is missing, which will cost about 3000 CHF, and the oil, then the removal can not take place. And

when the seat is a little damaged during assembly and the seal is not OK, then disassembly is very complicated and requires some imagination to reach the goal. For the Abpress pressure is enormous during the press association. For example, 2500 bar. In the case of interference fit oil port on the front was at the spindle nose. WU3490x

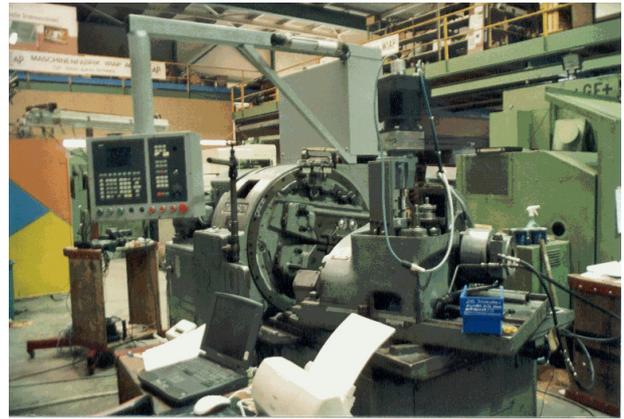
3 new feed motors were grown. The electrical cabinet compact, directly on the machine, fixed. WU5410

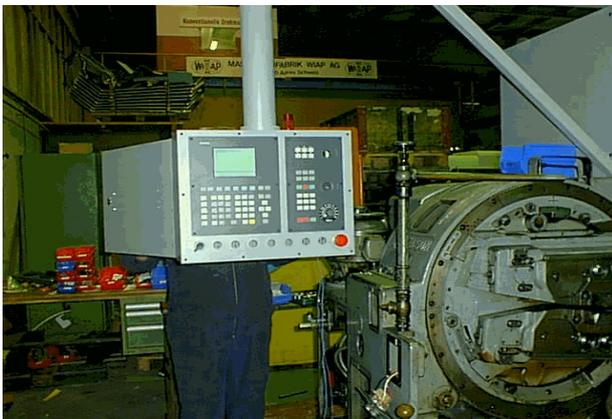
The customer has an old, conventional Gleason gear cutting machine. He wanted to upgrade this machine with a new CNC control. Anbau the new CNC control to the machine. WU5400

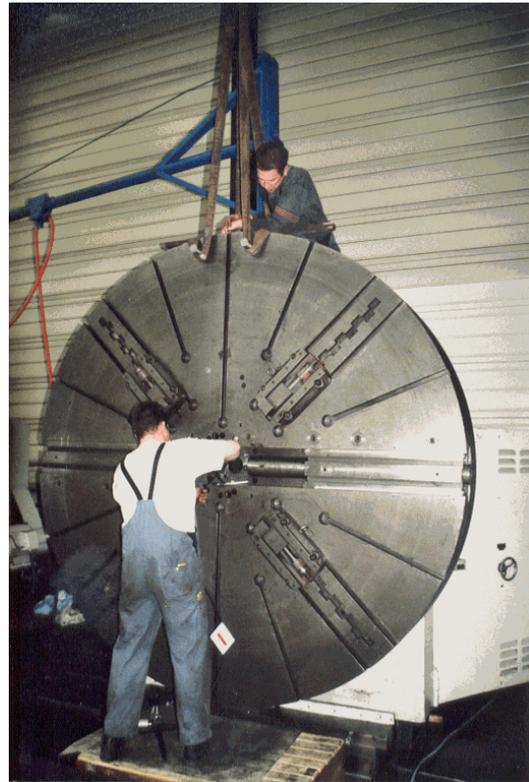
First, it is always dismantle this faceplate. WU3095

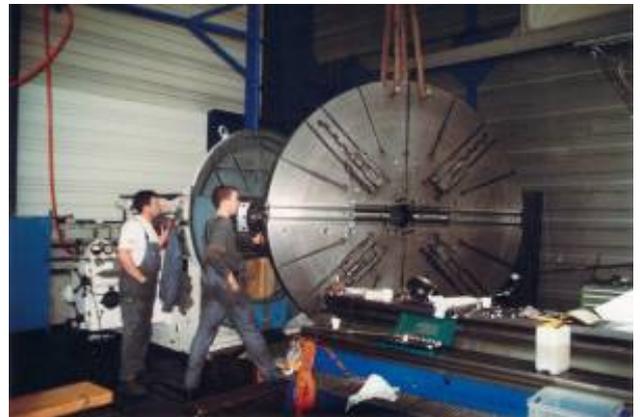
It takes a delicate handling by crane when a face plate must be removed from the spindle nose like that. WU3020

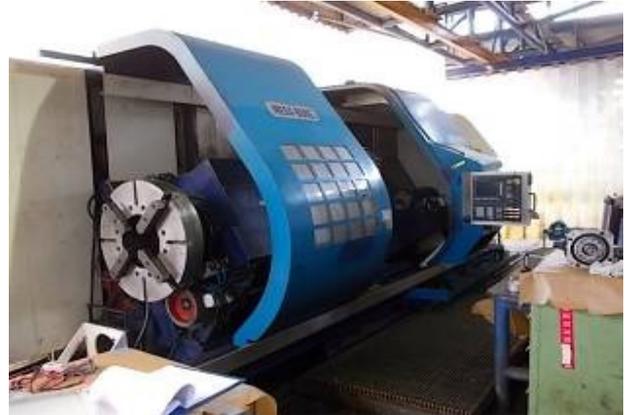
Machine weight of Mega Bore: over 20 tons.
WU_232_190

A hole in the casing of the Mega Bore CNC machine has caused damage to the water control Fanuc 18i. It was so complicated by the spare parts warranty-performance and the support of the manufacturer's control, that we decided to replace the CNC control incl. All engines with a new CNC control Sinumerik 802 D. We do not have spare parts in stock and Fanuc control, even after the third time in Fanuc repair, still not running. The respective repair costs with screen replacement and CPU did not lead to the goal. The stoppage was almost 3 months. After the conversion decision, the machine was running in 2 weeks. The electric plans everything in Asian writing to the PLC program text. It was still good, thanks to the experience of the many CNC machines that are already in use in Europe.

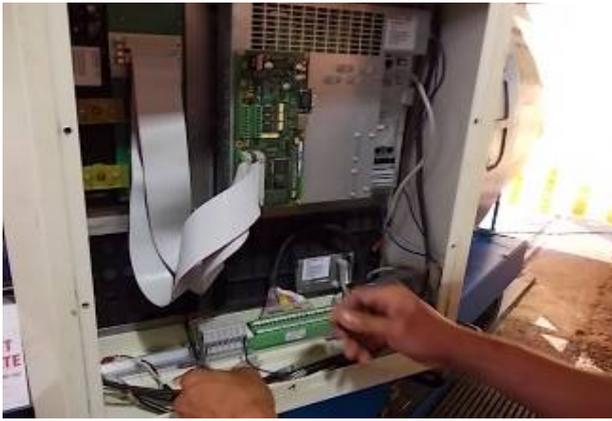
Significantly less cables that hang around there. Sure, only about 30%.WU_232_290

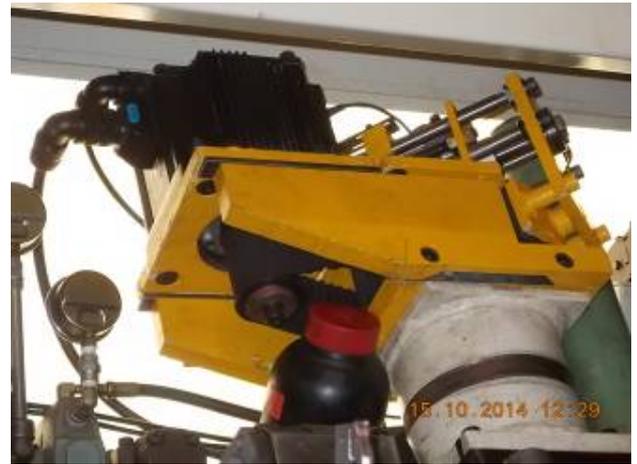
To ensure that all feed motors could be used without brakes, an external X brake was made from spare parts reasons, not in the engine.

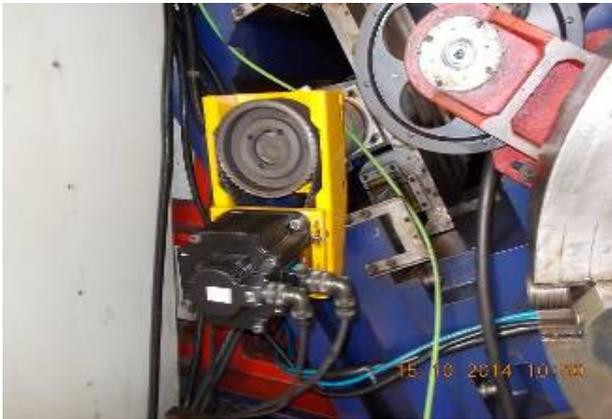
The whole was treated with a Z drive sub-reduction 1: 2 Construction WIAP renewed.

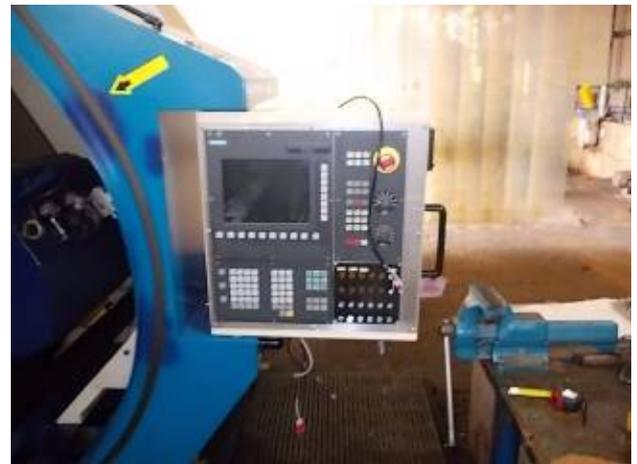
Here we will soon make the first tests with external 24V. WU_232_320

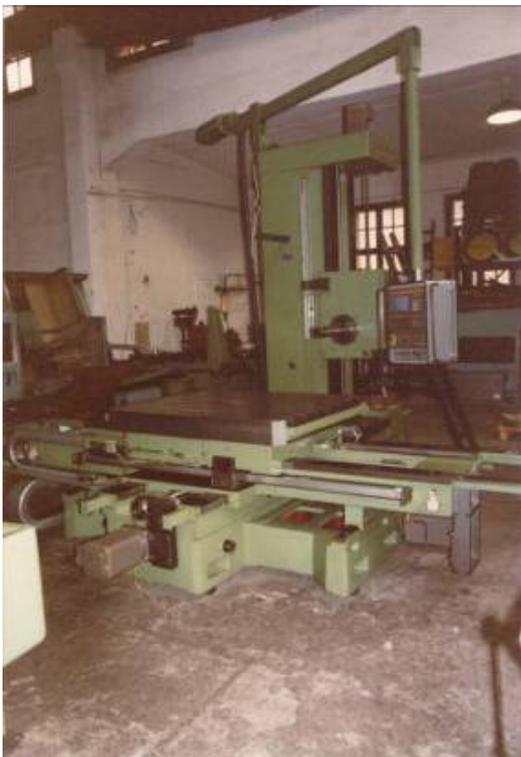
3 linear axes, X, Y and Z and the rotary table. In addition, even a linear axis W in the supplement to the Z axis. WU5010

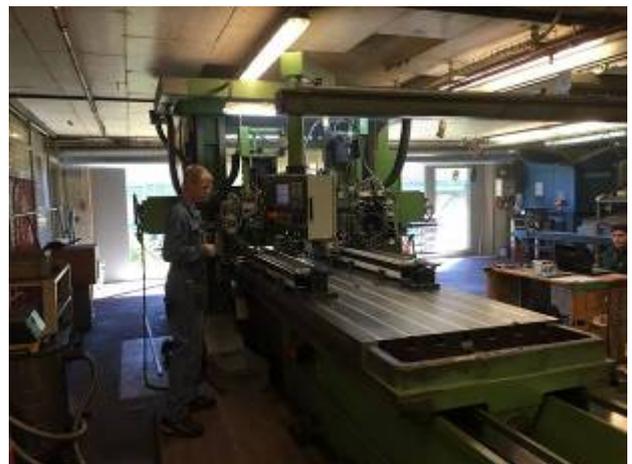
Scope: Dismantling of the central drive and Einzelachsenantriebe. Rotary table and CNC controlled. Cultivation of ball screws in the X, Y and Z axis and the individual Vorschubachsmotoren. Design and fabrication incl. Assembly of WIAP.

Here is the finished machine after reconstruction with the new Sinumerik CNC control. WU5009

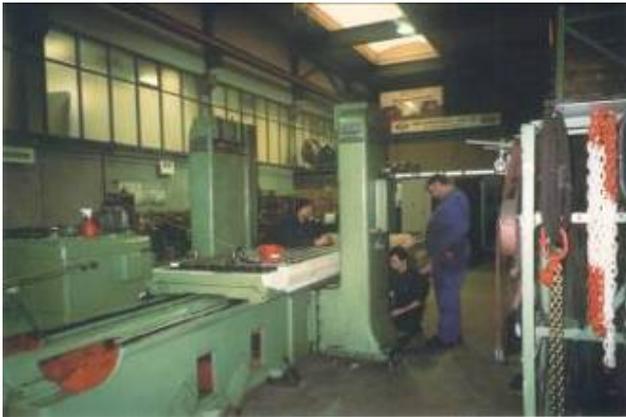
The planer with the shortened side column. First, we can drill 4 40 H7 pin holes on a boring mill at 0.01 mm accuracy. WU3120

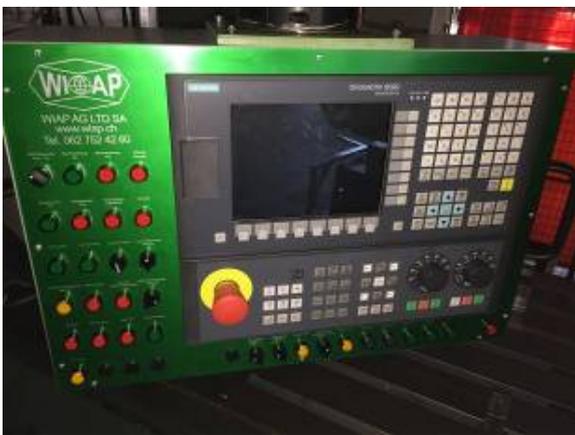
The new CNC control is the newest of the new. The customer can now expect to be able to work 20 years on again. WU4020b

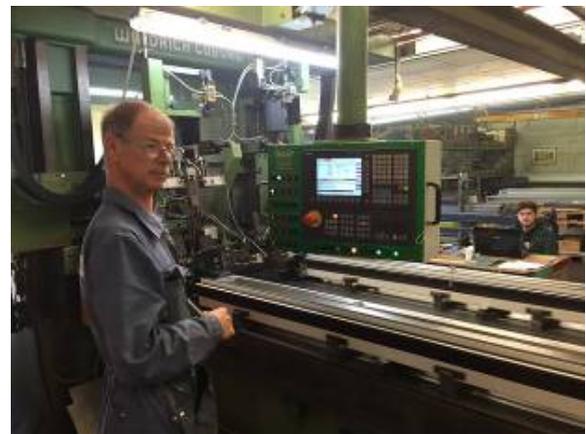
The surgeon, who 15 years has worked with the old CNC and now the new learning. At the same time he trains a new man, because he is the end of the year to the pension. WU3120a

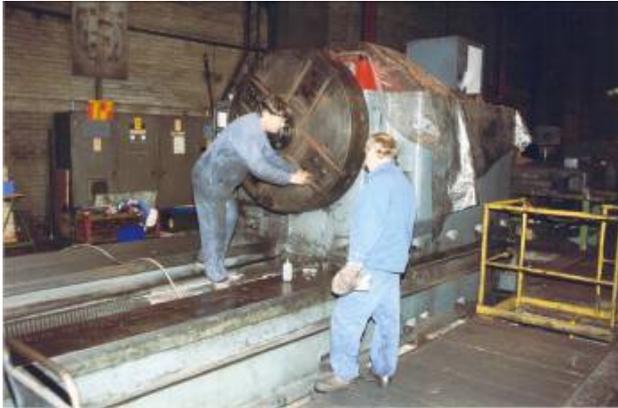
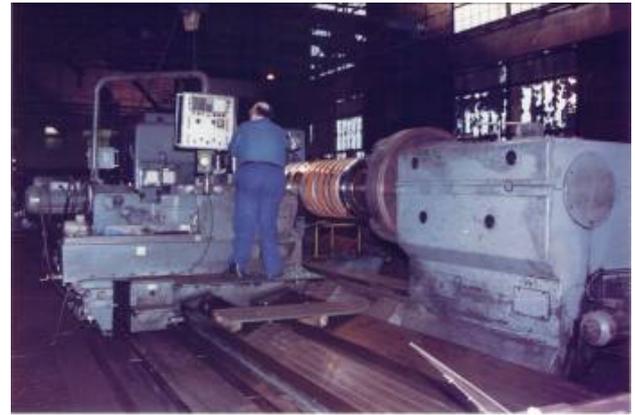
These professionals of skilled workers, which rotate these rollers are unlikely talents. WU4420

Task: The roll lathe must get control no new CNC. However, to be totally revised. The operators were accustomed to copy itself, so no CNC. The transmission had a damage. The tailstock guidance was lowered by several mm and had to be re eingeschabt. totally revise the cross-sled, all new sliding layer.

The machine could be only partially delivered to Switzerland for the revision. The breakdown of the 150 tons of machine was more expensive than to revise locally. WU4424

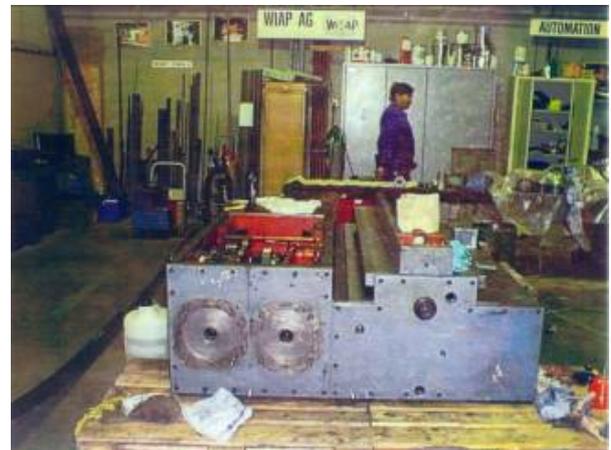
The carriage was continuously loaded with a thrust of 20 tons. WU4350

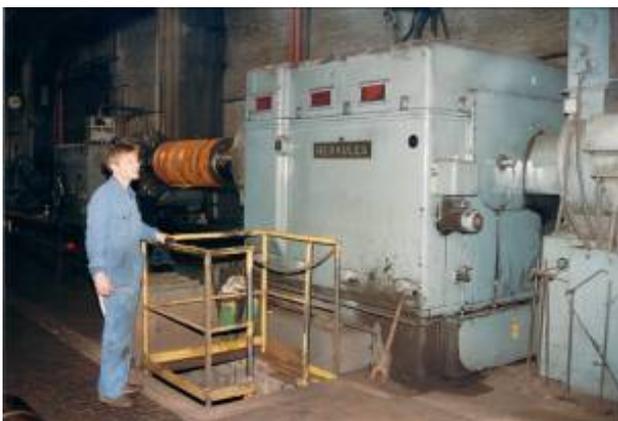
The machine has a spindle drive with 220 KW. The whole electrical system was renewed by us incl. The spindle drive. WU4415

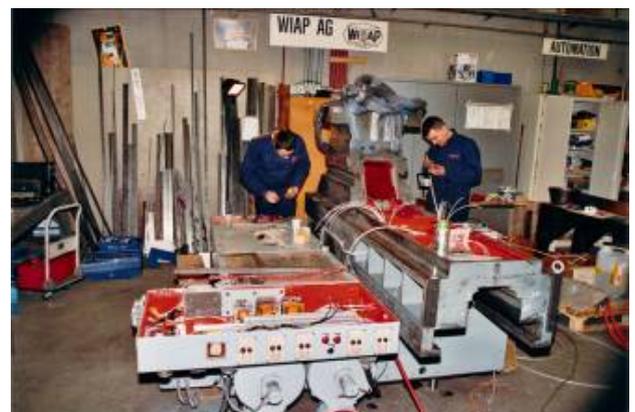
The carriage guide was re-occupied by SKC. The whole lubrication improved and renewed. The complete revision sled in Switzerland lasted 6 weeks. WU4302

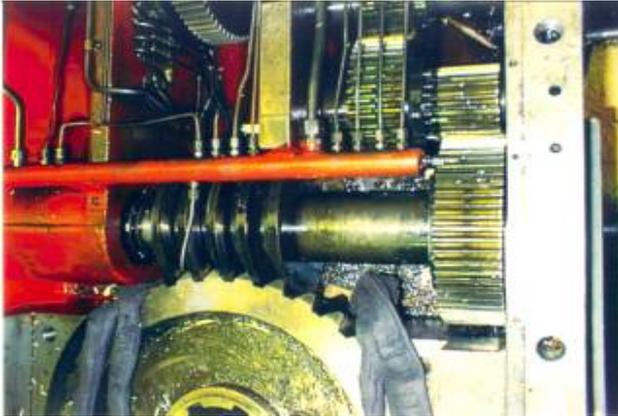
The whole longitudinal slide feed drive, which drive the rack was completely phased out. WU4310

Thanks to a Swiss gear manufacturer, we quickly had everything organized. The customer ordered within 1 day. Two weeks later, we had the gear to pattern. WU4125

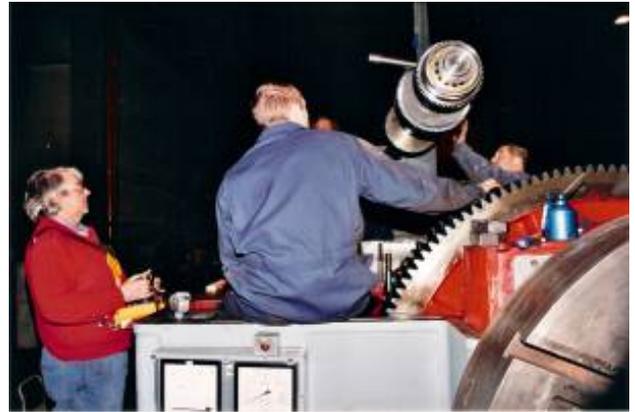
The installation worked very well. The transmission of the MFD, hats off, we can only praise the manufacturer. Sensational, like the whole structure was made accessible from above. Perfect. Thanks to MFD. This is one of the best machines we've ever seen. WU4145

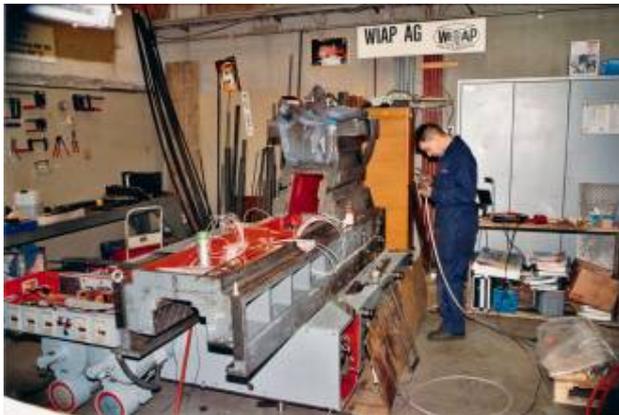
This, more than 20-ton sled was finally a revised sleigh with new SKC shows ect new eingeschabten gears, lubrication system. WU4324

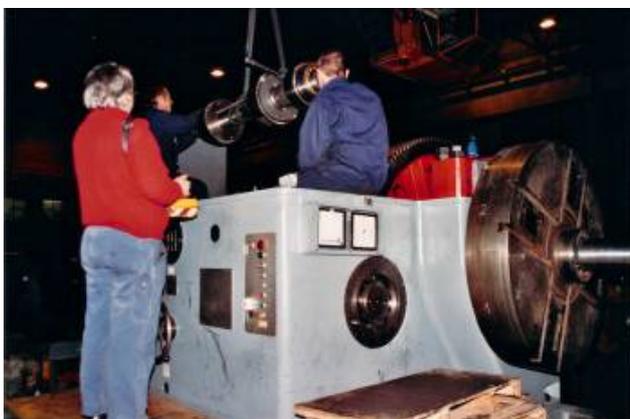
Finally the main gear shaft could be lifted out. Then we were able to offer the defective gear.

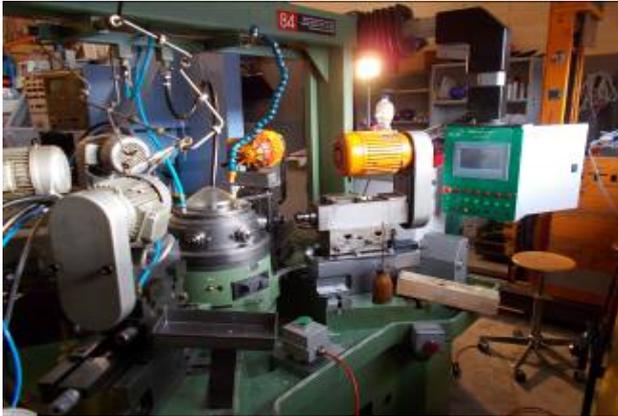
Enable the units to a central location. automate the machine. Simplified operation. Smooth regulation. Compact. replace many more conversion to new PLC and electrical cabinet. WU5150

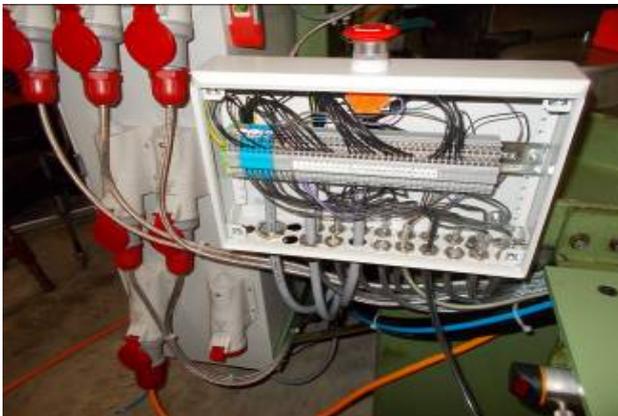
This cable box was arranged so as to avoid having to always open the electric oven at disturbances. All cable entries from below that in the heavily-operated with oil functions of the oil inlet is not possible. WU5130e

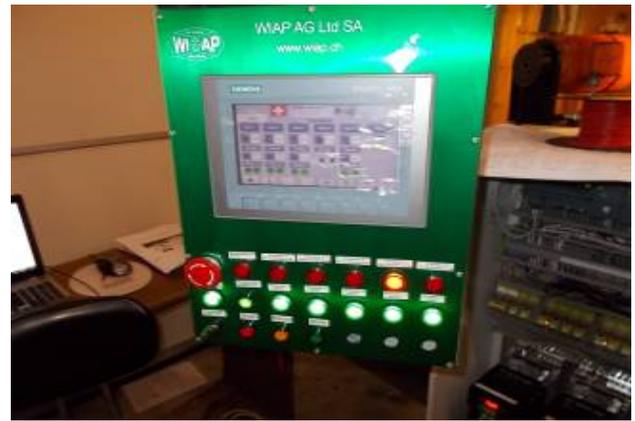
The panel in the final assembly phase. WU5130s

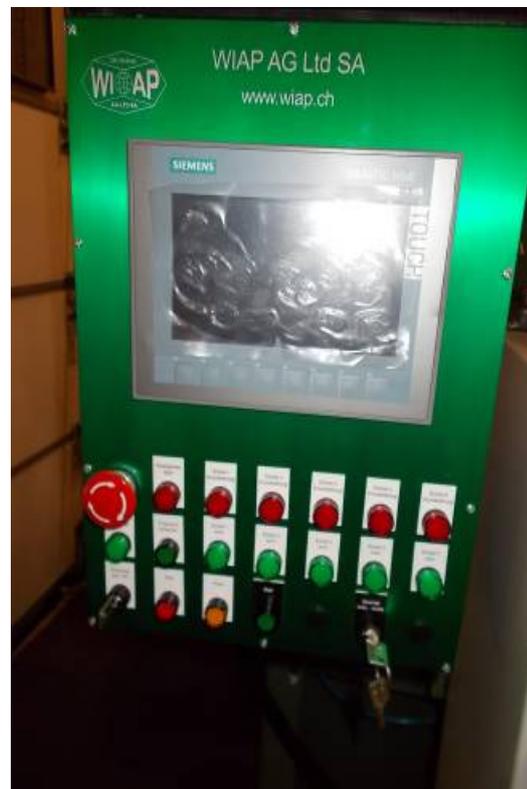
Soon finished panel of the machine. WU5130t

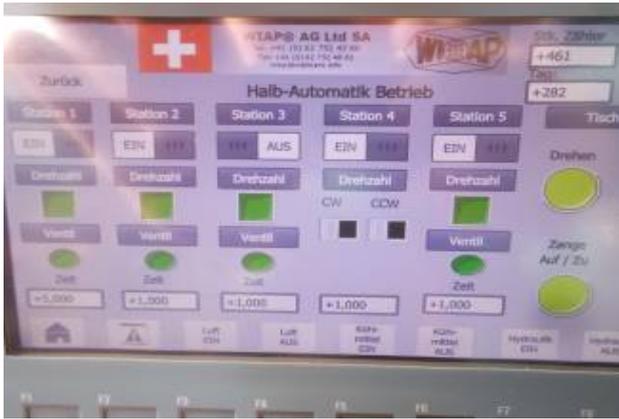
3 wallpapers of the machine:
Hand, semi-automatic and automatic, easy for
the surgeon for safe handling. WU5130u

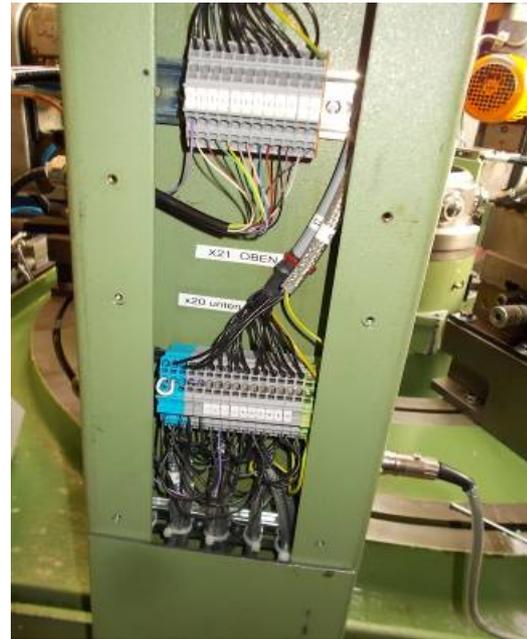
On the side of the column to the terminals for the
external panel. So that when a cable break to
have to solder without the cable can be replaced
quickly. WU5140

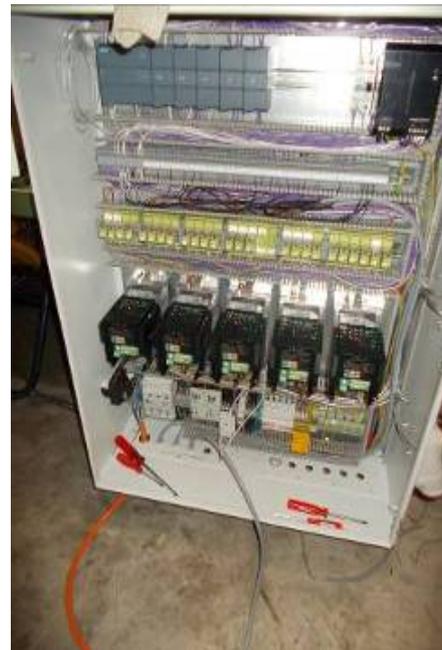
For all motors of the units we have built, each
with 0.75 kW instead of protecting equal to 5
pieces of frequency. These can be adjusted
continuously. From 0 to 70 Hertz, the option of
up to 100 Hz. I.e. twice the speed. Above the S7-
1200 is arranged. WU5140c

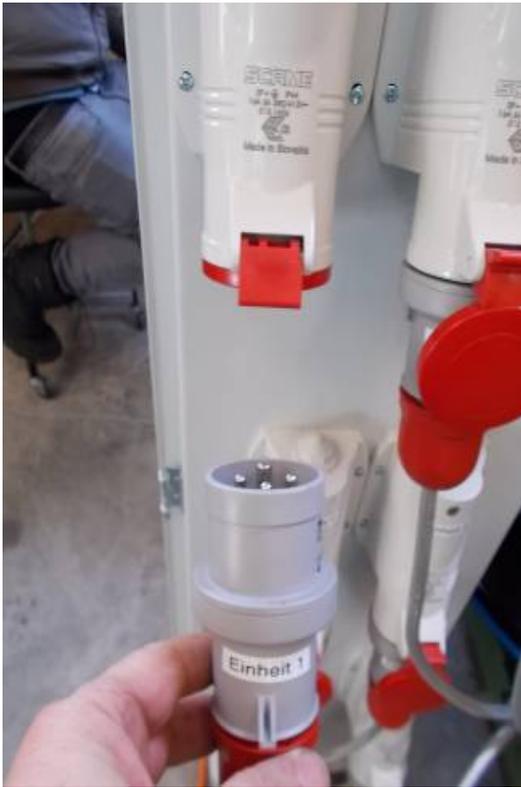
Each unit has its own plug. So that each unit can be removed individually. There's no danger to the operator, as the unit is safely isolated from the network by unplugging the connector. WU5140e

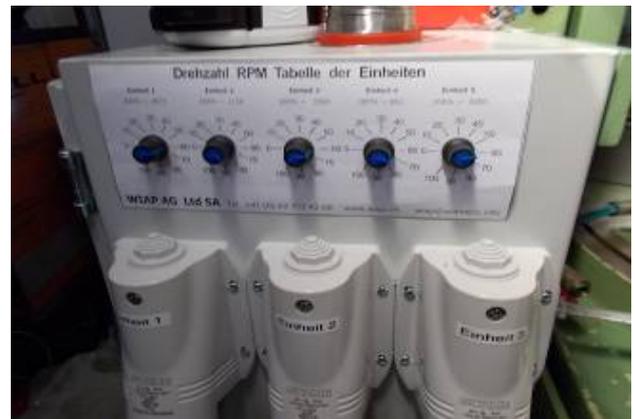
For all units can continuously, individually, the speed to be regulated. Thus an adjustment by third parties is not inadvertently possible, we have installed a plexiglass with the rotary knobs. WU5140h

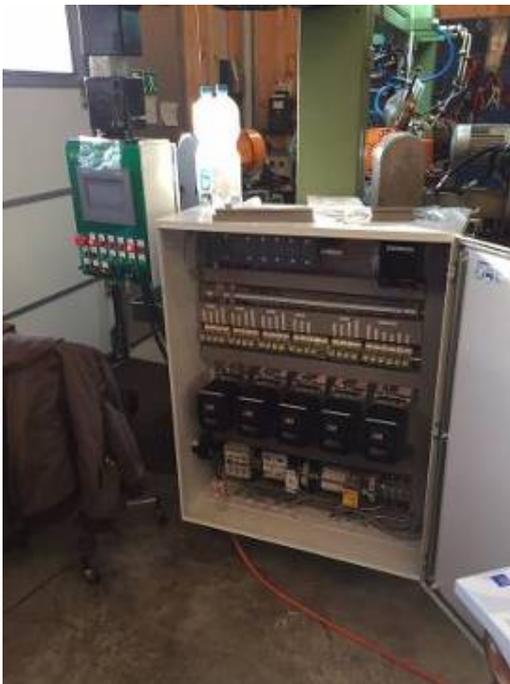
All relays are additionally written on the cable channel, thus, be seen in troubleshooting without electric scheme, which is for what. All functions

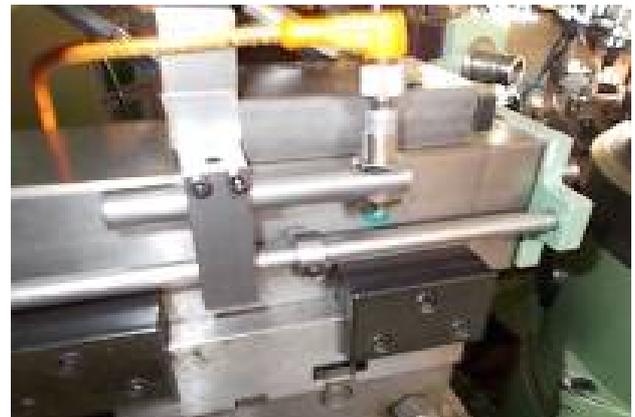
The unit 1,2,3 and 5 front had no position switches. So that they can work with a Ausschneidezeit, we have designed, manufactured and installed this shift linkage. When the switch forwards reports the entry time on the panel, waiting to make a cut. ie this switch must be set never because the stroke is constant 20 or 40 mm and only the switching point from

rapid to feed with a screw in accordance with image WU5140j can be adjusted. WU5140l

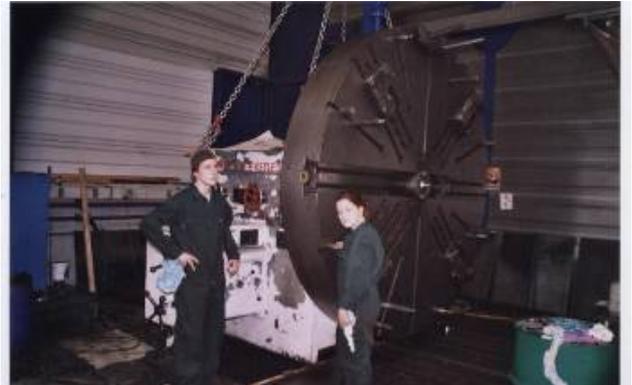
The machine had a geometric error. The customer has asked us to correct this. we were still electrically contactors and relays in the machine, which had for the museum. These were also replaced the same. WU3270

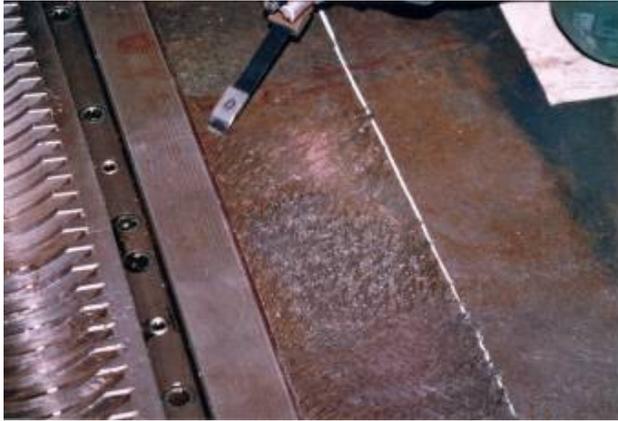
Now the problem with the shaving machine has been corrected. As a rule, per scraping passage, depending on the pressure, about 0002 to 0005 mm away, ie when an error in the 0.1 mm range is, but a lot needs to be scraped. WU3130

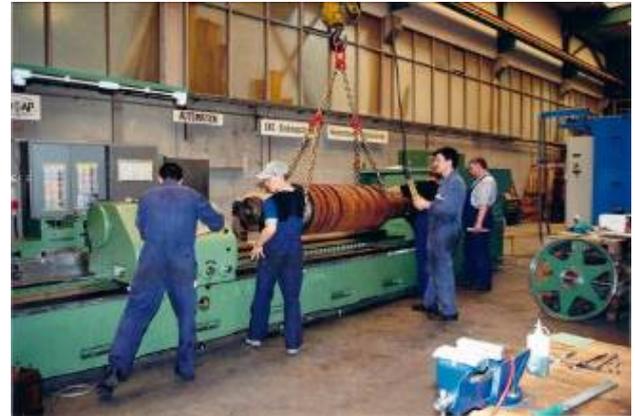
Task: The conventional copying roll lathe is to get control of a new CNC. With total revision. The surgeons had to copy itself usual, so very simple parameterized, designed by WIAP and created CNC programs. Only a few entries with R parameters could all be typed. New ball screws 80's in the Z axis. reground bed, new eingeschabt sled. New, automatic lubrication system. The 4 claws box were also revised.

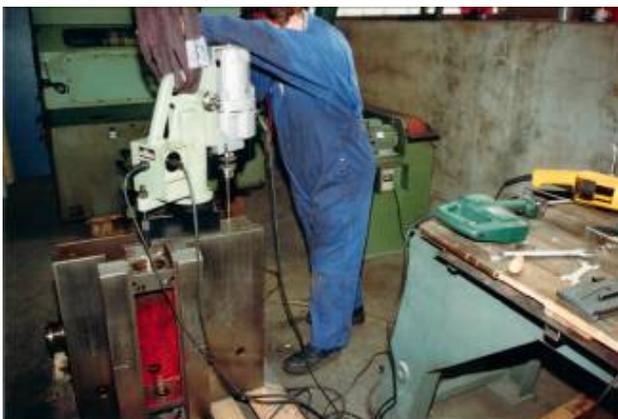
In Russia, if not boring machine was available, and elements were separated. It is something that still had to learn a machinist. WU4627

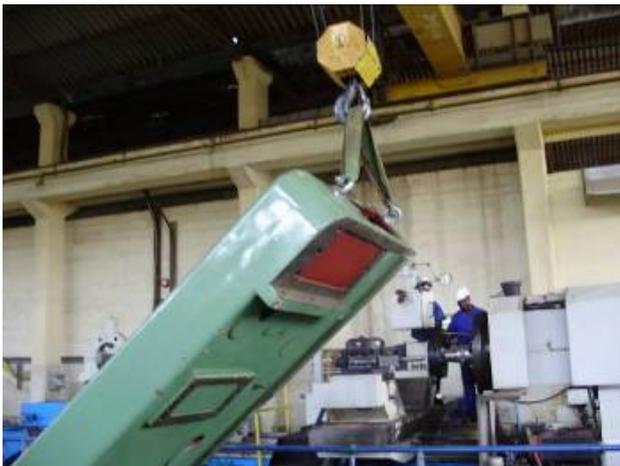
Now the second side stand is mounted.
WU_240_50

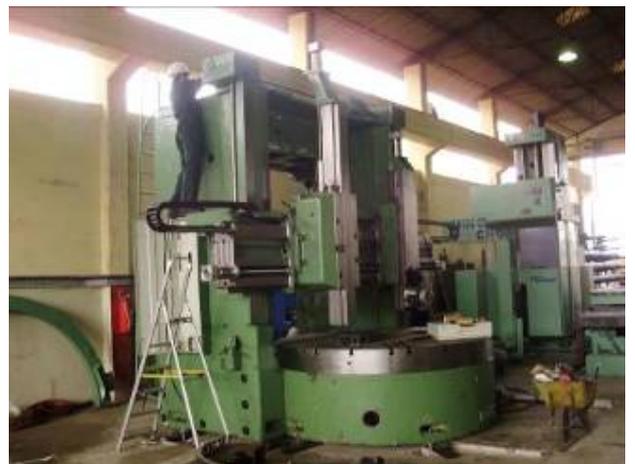
The side stabilizer below. WU_240_60

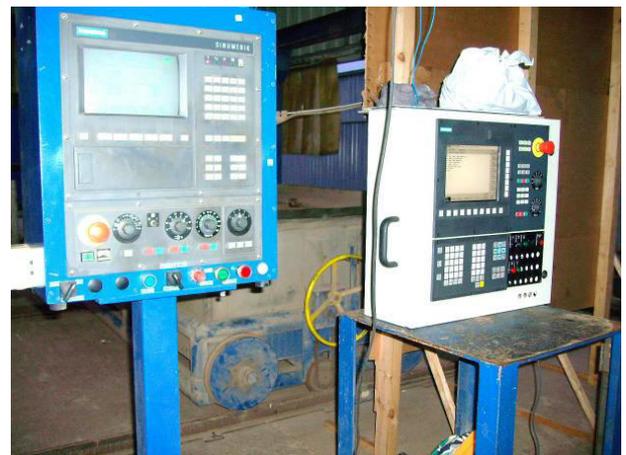
This is the new controller for the water jet machine. Again, the old Sinumerik 810M is greedy. The air conditioning system, the condensate and the aggressive air almost dissolved the boards.

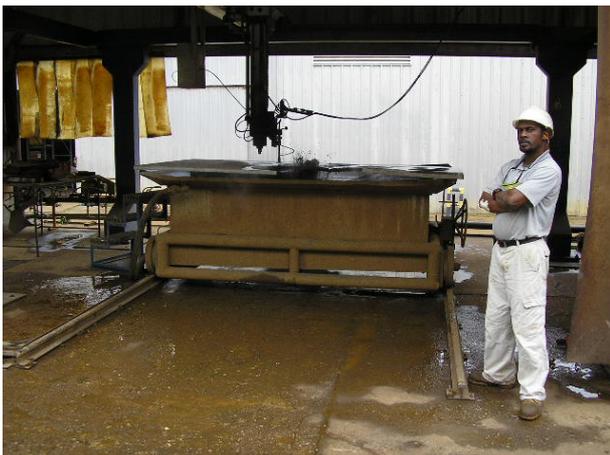
Here you can see the work of the water jet machine. You can edit plates 3 x 4 meters. Above all, we need this machine for the stainless material because with gas cutting machine (Q xy Cut) can not cut stainless.

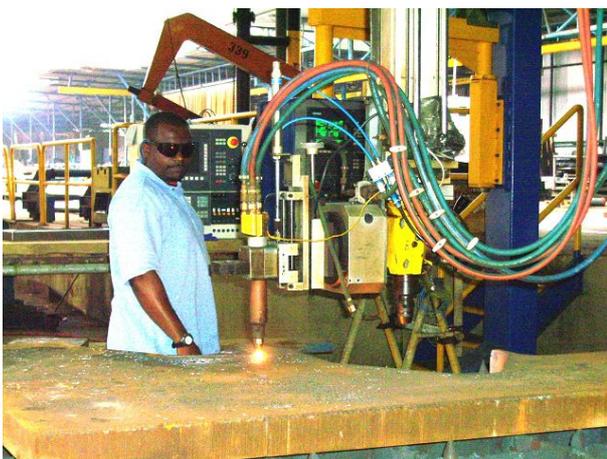
Here, a section is prepared by a 100 mm thick steel plate.

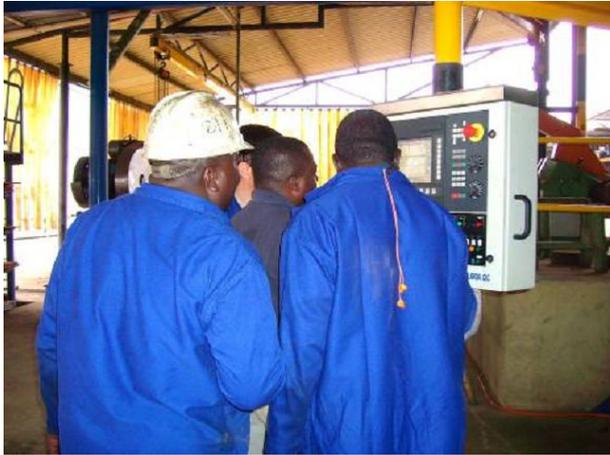
Now the machine does everything automatically. The programming for the preheating and the div. Valves was still a few hours of work, because the whole process needs a little experience.

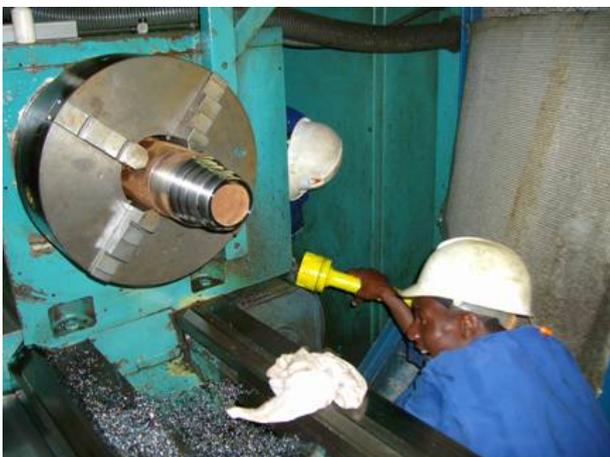
Photo: During commissioning, the lubrication will not the way we want it. No pressure build-up. Joba investigated. Then you see that the pump is faulty, so a conversion also helps error that can cause expensive consequences, are found before the damage.

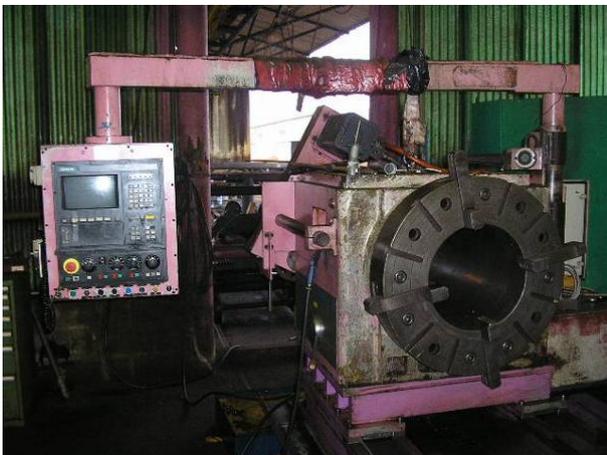
Photo 1: engine is not running for several days. Spindle drive does not work. replace def. decision immediately the CNC.

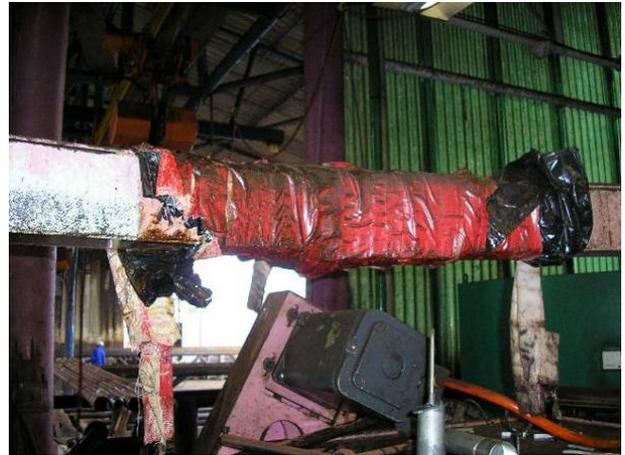
Photo 2: Here you have prevents water from running into the CNC, nevertheless was always wet. It looks like a large amount of condensation. The aircon was always running at full speed.

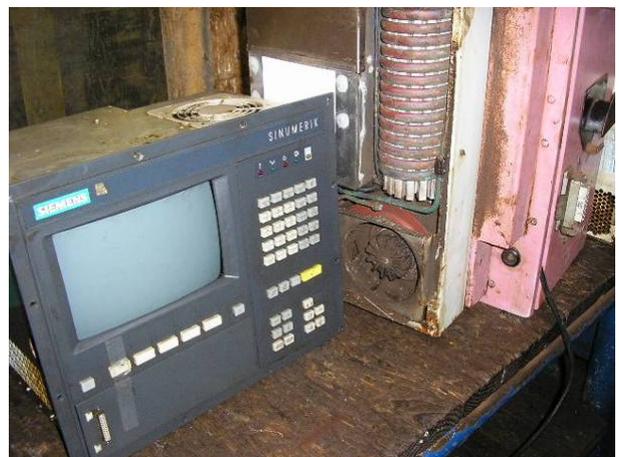
Photo 4: Only rust.

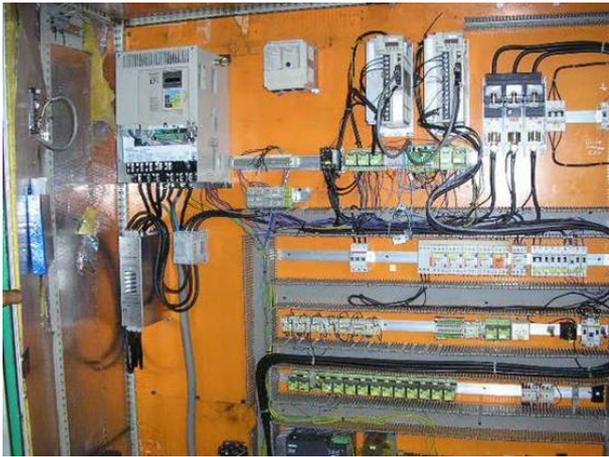
Photo 8: All that was cable away. (We had an idea, Wireles). The sources were too large, the machine had so much in it such as fairs, break monitoring Driven tools C axis. But you never brauchet it. The machine was fully occupied with pipe turning, so we have only the bare minimum before it for maintenance.

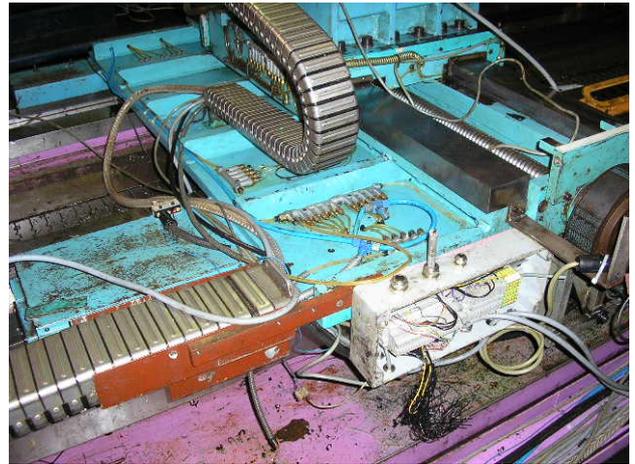
Photo 24: In the past, the lubrication on Z sled, new back of the headstock was. There are fewer EI lines that need to Z slide and is operator friendly.

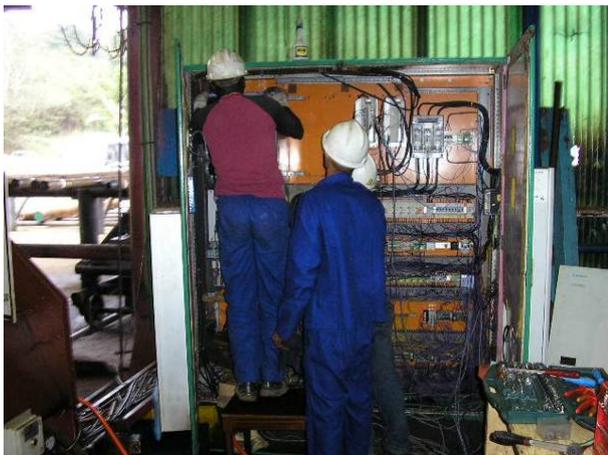
Photo 20: Here you build the old Siemens from regulators.

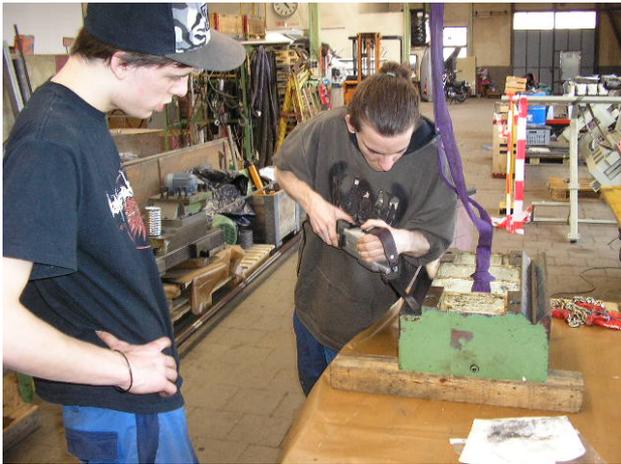
Scraping the geometry Per times about 0.004 mm

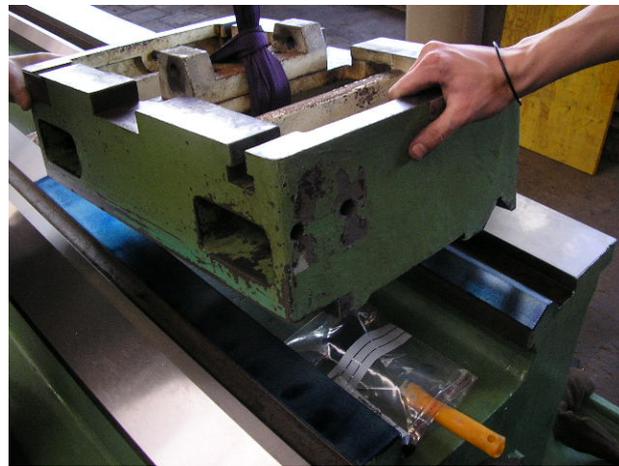
Photo: Abduschieren the tailstock

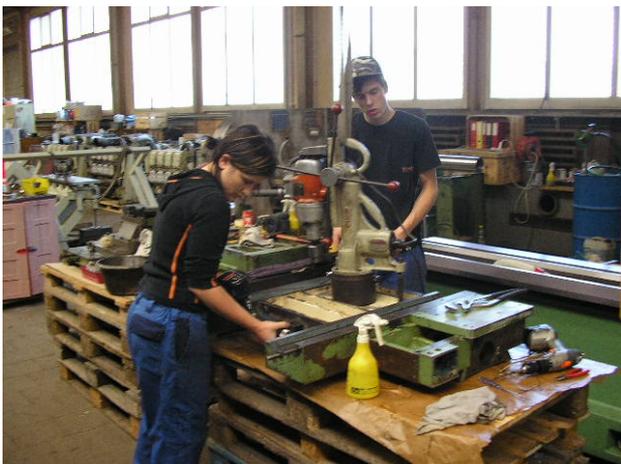
Photo: Caro drilled new lubrication holes in the sled.

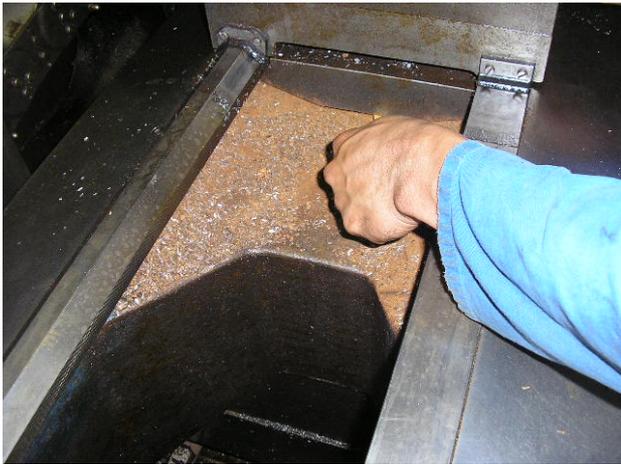
Photo: Dan, one finds the rust under all covers, almost like in Angola! So you decide to unscrew many sheets.

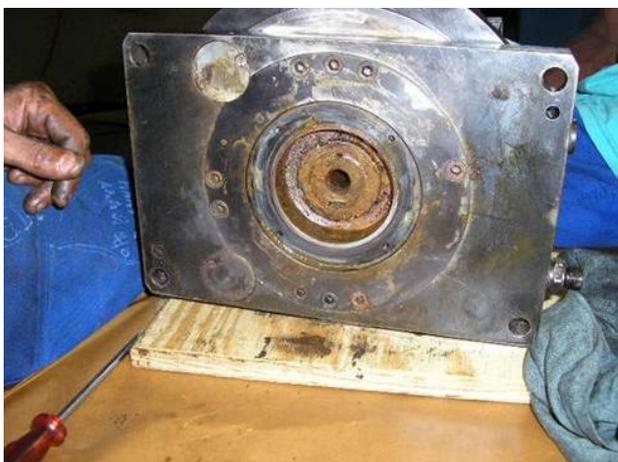
Photo: Here Carlo Wired still new after saw the clips from the Water suffering.
