Umbauten, Erneuerungen, Retrofit

Photo report collecting information WIAP 2016 WU500

Detailed photo report remodeling Heid
WU190

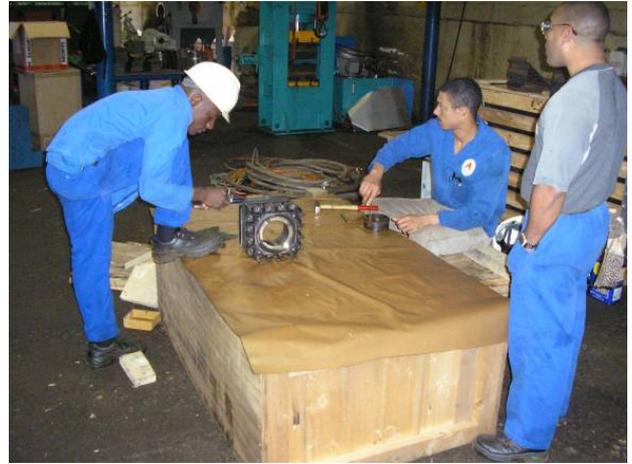
Photo: When the tank turret, the first grate prior notice.

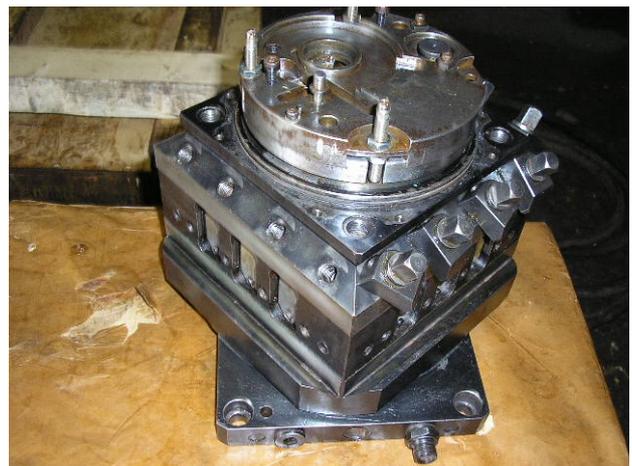
Photo: Assembly.

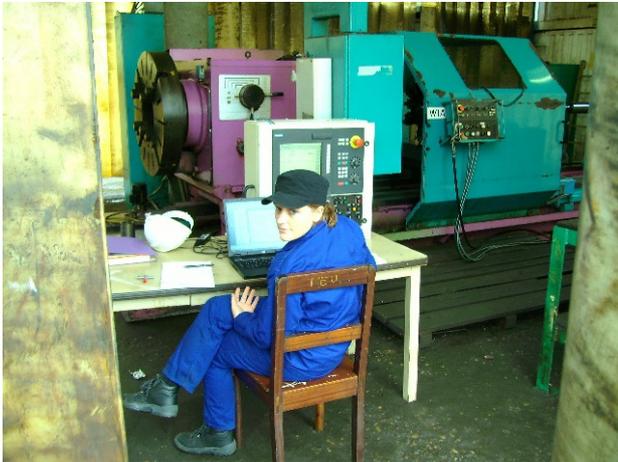
P2: So the machine looked before the renovation.
Caroline Widmer in programming

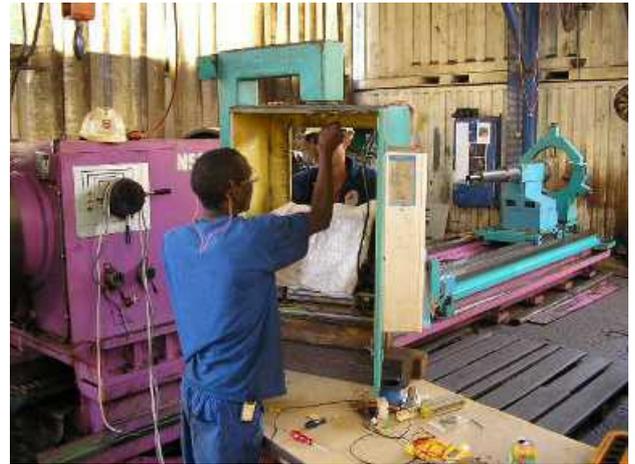
P8: Now you begin the reconstruction of the CNC.

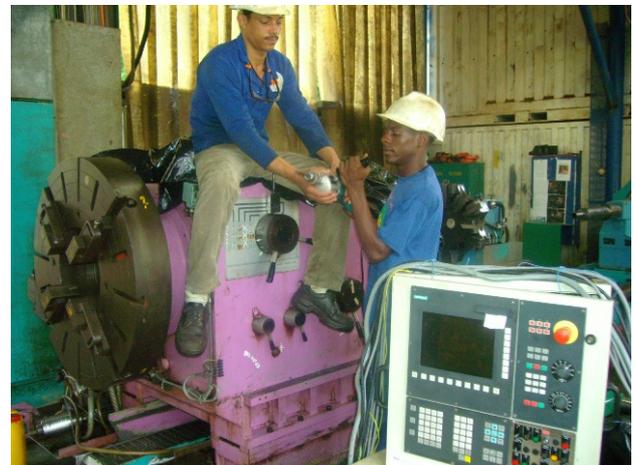
P12: Gear tag for mounting to circuit breakers so that the transmission can not be connected incorrectly. Especially without gear stage no speed.

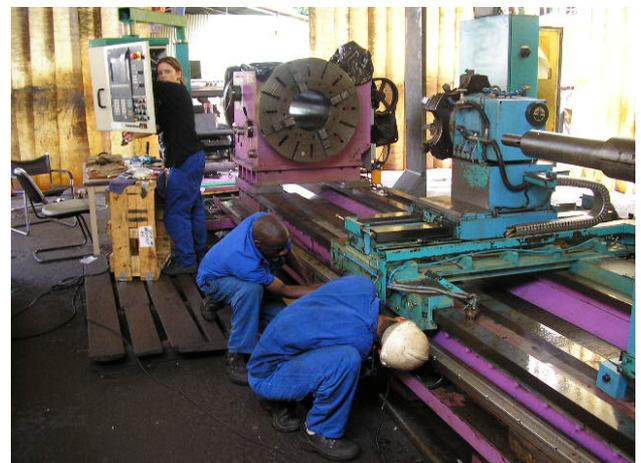
P29: Preparation of stand Z sled, you looked as tracks and wanted to know what's going on

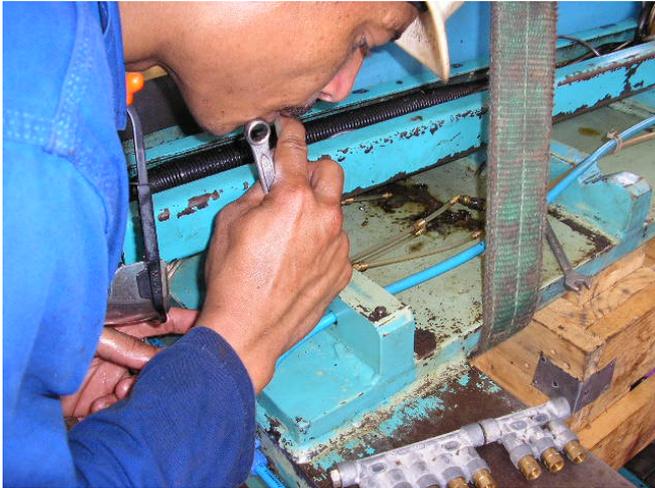
P36: Important: Before letting the sled down, lubrication must be checked. On the machine you have months instead slides oil, used rust protection. Some lines were shut good that we dismantled it. Carlo blows with the mouth; We use compressed air.
