## Umbauten, Erneuerungen, Retrofit

Photo report collecting information WIAP 2016 WU500

### The WIAP has some remodeling done projects. Below are a few excerpts.

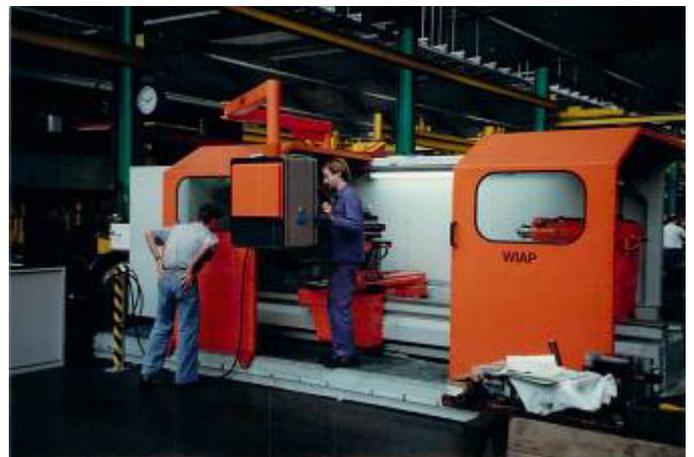
Finished machine after the conversion. WU5291

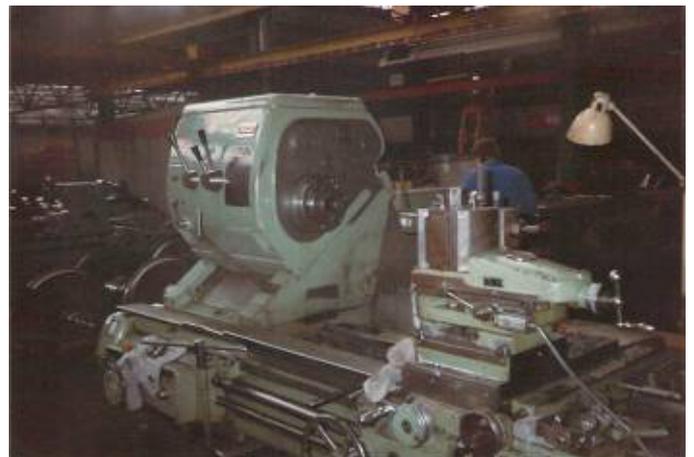
Old Conv. Machine before the conversion. WU5205

Task: The conventional copying lathe Heid should get a new control CNC. Through all the conversion it is to be a new CNC machine with automatic transmission shift, full enclosure and chip conveyor. There is a total overhaul. Very

simple parametric programming designed and produced by CNC WIAP programs. New ball screws 63-ies in the Z axis and in the X axis he 50th the bed reground; Carriage newly scraped. New fixture with WIAP clamping concept, double clamping cylinder, which can feed voltage for the roughing and finishing with 2 clamping pressures working on the holding. New automatic lubrication system. 4-fold head turret for low in collision rotating the railway wheels. The machine produced in the Federal Railroad. WU5205

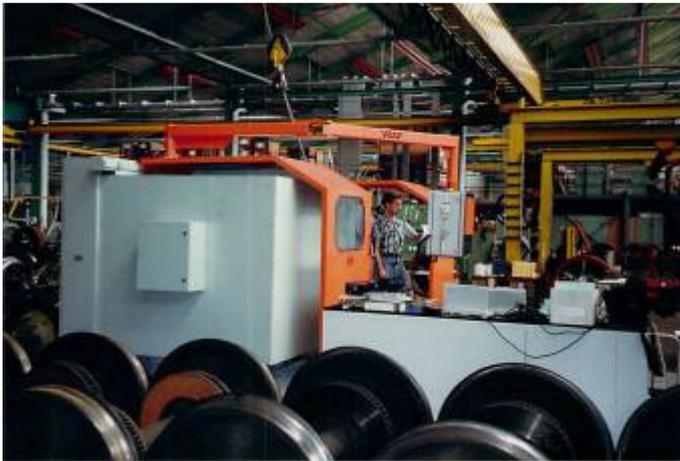
The machine at the customer placed. This is all a immerr delivery. Everything from A to Z is made of the WIAP. No third party, hence no coordination planning for the customer needed, which makes the cost more controllable. Here the machine is already in production. WU5290

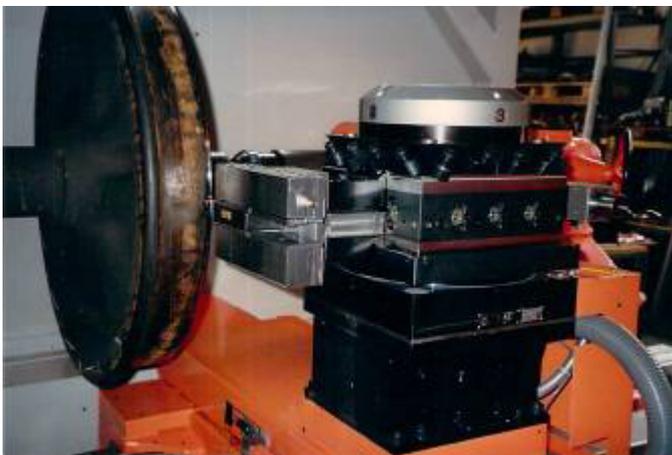
Turn wheel flanges is particularly subject. But the CNC technology knows no bounds since. In contrast to the previous point turning certainly much easier. WU5287b

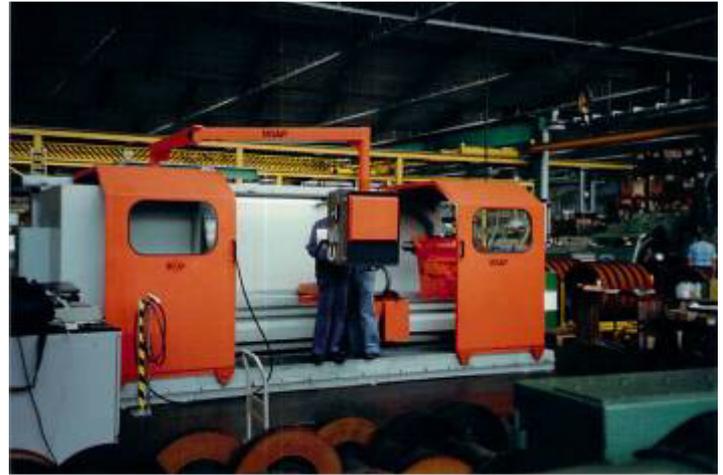
A conversion concept: Created and designed from A to Z of the WIAP without third support. This is possible because the WIAP manufactures own CNC lathes. And annual tithe experience in things turning. And today is the second generation of WIAP there which will be even better, which is getting easier thanks to the electronics. WU5290d

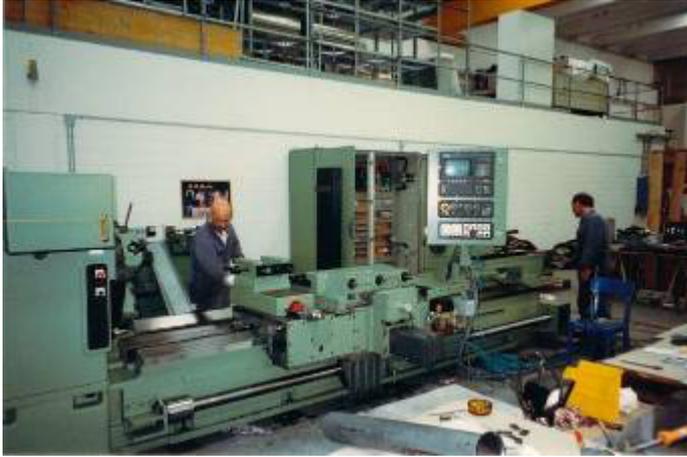
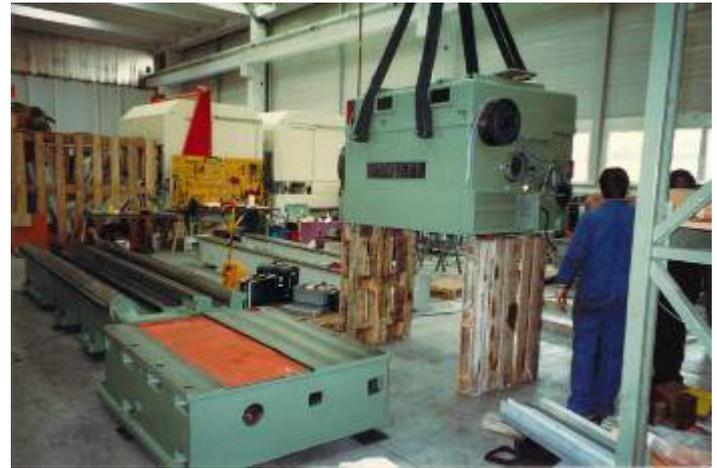
This sturdy, heavy, conventional roll lathe must be moved from the WIAP on CNC. WU4725

Task: The conventional copying roll lathe to get a new control CNC. With total revision. The surgeons had to copy it usual, so very simple, parameterized, conceived by WIAP and created CNC programs. Could be programmed only by the input of the R parameters after reconstruction everything.

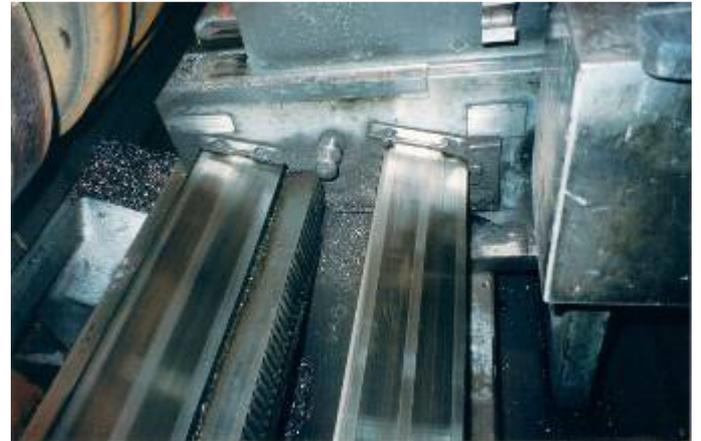
New ball screws 80th in the X and Z axes. Bed reground; Carriage newly scraped. New automatic lubrication system. The 4 claws boxes were also revised. Insert strips made of spring steel, which we shared. WU54715

The Z-axis guide is designed for a very strong cross shank cut pressure. The machine had 4 steels, which simultaneously rotates the roll contour. This gives a very large management burden. The machine had insert strips made of spring steel, which we shared. WU4740

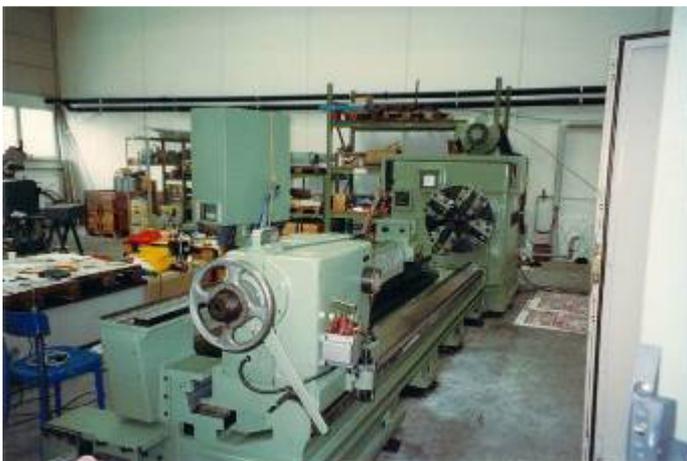
The machine consists of good, heavy cast, so this machine can turn vibration. WU4735

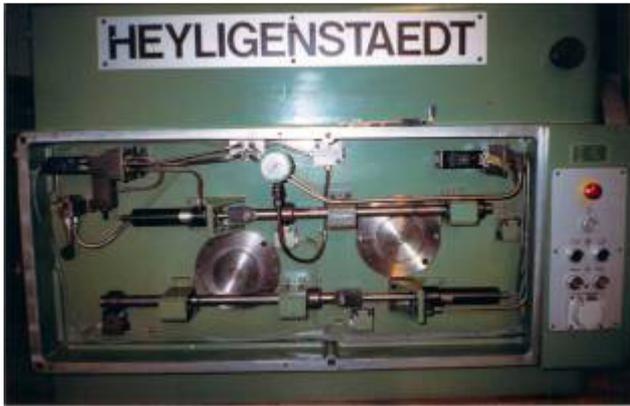
The shift rod of the shift forks is controlled by cylinders. A well thought out, intelligent switching solution. WU3420

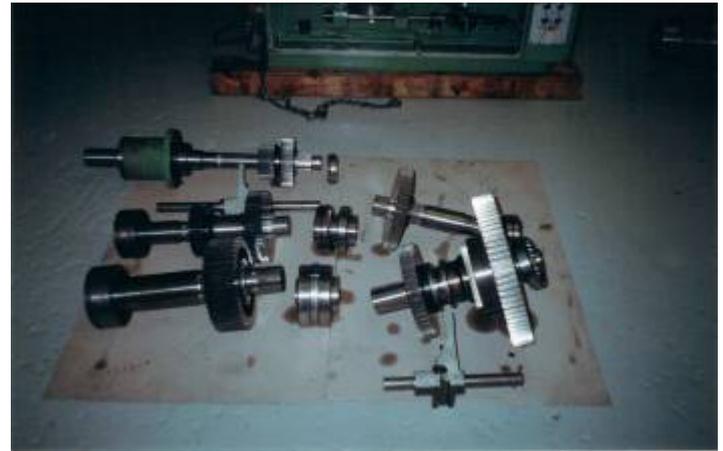
Everything here is so laid from the headstock, thus all spacer rings come back to the right place. WU3490g

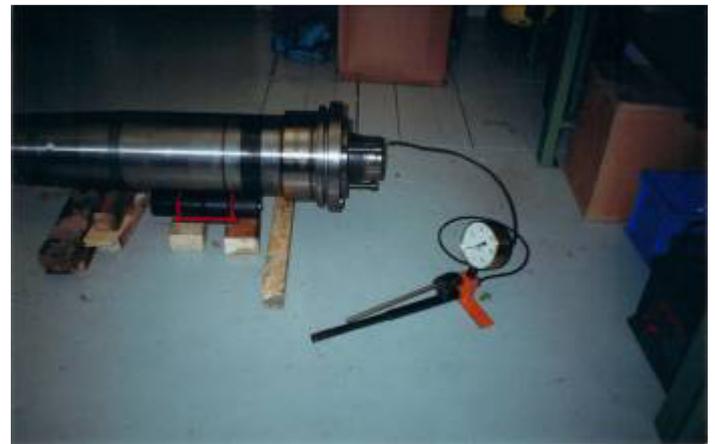
Here, the bearing is pressed with the press compounding pump. The process was a few years very popular. However, when such a pump is missing, which cost about 3000 CHF and the oil, then the removal cannot take place. And when the seat is a little damaged during installation and the seal is not OK, then disassembly is very complicated and requires some imagination to get to your destination. Because the pressure is enormous in the press compounding. For example, 2500 bar. In the case of interference fit oil terminal was at the front of the spindle nose. WU3490x

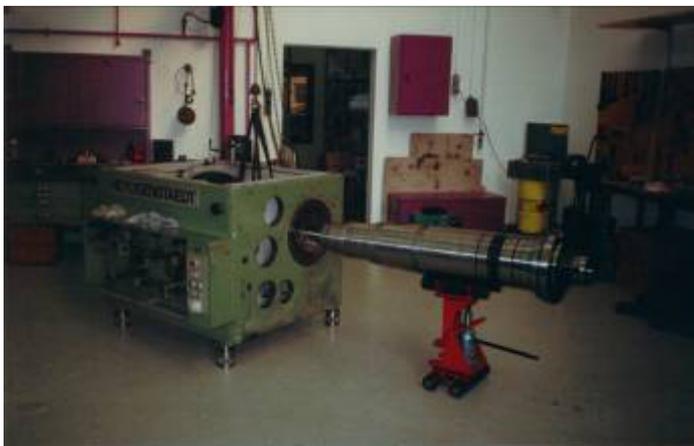
Second Repair of headstock bearing defect. View of the expanded main spindle of the machine Heyligenstaedt. WU3470

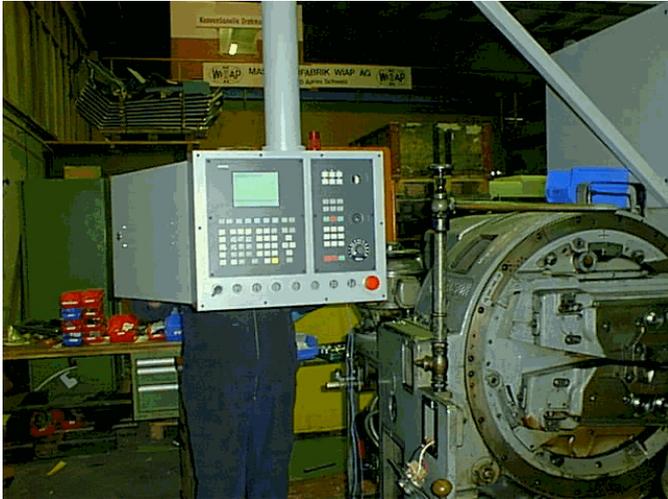
The customer has an old, conventional Gleason Gear Shaper. He wanted upgrade this machine with a new CNC control. Assembly of the new CNC control on the machine. WU5400

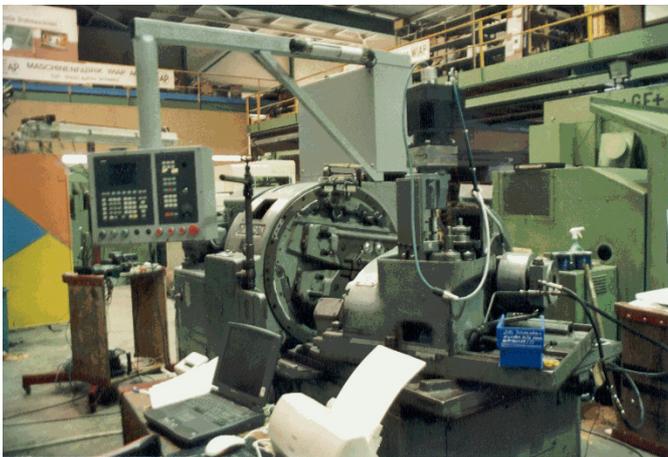
3 new feed engines were grown. The compact electric cabinet, directly on the machine, attached. WU5410

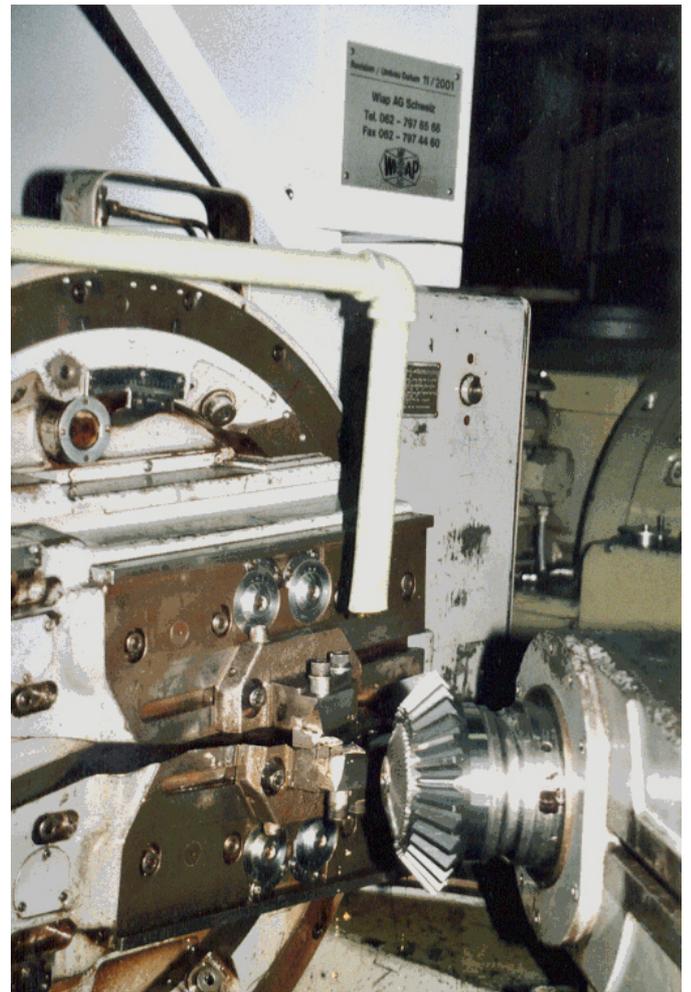
Only a few parameters, the operator can enter the number of teeth of the module, etc. A simple, quick solution to produce bevel gears. WU5420

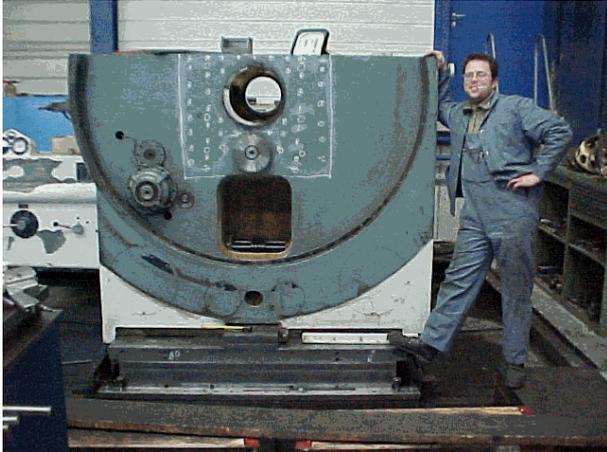
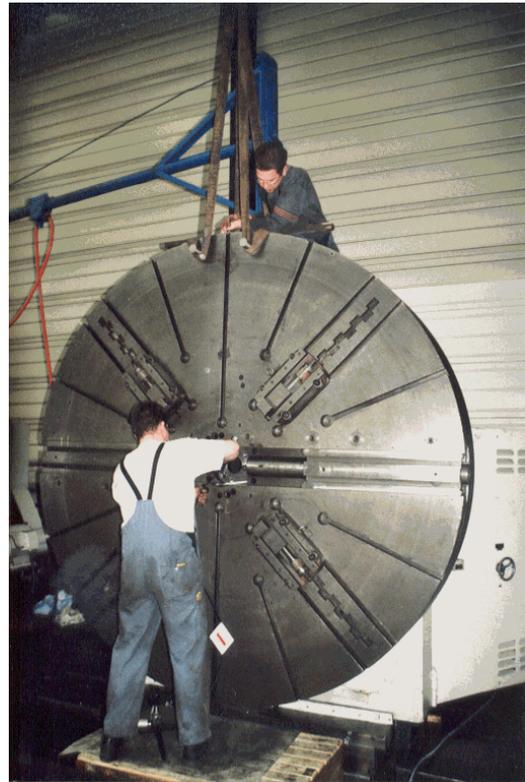
Client had clamped to large work piece on the machine. This has torn the headstock. Measures of WIAP: Spindle dismantled. Headstock casting repaired. New spindle bearing made. Instead bearings, the best NN storage in the existing main spindle installed. It with a 2-part box, so it was mounted. Construction, assembly and disassembly of WIAP AG. Processing the customer. Place of delivery of the project: in Switzerland.

Here we have penciled as we attach a new faceplate. The headstock had split a crack transversely. The large front panel we have prevented a further spreading. On a boring everything had to be milled clean and many great threads were needed to enable the pressing force coincides with the friction to continue loading large workpieces. WU3320

The first step is always dismantle these faceplates. WU3095

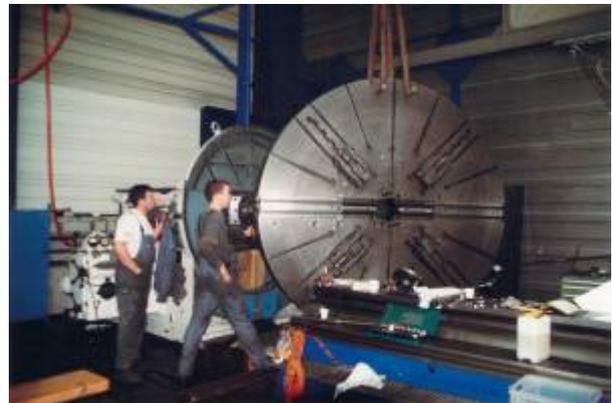
It takes a delicate handling of the crane, if such a face plate must be removed from the spindle nose. WU3020

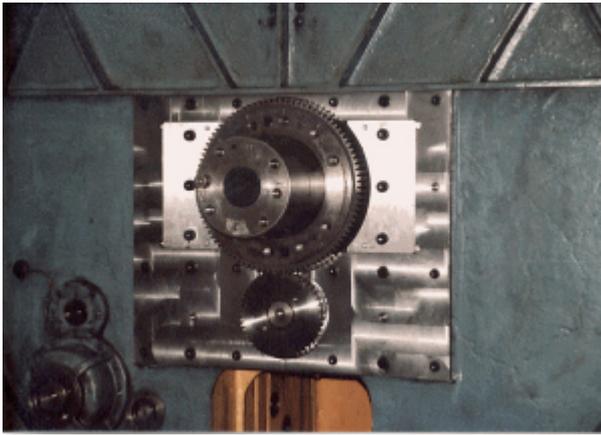
The new plate. The spindle bearing, which was previously a slide bearing, we have replaced with a proven NN storage. The recessed spot where the slide bearing was in it, we have made a detailed 2-part sleeve so that the bearings are assembled and disassembled. This bearing is opposite spindle bearings, complicated to adjust, because the bias voltage can be, depending on the rotational speed are set. Thereby, also the vibration characteristics are regulated. WU3340

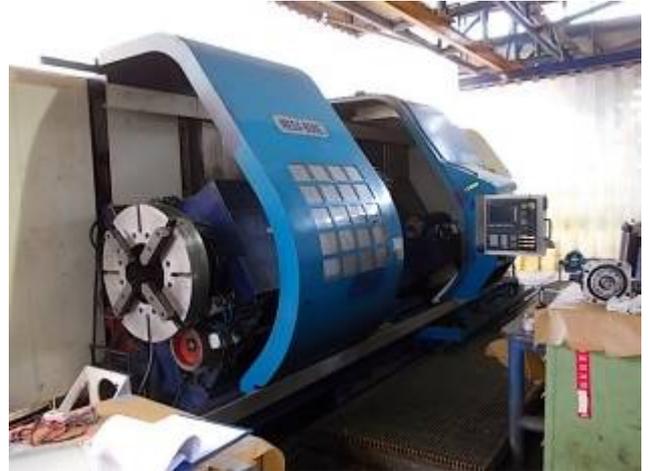
Machine weight of Mega Bore: over 20 tons.  
WU\_232\_190

A hole in the casing of the Mega Bore CNC machine has water damage to the Fanuc 18i causes. It was so complicated by the spare parts guarantee-performance and the support of the control manufacturer that we decided to replace the CNC controller incl. All engines with a new CNC control Sinumerik 802 D, because we have no spare parts for the Fanuc's stock and the controller for repair still did not work even after the third time in Fanuc. The respective repair costs with replacement and CPU screen did not lead to the goal. The stoppage was almost 3 months. After the conversion decision, the machine was running in 2 weeks. The electric plans everything in the Asian font to the PLC program text. It was still good thanks to the experience of many CNC machines that are already in use in Europe.

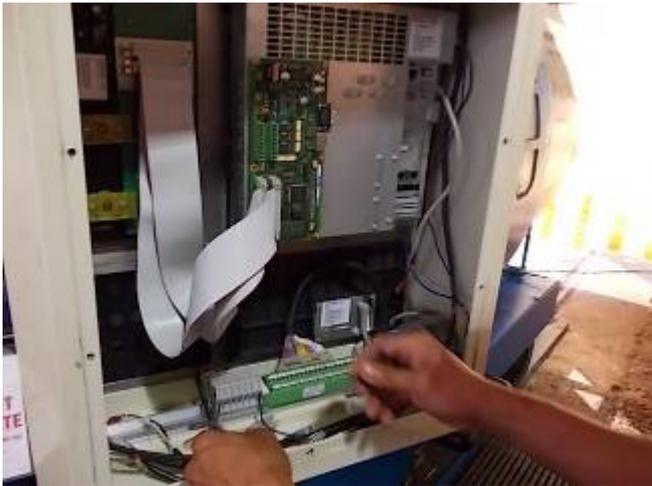
Significantly fewer cables that hang around there. Sure, only about 30%. WU\_232\_290

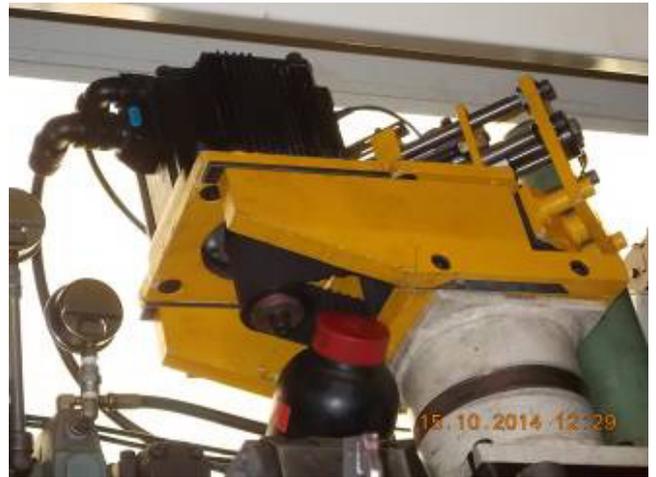
To ensure that all feed motors could be used without brakes, was from spare parts reasons, an external X brake produced, not in the engine.

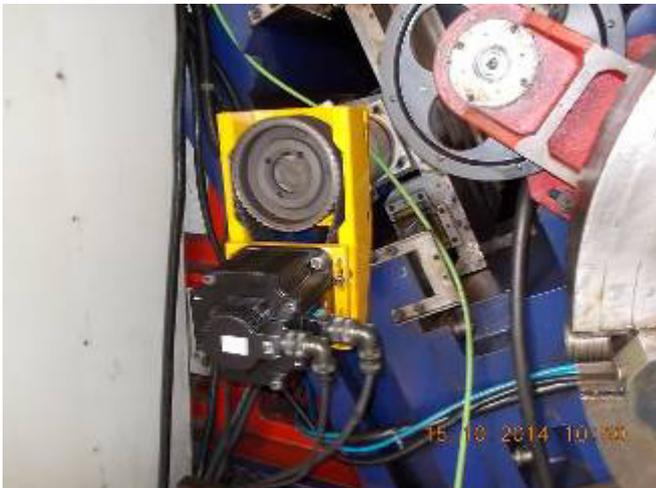
All the Z drive was a submission 1: 2 Construction renewed WIAP.

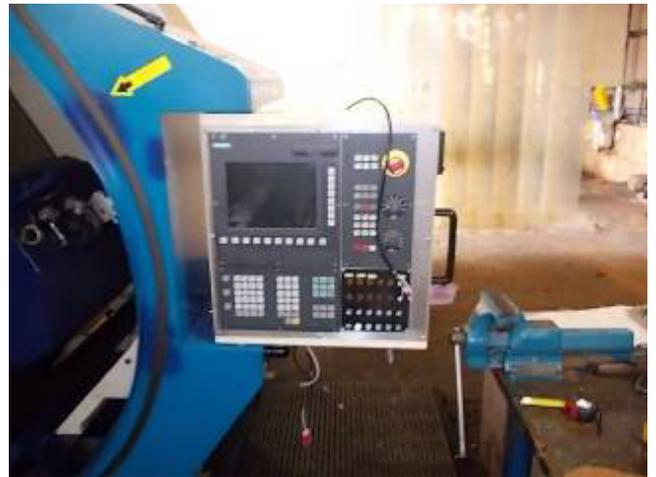
Here soon the first tests are making with external 24V. WU\_232\_320

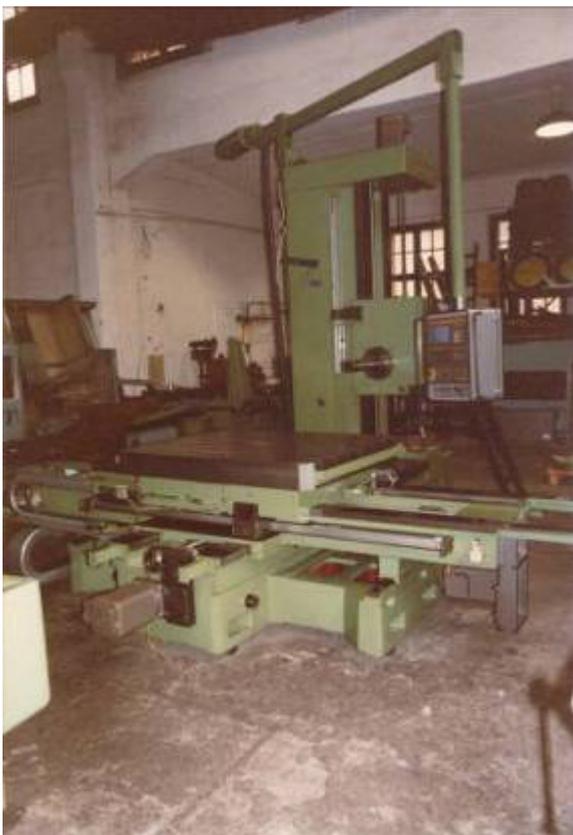
Scope: Dismantling the central drive and single axis drive. Roundtable also CNC controlled. Cultivation of ballscrews in the X, Y and Z axis and single-axis motors feed. Design and manufacture incl. Assembly of WIAP.

Here is the finished machine after reconstruction with the new Sinumerik CNC control. WU5009

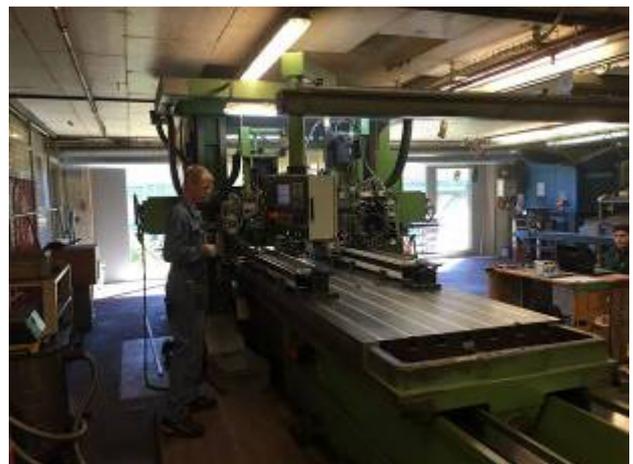
Project Description: The Waldrich planing machine was rebuilt in 2001 by the WIAP, with a new control: Multitron.

years. The finished rebuilt planer planning the first 2 bars with the new CNC control. There are 8 and 4 tools engaged simultaneously. WU5380

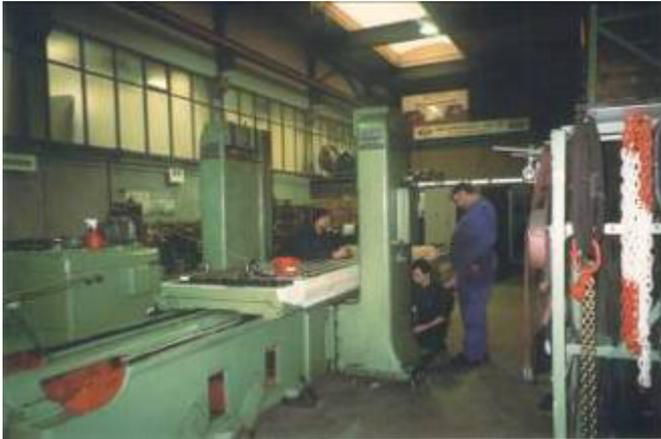
The planer with the shortened side column. First, we can drill 4 40 H7 pin holes on a boring machine in 0.01 mm accuracy. WU3120

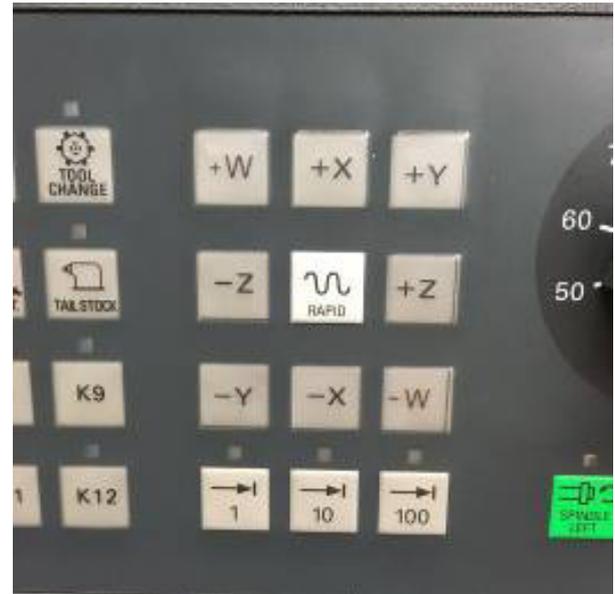
The machine has 4 axes: X, Y, Z and W axis. Each 2 axes operate simultaneously. X and Y, and Z and W. WU5300

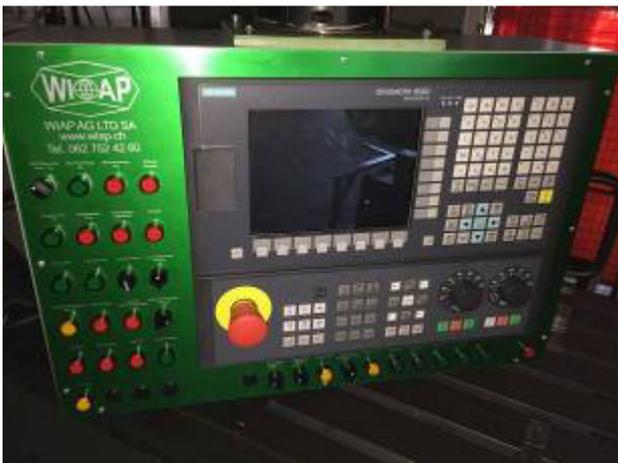
The new CNC control is the newest of the new. The customer can now again assume to be able to work for 20 more years. WU4020b

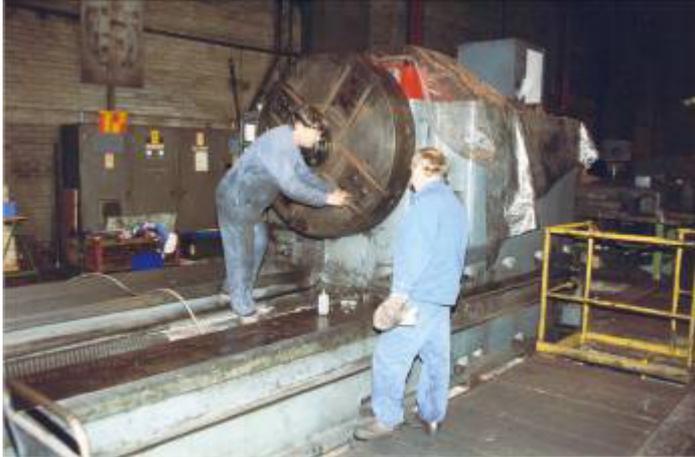
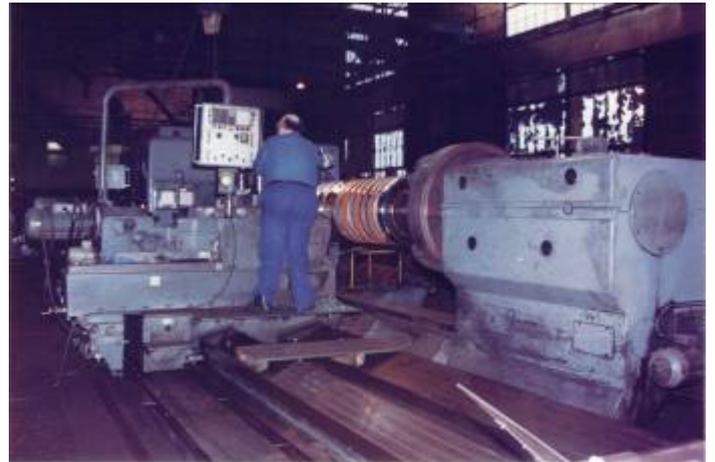
Task: The roll lathe may get control no new CNC. Should, however, be totally revised. The surgeons had to copy itself usual, so no CNC. The transmission had a loss. The tailstock guidance was lowered by several mm and had to be scraped. Totally revise the cross-slide, all new sliding coating.

The machine could be only partially delivered to Switzerland for the revision. The breakdown of the 150 tons of machine was more expensive than to revise the spot. WU4424

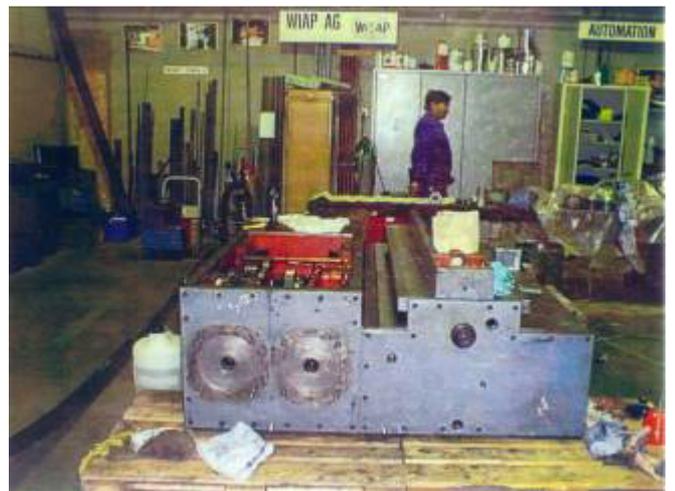
The carriage was constantly loaded with a feed force of about 20 tons. WU4350

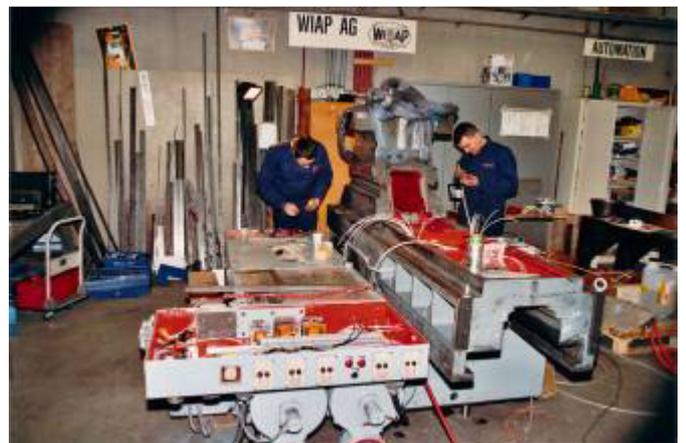
The slide guide has been re-occupied by SKC. Improves the whole lubrication and renewed. The

entere carriage Revision in Switzerland lasted 6 weeks. WU4302

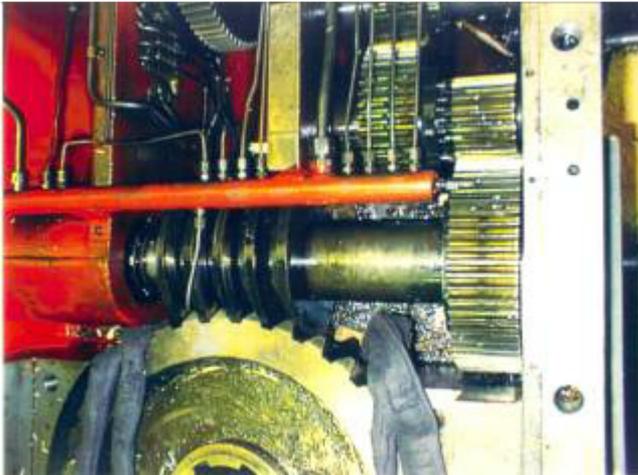
All the longitudinal slide feed drive, which drive the rack was completely expired. WU4310

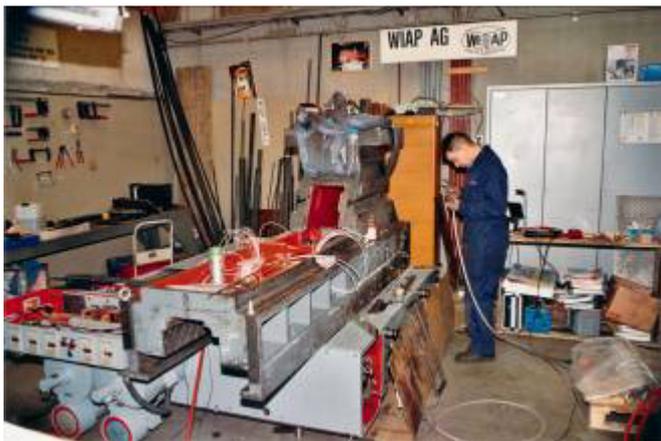
This, more than 20 tons carriage was finally a revised carriage with new SKC shows new scrap gears, lubrication system ect. WU4324

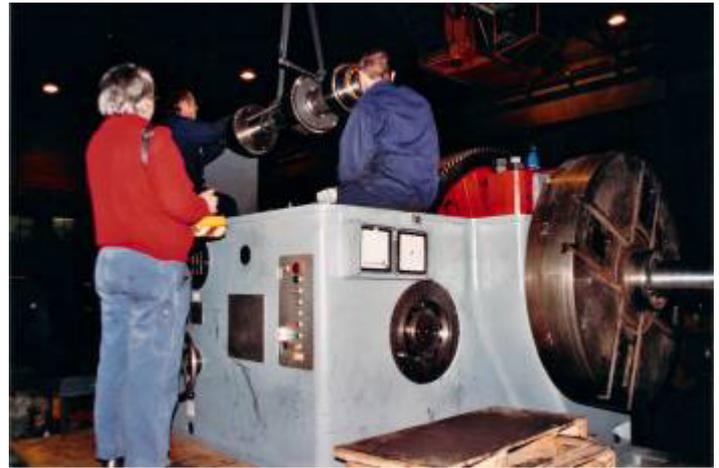
Finally the main gear shaft could be lifted out. Then we were able to offer the defective gear. Thanks to a Swiss Gear Manufacturer we had quickly organized everything. The customer ordered ships within 1 day. Two weeks later, we had the gear to pattern. WU4125

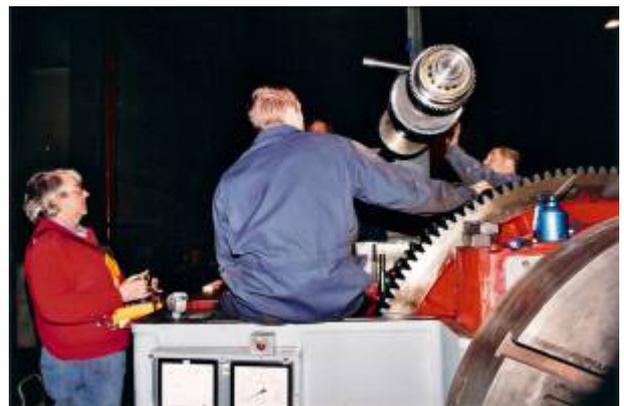
The installation worked very well. The transmission of the MFD, hats off, we the producers only praise. Sensational, like the whole structure was made accessible from above. Perfect. Thanks to MFD. This is one of the best machines we've ever seen. WU4145

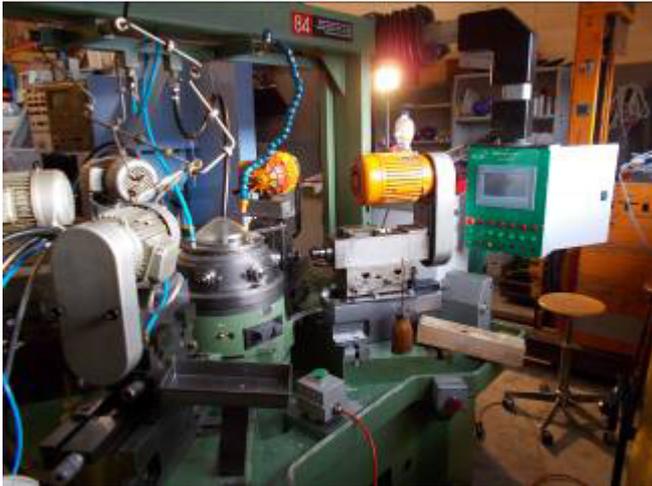
Move the units to a central location. Automate the machine. Simplified Operation. Smooth regulation. Compact. Replace. And much more. Conversion to new SPS and electrical cabinet. WU5150

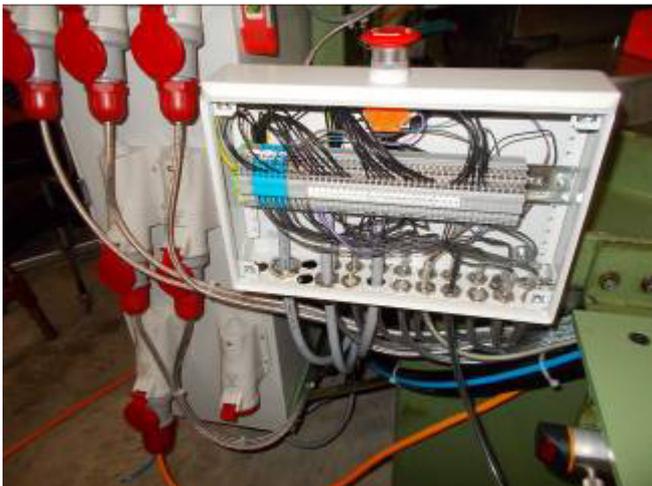
This collective cable box was arranged in order to not always open at the interference electric cabinet must. Also all cable entries from below that in the highly-operated with oil features the oil inlet is not possible, which is now placed under the units. WU5130e

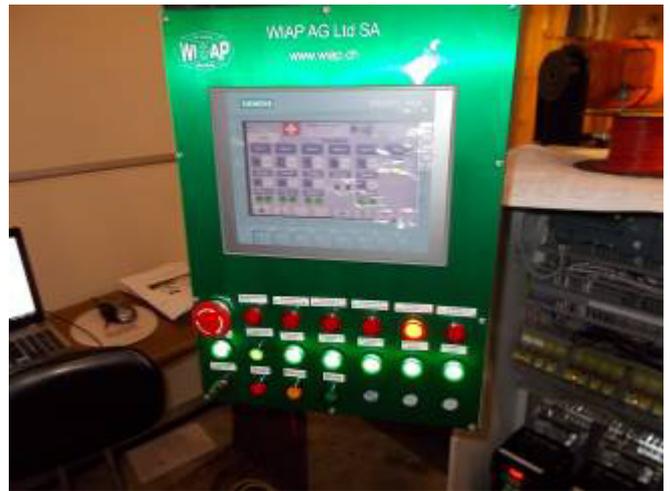
The panel in the final assembly phase. WU5130s

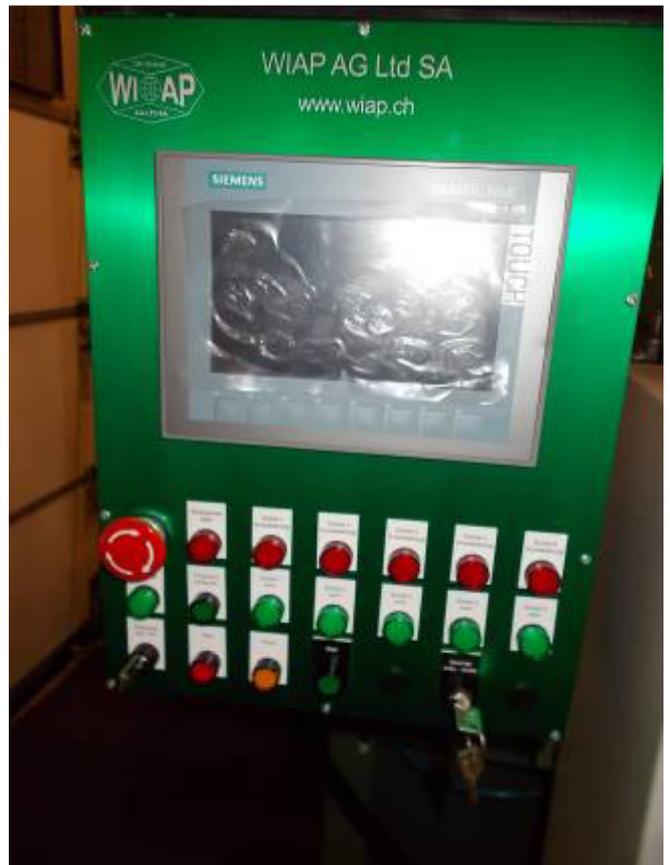
Soon finished panel of the machine. WU5130t

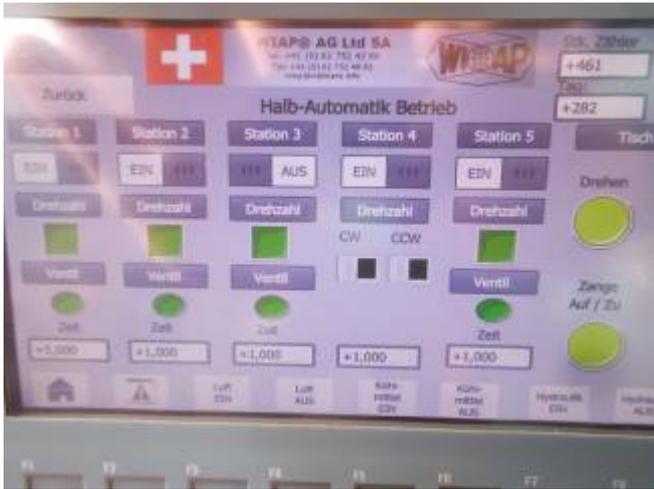
3 wallpapers of the machine:  
Hand, semi-automatic and automatic, easy for the surgeon, for safe handling. WU5130u

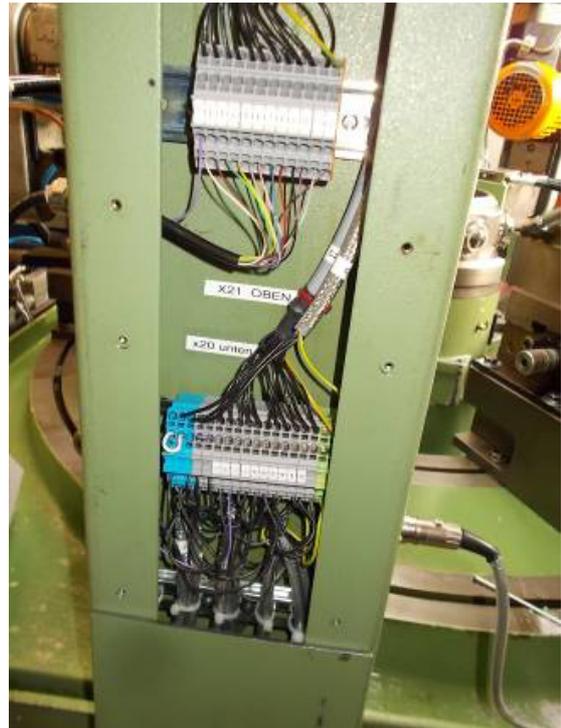
On the side of the column to the terminals for the external panel. So that the cables break without having to solder, the cable can be replaced quickly. WU5140

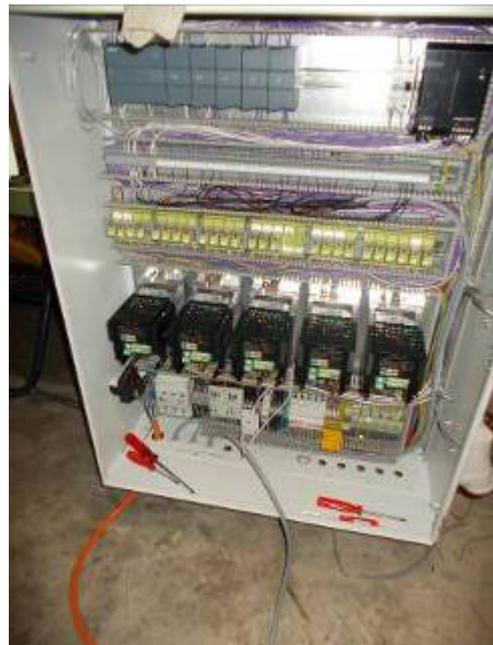
For all motors of the units we have installed instead of protecting equal 5 St. Frequency a 0.75 KW, which can be infinitely adjusted. From 0 to 70 Hertz, the option of up to 100 Hz. That is double the speed. Above the S7-1200 is arranged. WU5140c

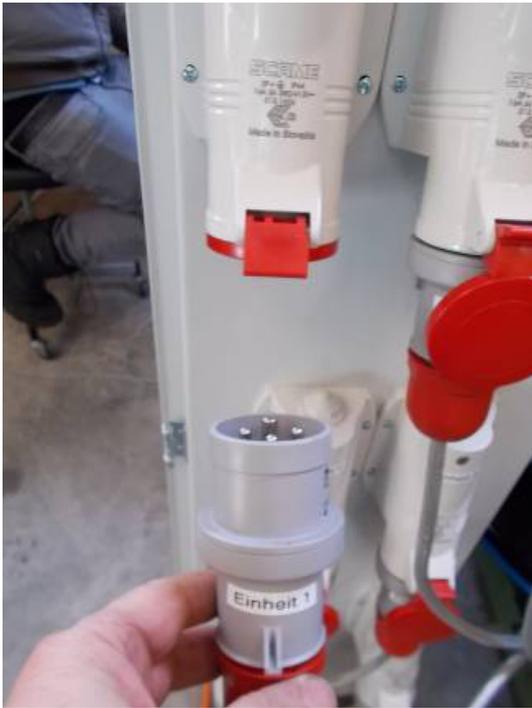
Each unit has its own plug. Thus, each unit can be dismantled individually. There's no danger to the operator, as the unit by unplugging the connector safely unplugged. WU5140e

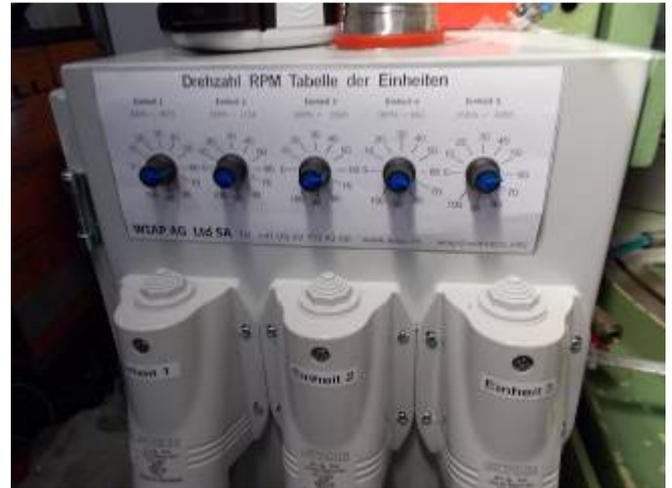
All units can continuously be regulated individually the speed. Thus, a simple adjustment by third parties is not inadvertently possible; we have installed a Plexiglas with the rotary knobs. WU5140h

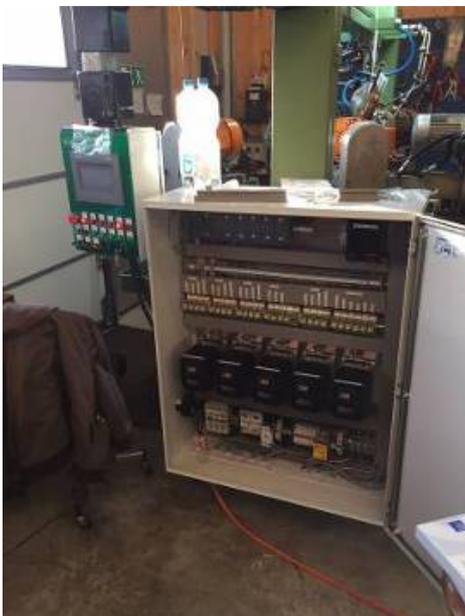
be done without electronics also by the surgeon. That is detecting whether the error source is electrically or mechanically. WU5140f

All relays are additionally written on the cable channel that when troubleshooting is recognizable without wiring diagram, what is for what. All functions passing through relays, so that everything can be selected from an external telephone. If errors in the PLC are not recognized immediately, a preliminary diagnosis can already

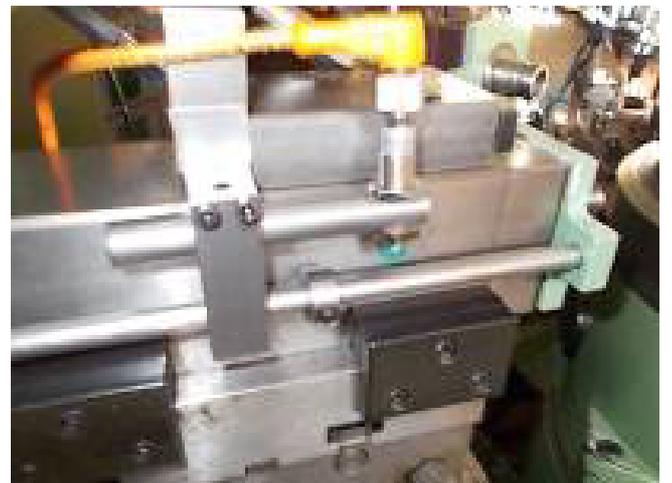
The unit 1,2,3 and 5 had no front position switch. That this can work time with an excision; we have designed, manufactured and installed that when the switch forwards reports the input time of the Panel will wait to allow a cut of this scarf linkage. That is, this switch must never be set because the Hub, 20 or 40 mm is constant and only the switching point from rapid to feed with a screw as shown in Figure WU5140j can be adjusted. WU5140l

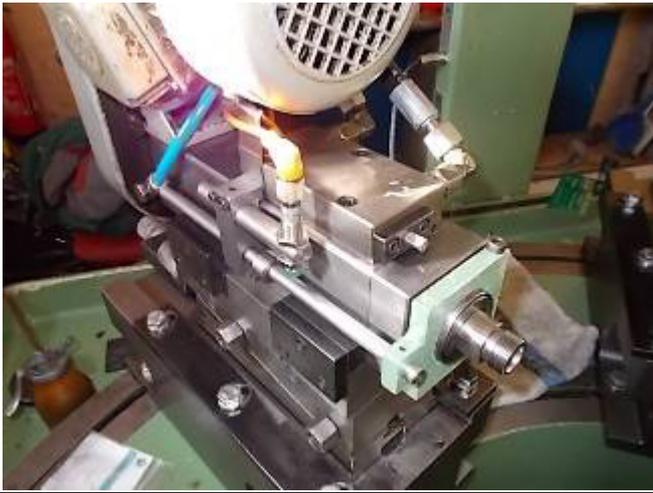
View of the lifting unit from above. The fact that the unit is back, we could use the old signal and had to install any additional switches. What would also have been a problem? Preparations are present. WU5140n

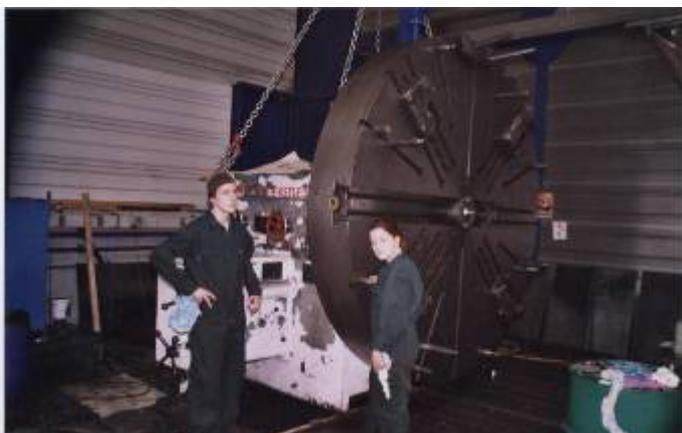
The machine had a geometry error. The client asked us to correct this. Electrically were still contactors and relays in the machine, which were

for the museum. These were also replaced the same. WU3270

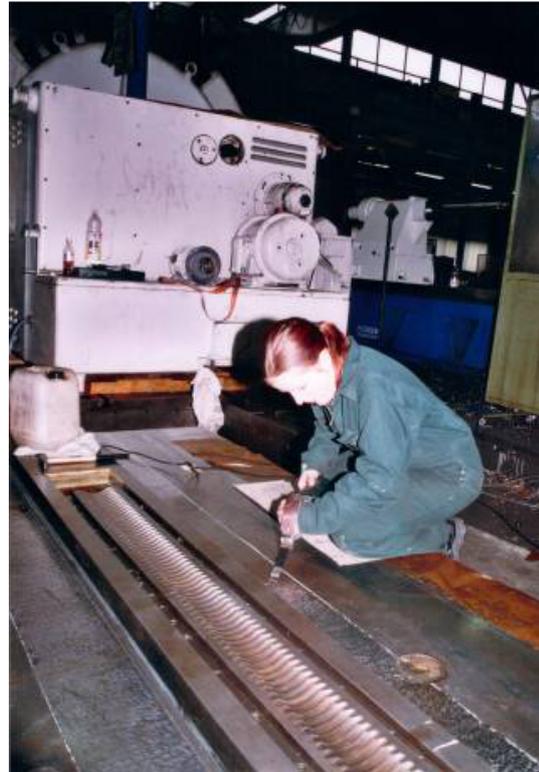
Now the problem with the shaving machine was corrected. As a rule, per scraping passage, depending on the pressure, about 0002-0005 mm away, i.e., when an error in the 0.1 mm range is, but a lot needs to be scraped. WU3130

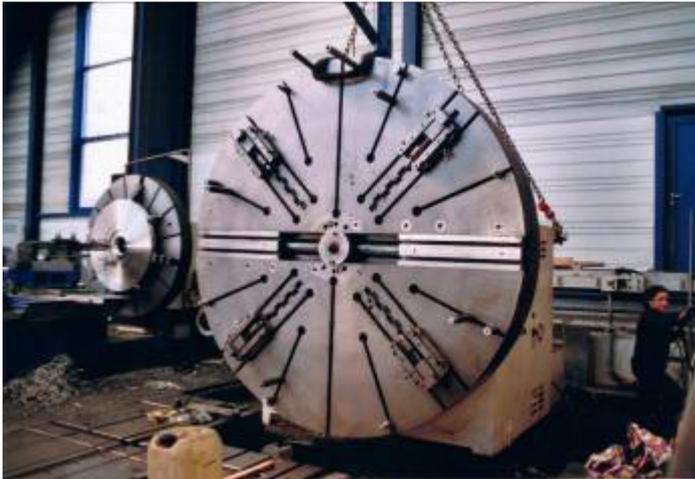
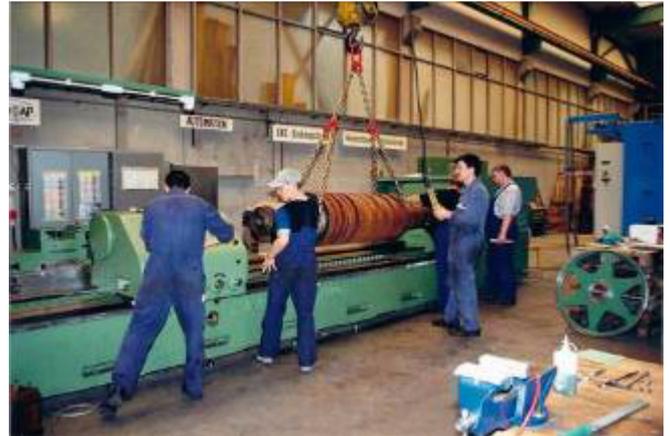
Put new so a terrible headstock for each measurement, is tedious, that it is worthwhile to know exactly how many hundredths are where removed by scraping. Thanks to the great experience through many renovations and the intensive training with lathe manufacturer all employees were able to learn a lot and can also experience USING to perform a good job. WU3025

Task: The conventional copying roll lathe to get a new control CNC. With total revision. The surgeons had to copy itself usual, so very simple parameterized, conceived by WIAP and created CNC programs. Only a few entries with R parameters could all be typed. New ball screws 80th in the Z axis. Bed reground, new scraped carriage. New automatic lubrication system. The 4 claws boxes were also revised.

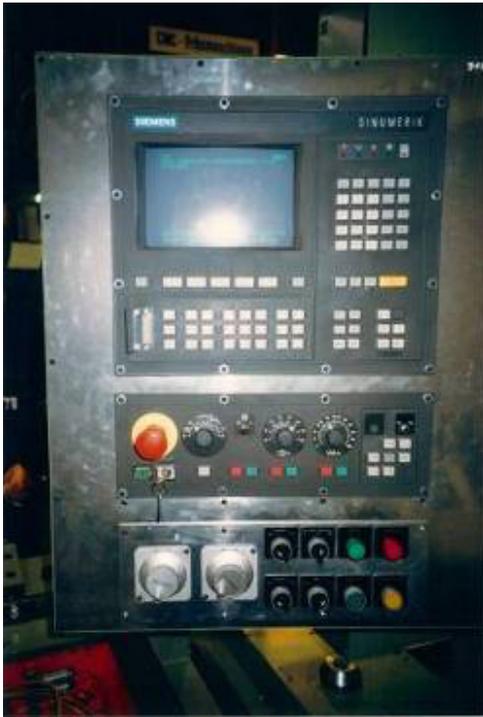
The CNC Sinumerik 810T was made easy to use for operators, almost no switches were needed to work with the machine. WU4605

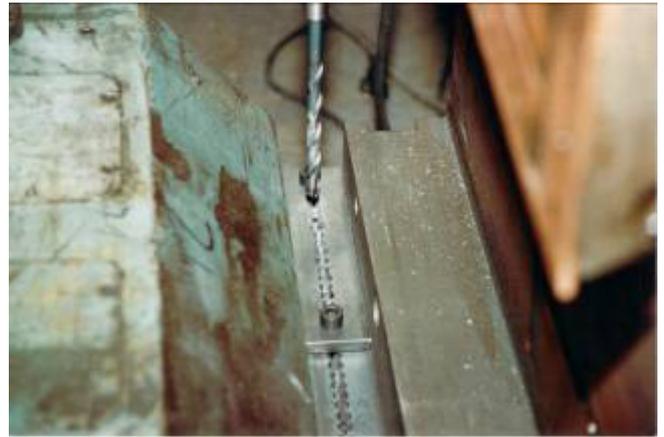
In Russia, if not boring was present also elements were separated. It is something that had to learn a machinist yet. WU4627

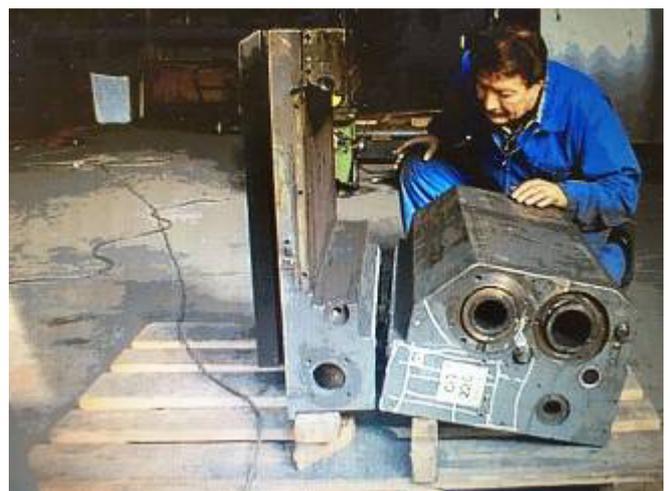
The roll lathe MFD was approximately 40 tons. The old feed gear portion was separated. WU4630

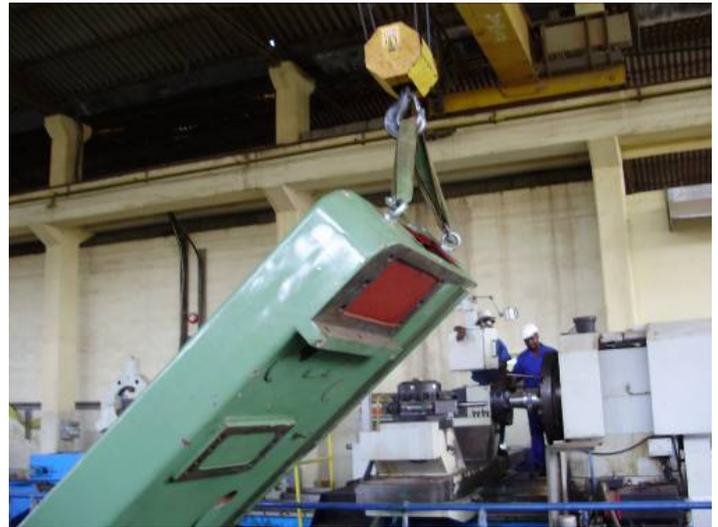
Setting up phase 2. WU\_240\_40
