## Umbauten, Erneuerungen, Retrofit

Photo report collecting information WIAP 2016 WU500

### The WIAP has some remodeling done projects. Below are a few excerpts.

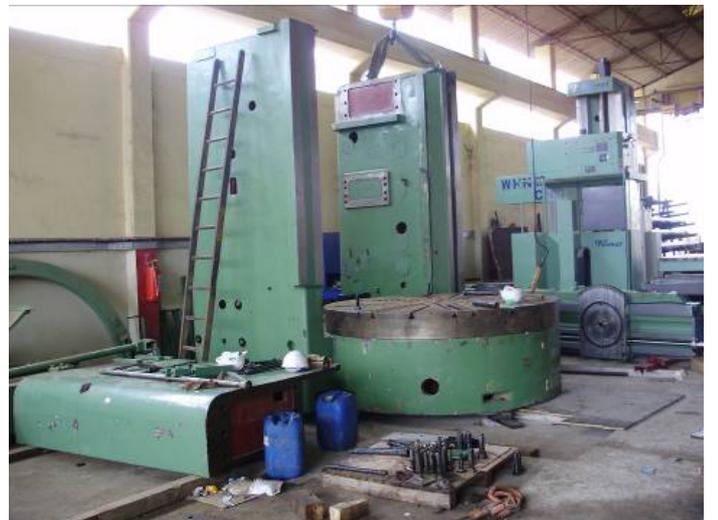
Now the 2nd side stand is mounted. WU\_240\_50

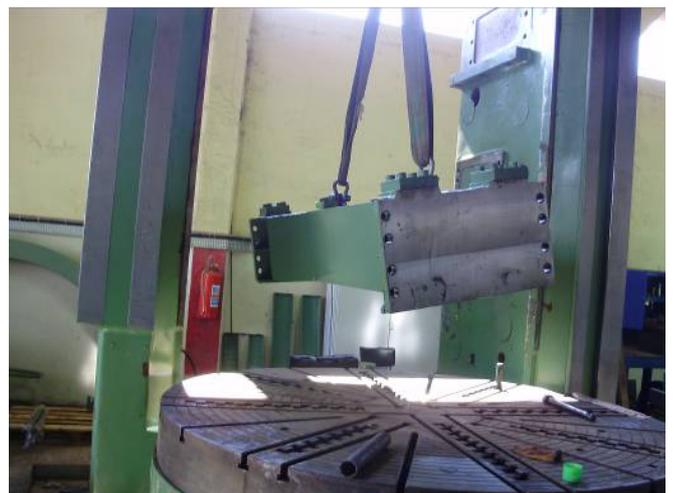
The side stabilizer below. WU\_240\_60

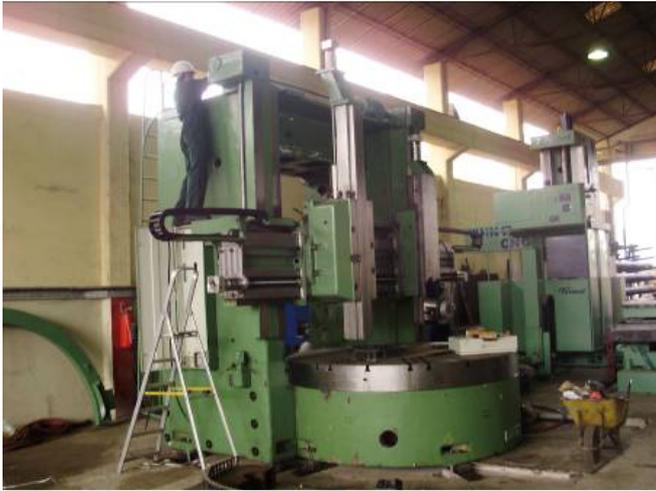
Previously a conventional turret lathe and now new a CNC controlled machine. WU\_240\_210

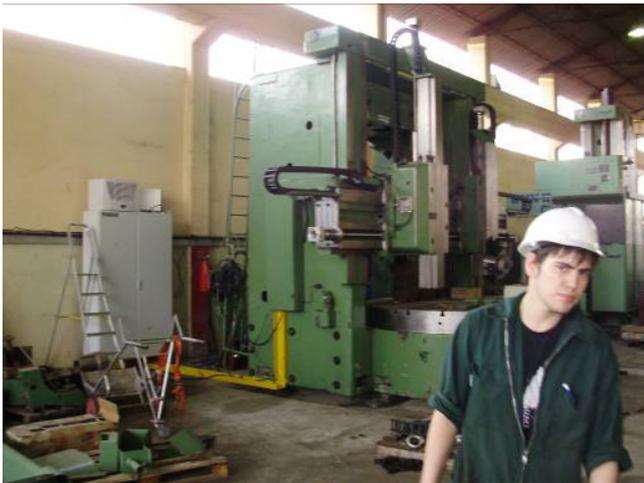
Start the cabling. Sven Widmer. WU\_240\_220

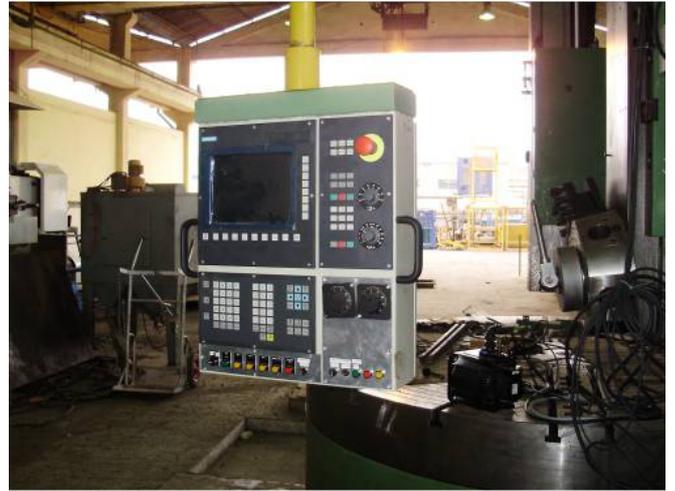
Sinumerik CNC. WU\_240\_240
